Tanami Gas Pipeline
Annual Compliance Assessment Report
EBPC 2017 / 7997 – 2023/24

E-REP-089

Revision: 1
Date: 6 August 2024

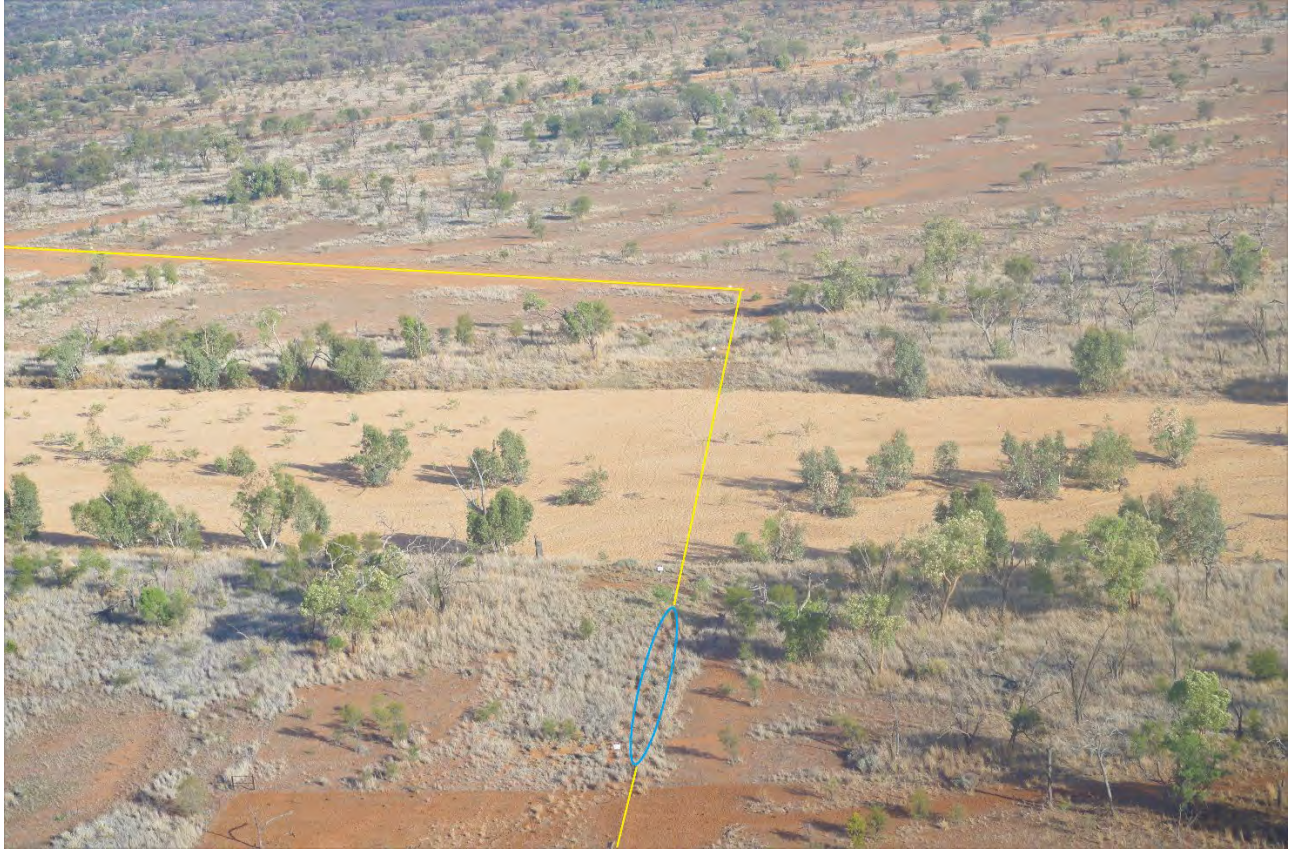
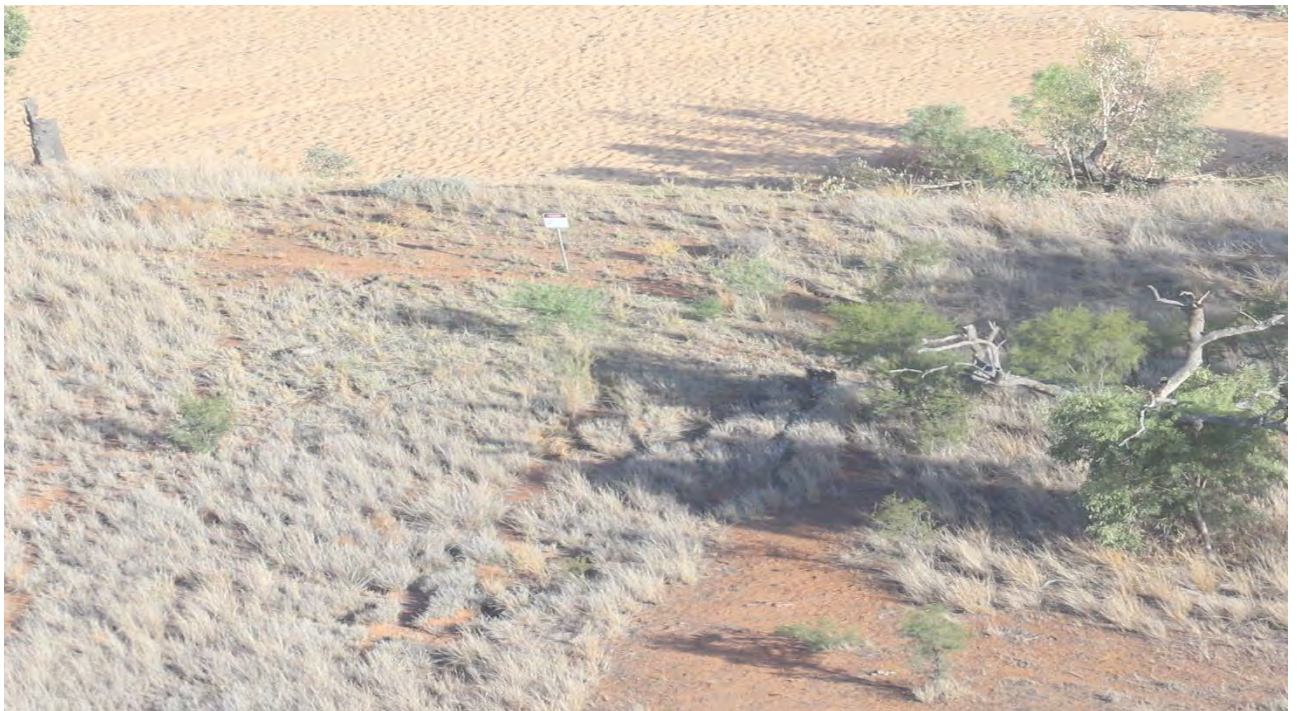
- No change observed as previously reported to erosion on the upstream side of the Napperby Creek.
- Average 400mm wash out over pipeline and 35m long; 700mm depth of cover at lowest section.

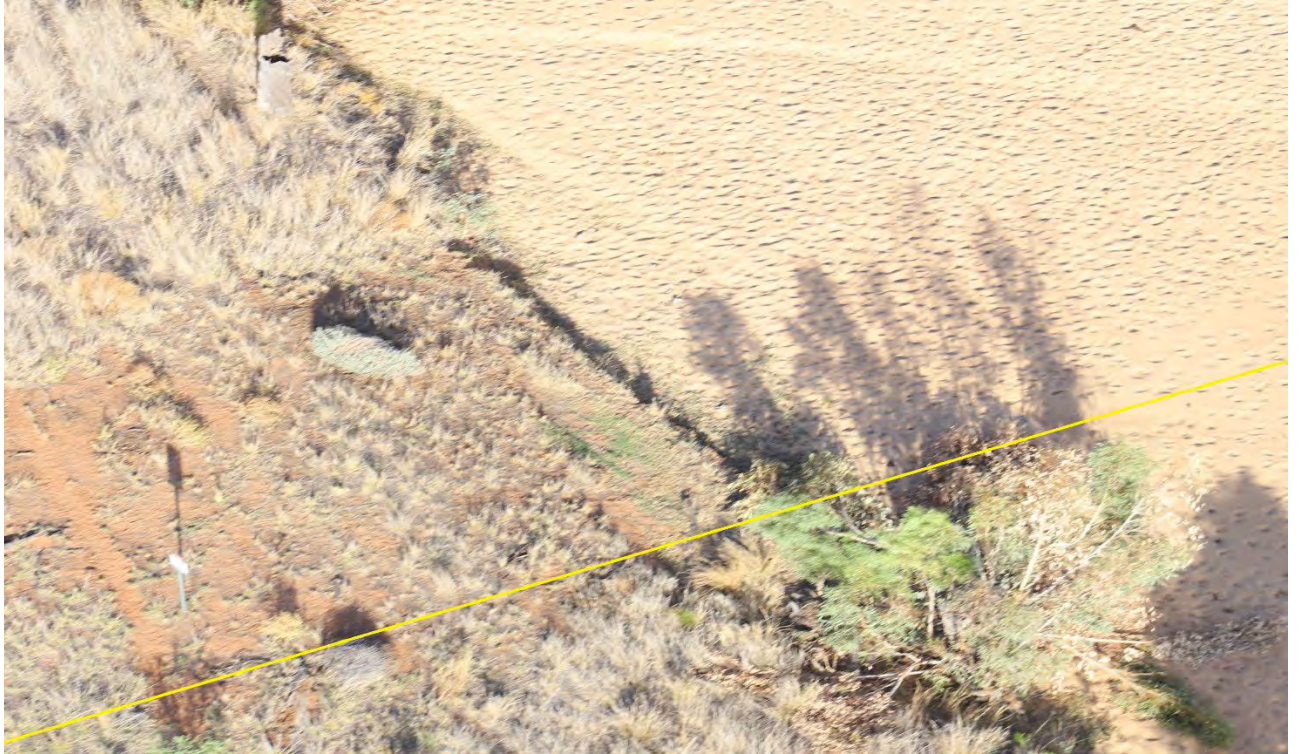
February 2024:

- Below image shows the current condition of the creek.
- Upstream bank had significant damage but no major changes since Feb 2021.

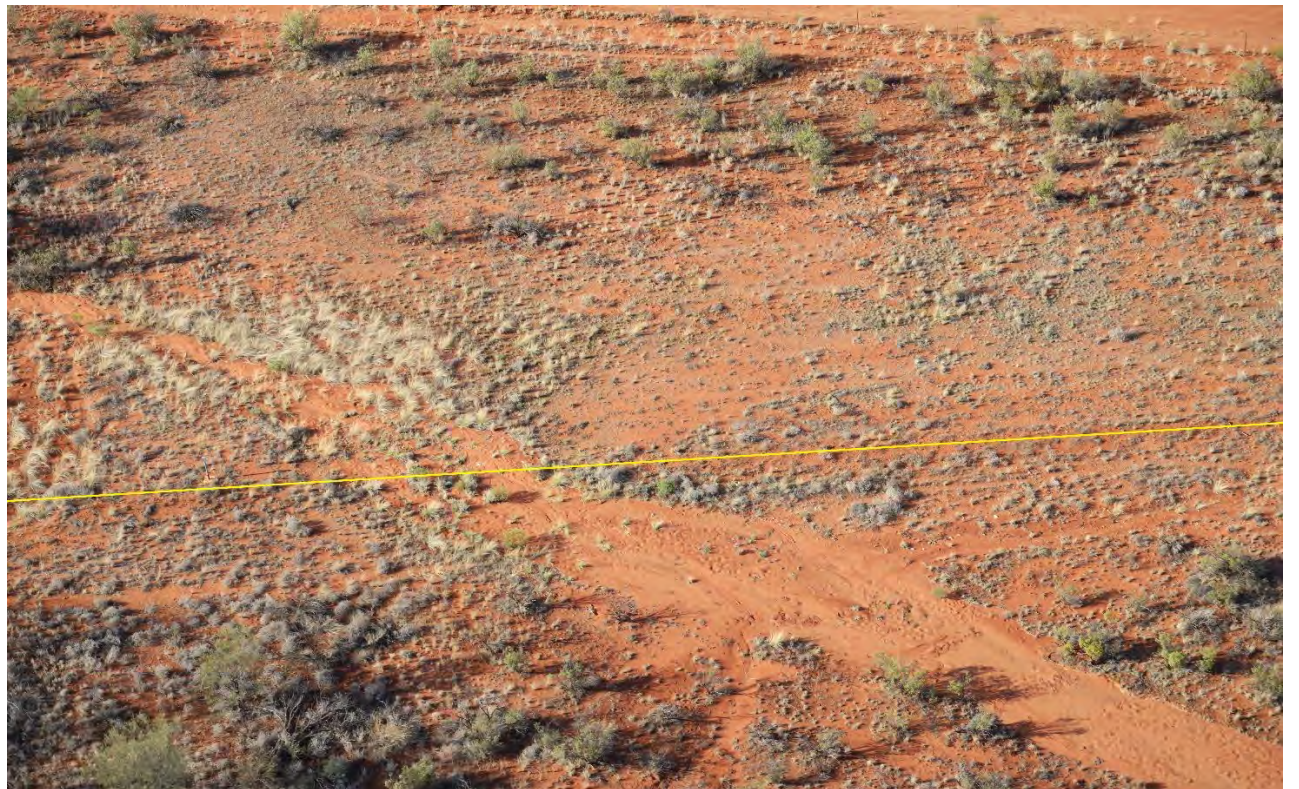
KP 40.01

- No major changes observed to the existing erosion at the T3 water crossing.

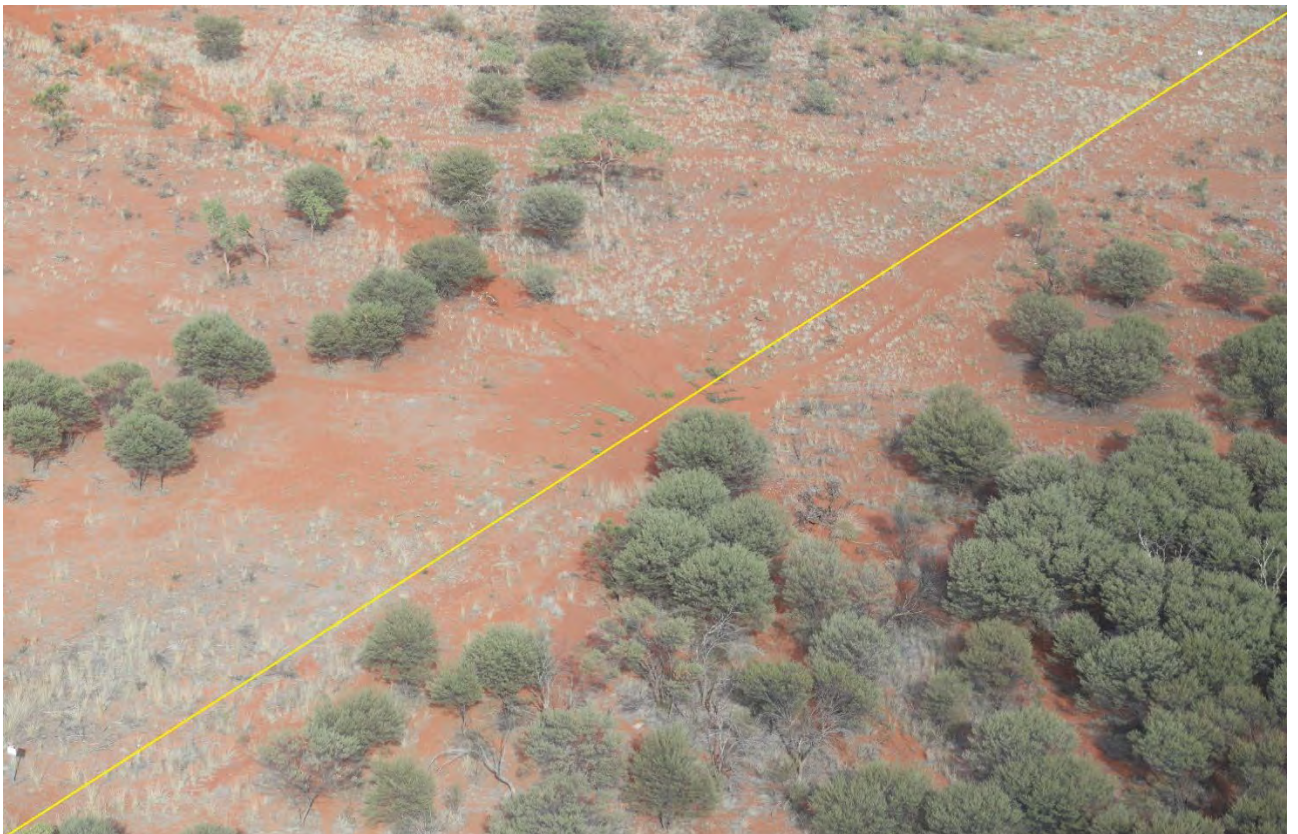
KP 133.60

- Image below shows no significant changes observed to the erosion developing across the pipeline at this location.

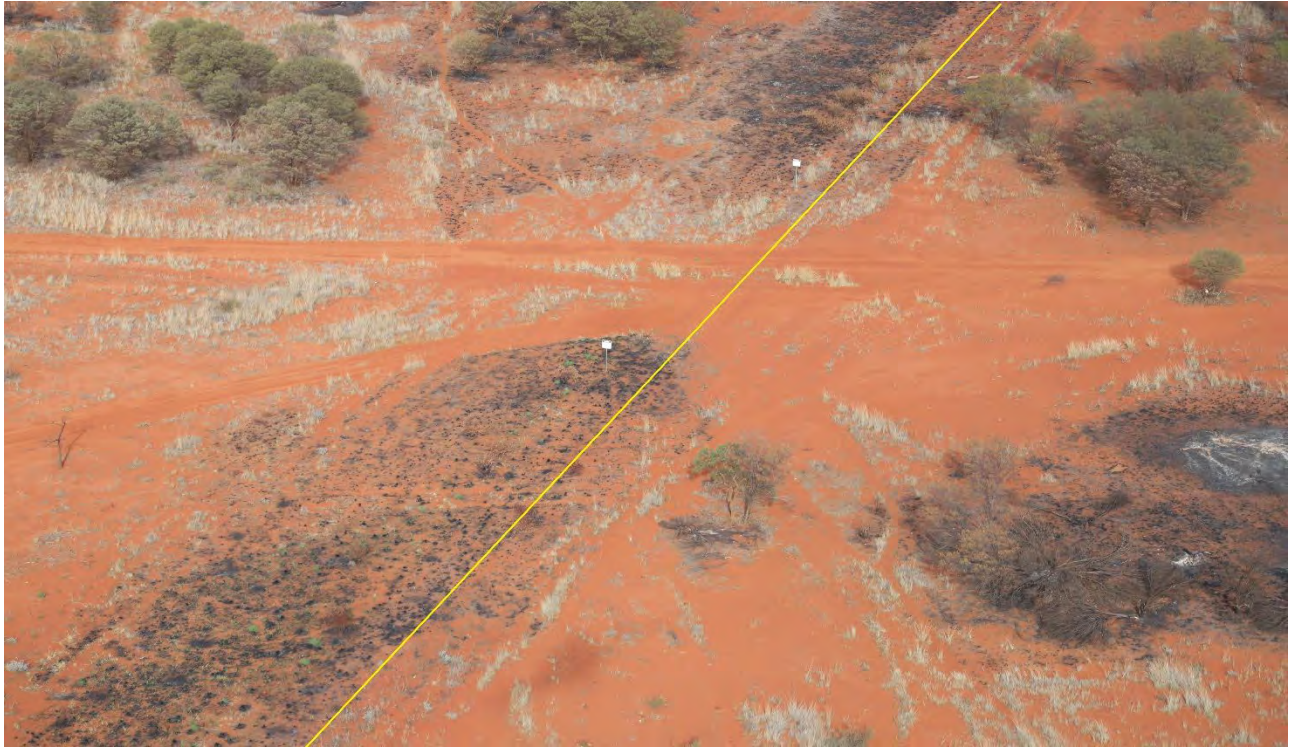
- Road crossing appeared in reasonable condition.
- A small scrub fire has crossed over the easement since previous report, Danger signage remains readable.

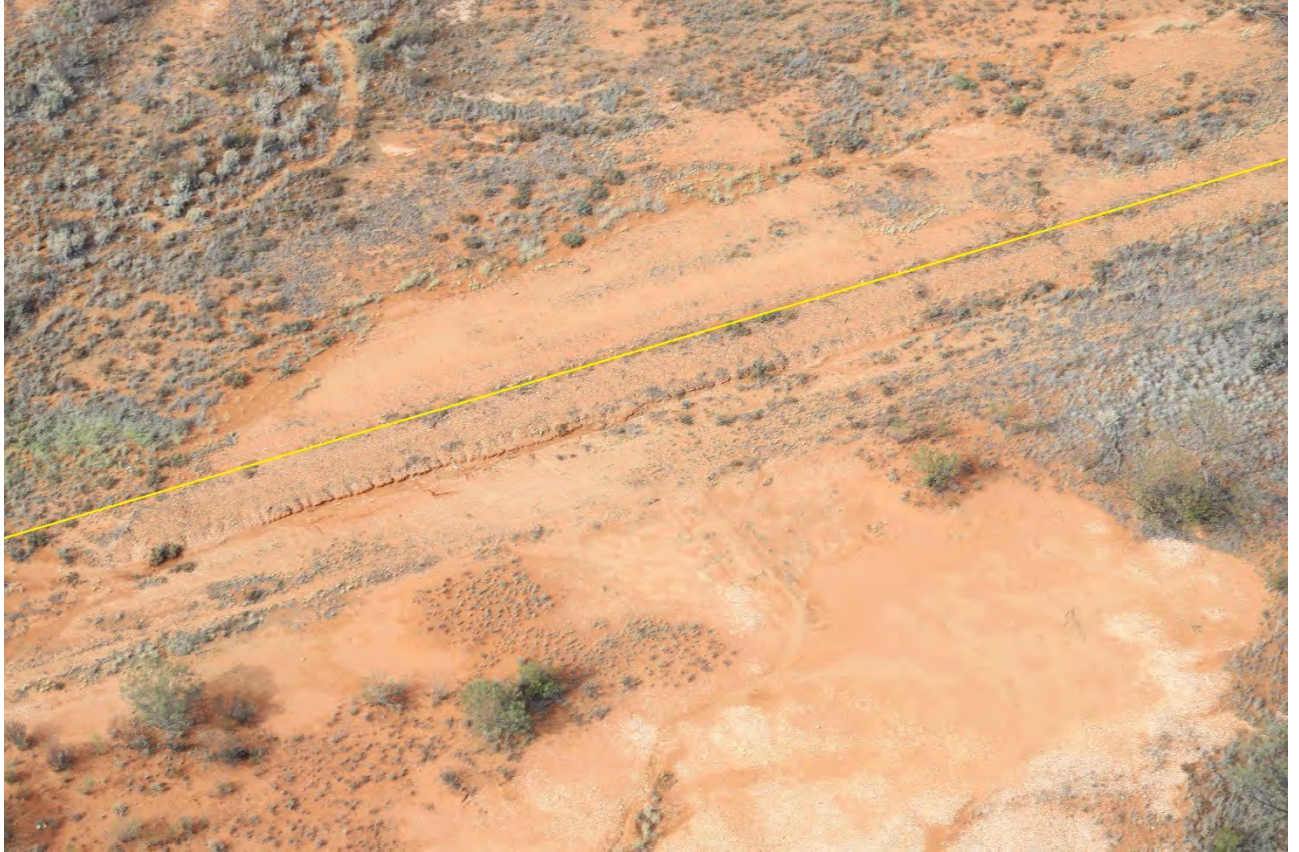
- Known and previously reported erosion paralleling the pipeline remains without change.

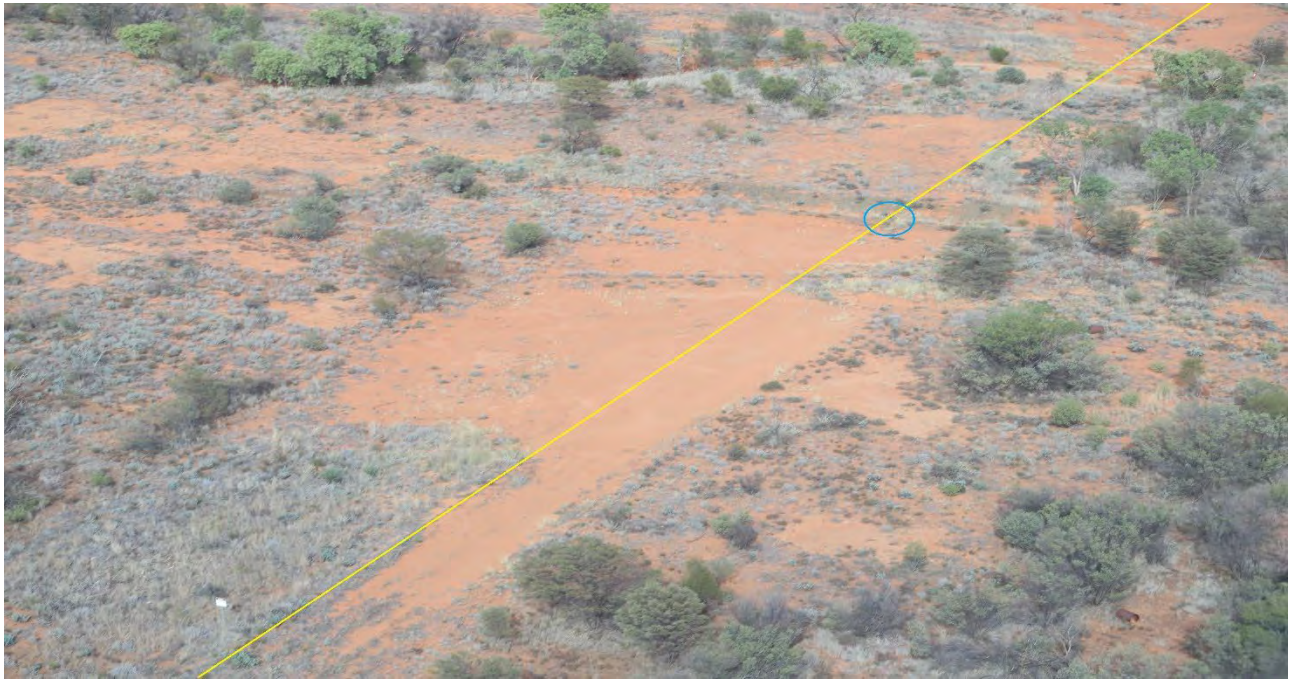
February 2024:

- Creek appears to be in reasonable condition and no significant change to erosion observed since the time of last flight.
- The erosion appears to be at least 1m in depth on the D/S bank.

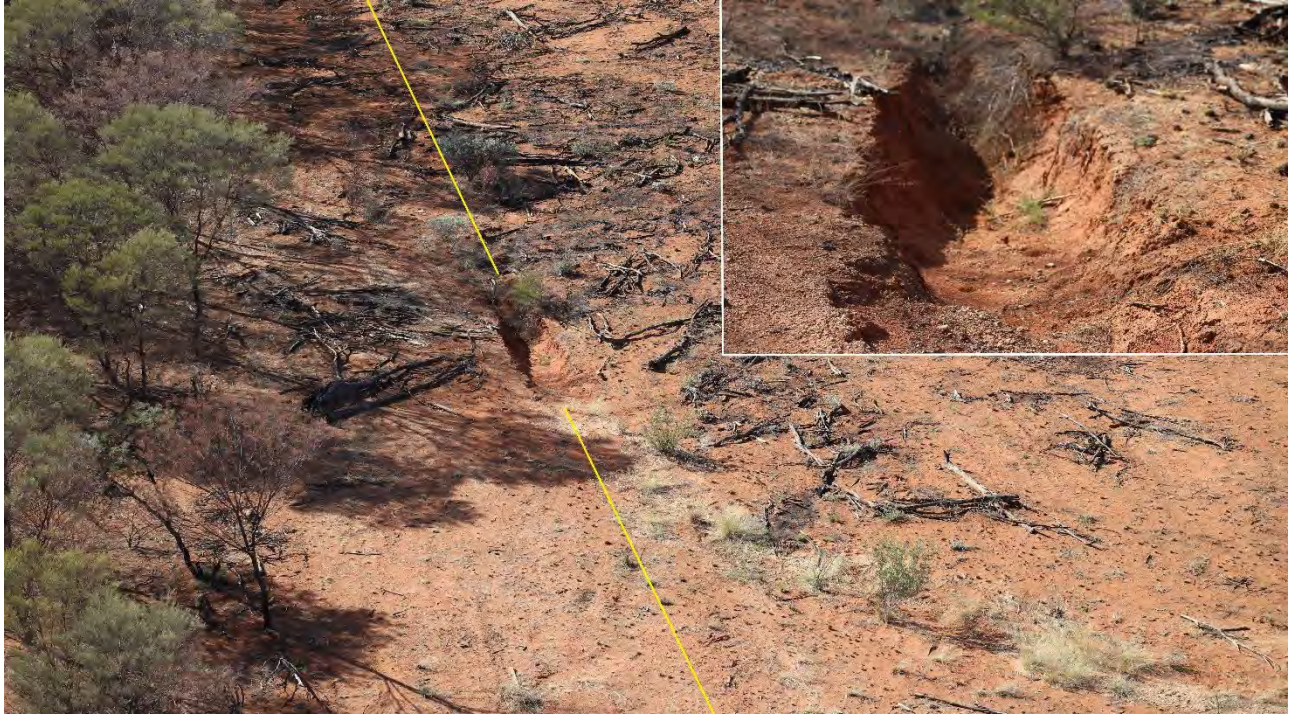
<p>KP 178.78</p>	<ul style="list-style-type: none"> Below image shows the current condition a of previously reported subsidence over the Tanami pipeline area. Helicopter landed and confirmed the depth hasn't changed since previous inspection (December 2023) subsidence remains approximately 900mm below NGL, leaving approximately 600mm of cover over the pipeline. This remains unchanged since the location was inspected in April 2023.

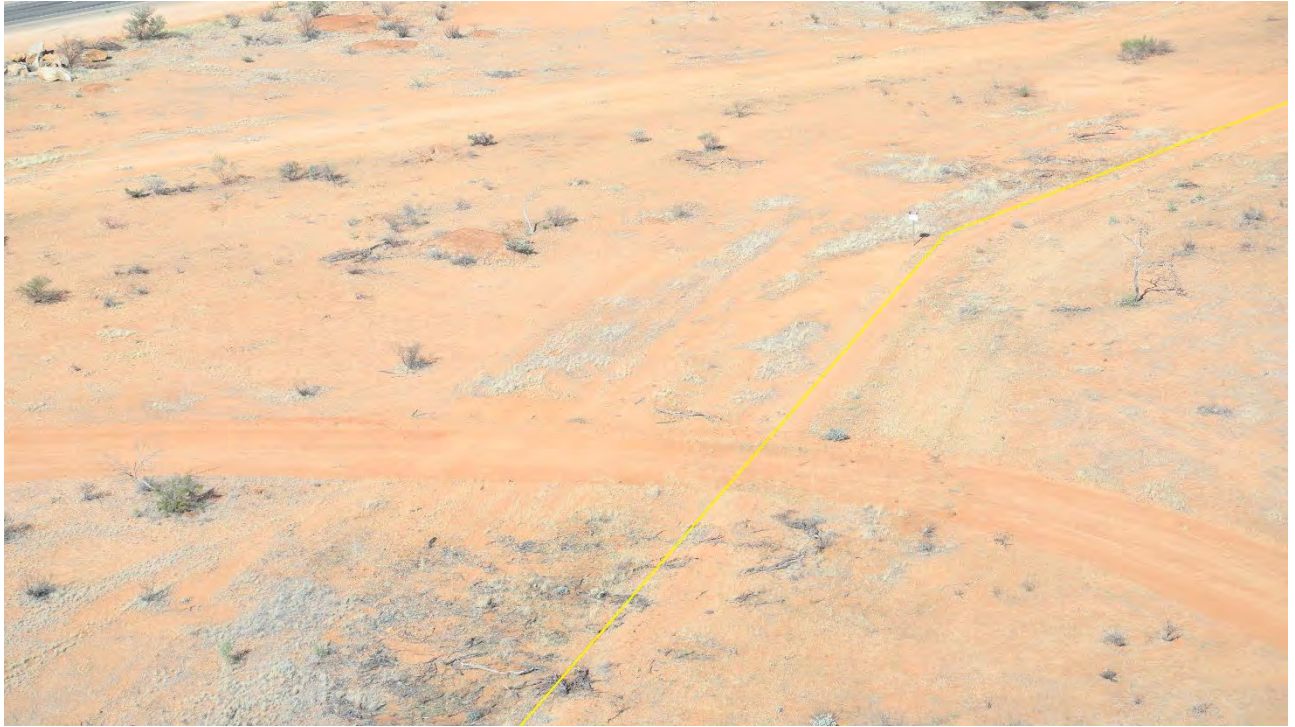
- Image below shows a track that has been graded across the corridor at this location.
- This does not align with the list of approved crossings initially provided by Exact contracting; enquiries continue.

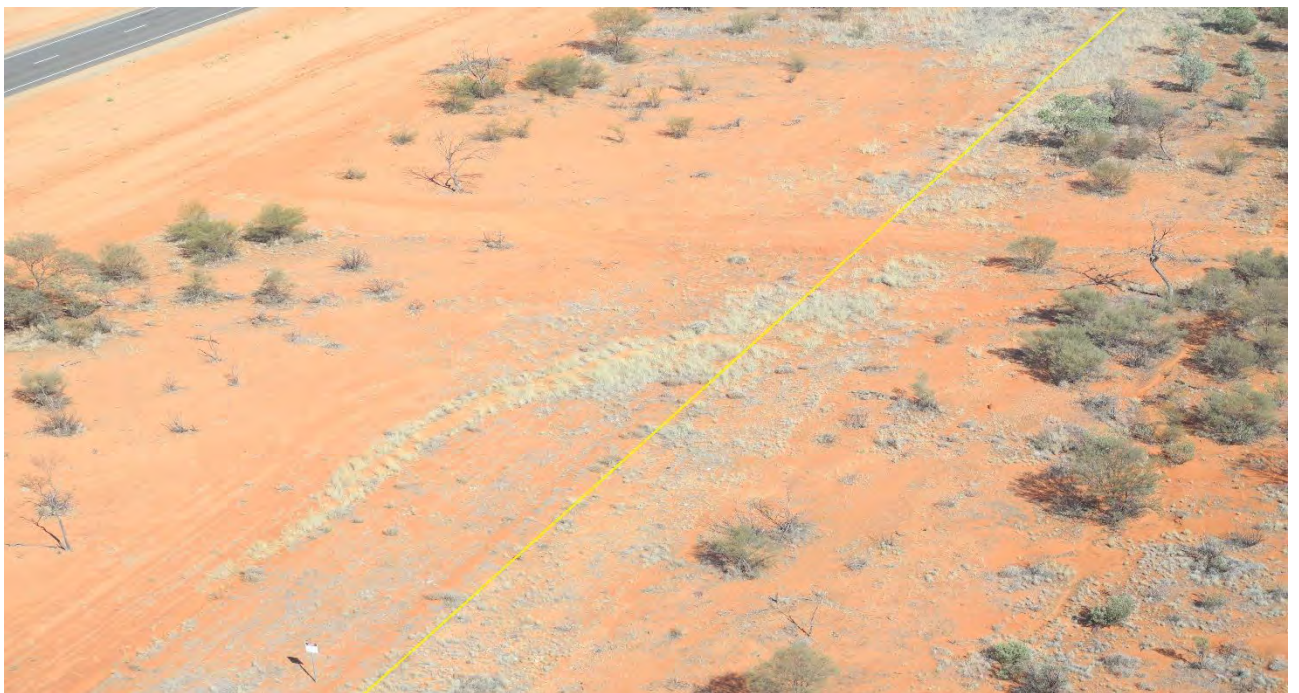
KP 191.61

- Image below depicts an ad hoc crossing / clearing that has not been previously observed.
- This does not align with the list of approved crossings initially provided by Exact contracting; enquiries continue.

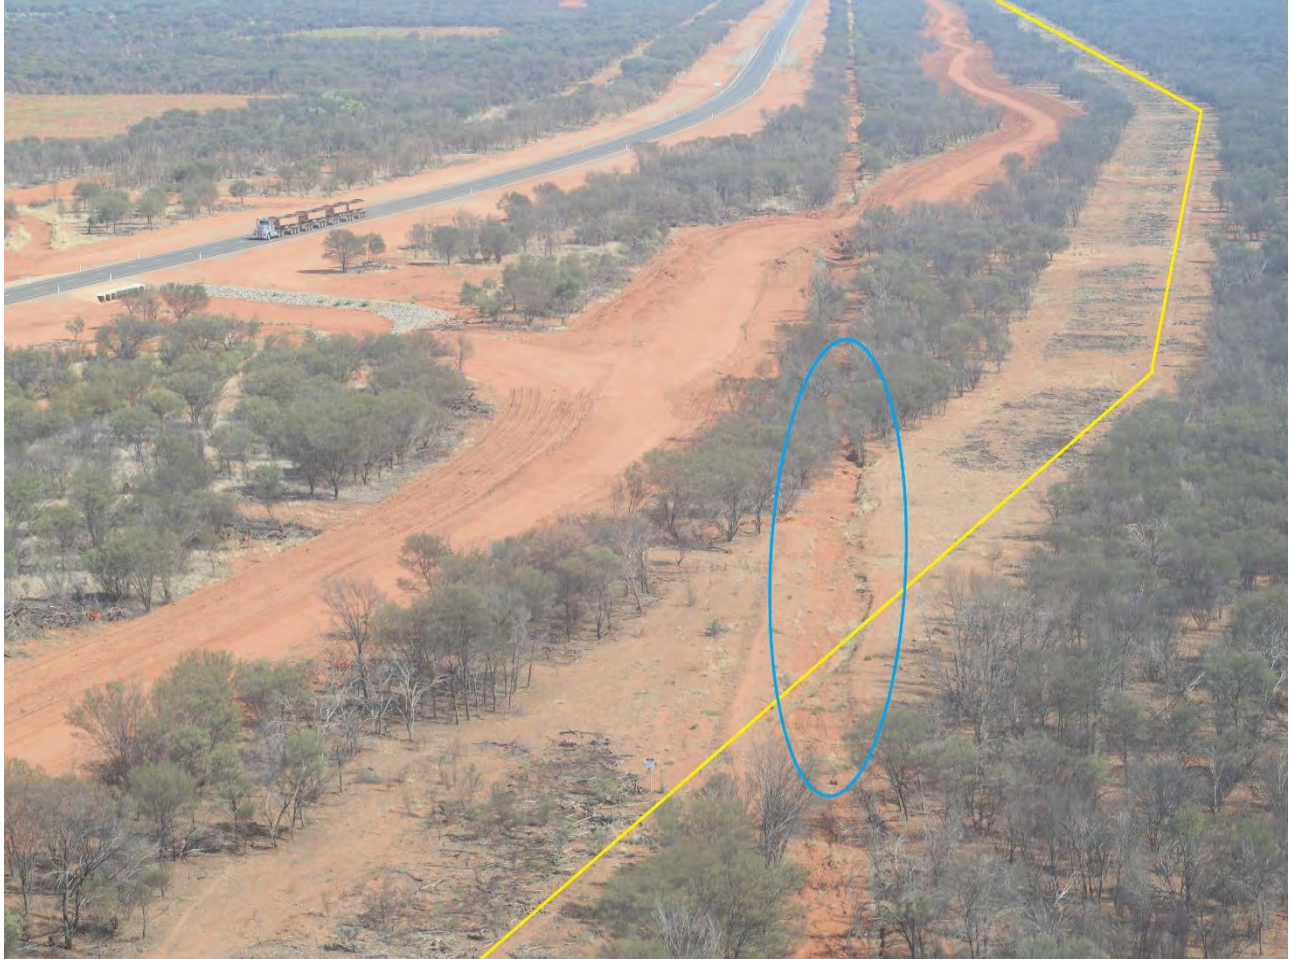
- Below image shows the activity surrounding the previously reported major erosion and washout.
- New headwall and drainage culverts have been installed to direct surface water to this pre-existing channel across the pipe corridor as part of the Tanami Road upgrade.
- Increased water flow may lead to further erosion across the pipe; ASO's will continue to monitor.

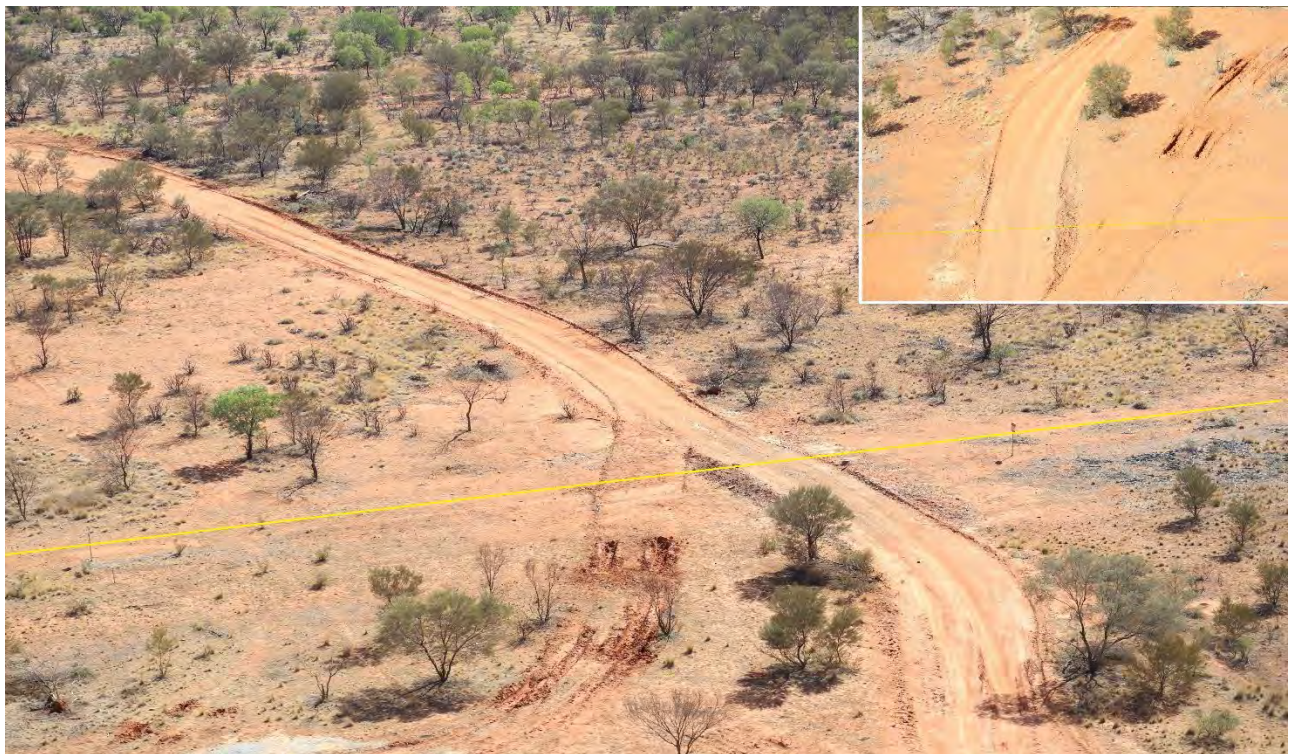
KP 228.39

- Below image shows an approved H.V crossing (No.12) built up by Exact Contracting for works associated with the Tanami Road Upgrade.
- No change to the previously reported wheel ruts in close proximity to the pipeline.

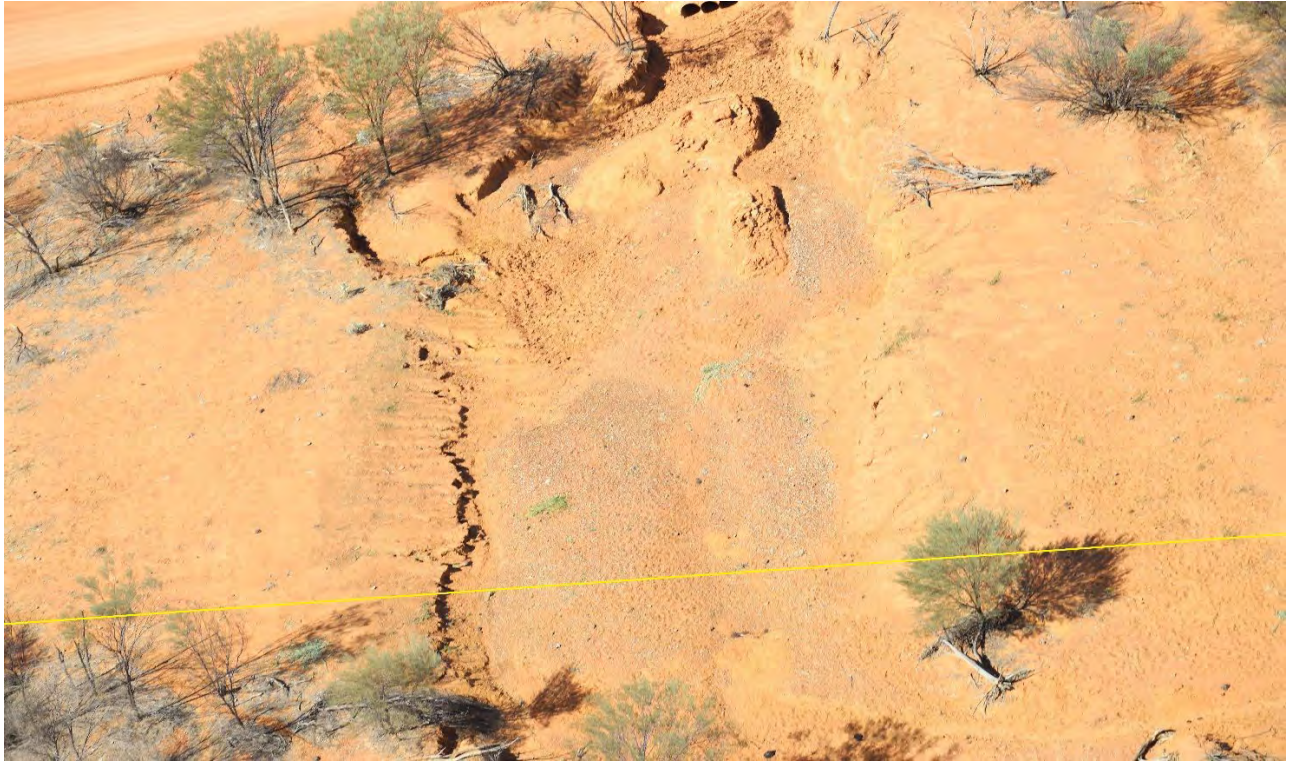
- No change observed to the previously reported erosion on the upstream bank of the unnamed watercourse.
- ASO's to continue monitoring.

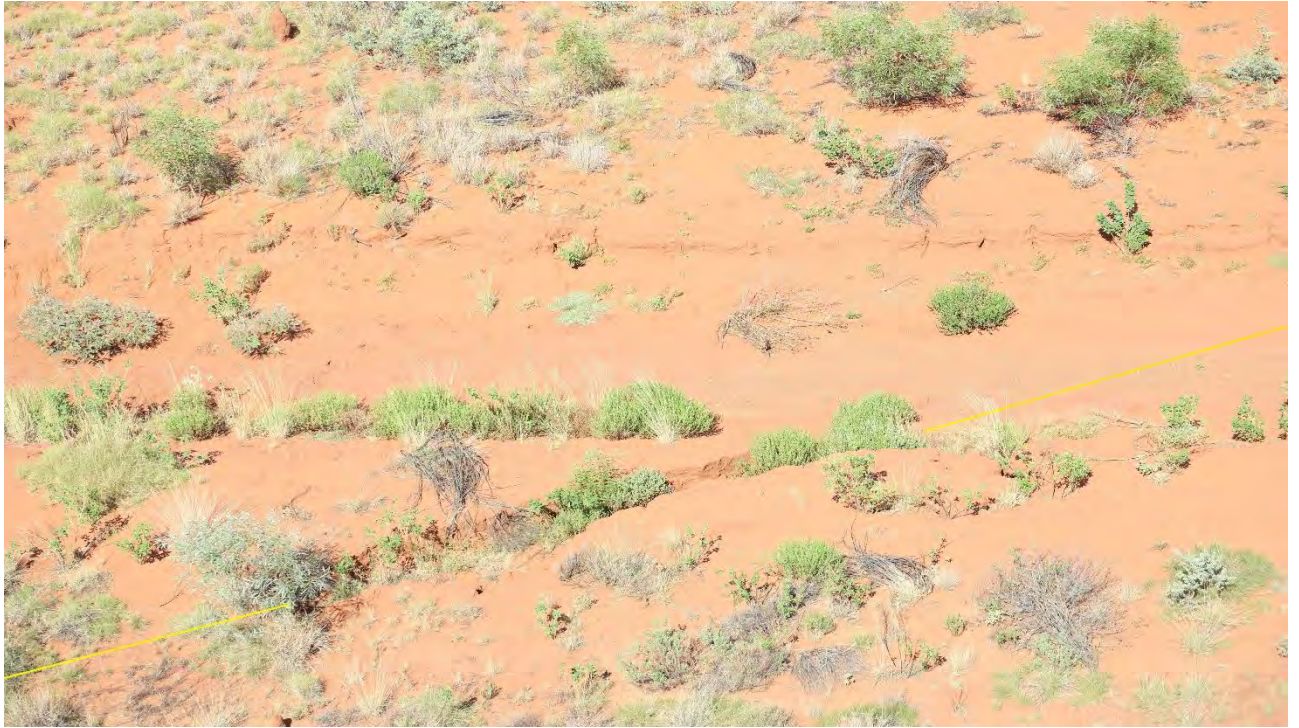
- No major changes observed to the significant erosion on the upstream bank of the swale drain.
- Helicopter landed August 2023 and measured remaining DoC at 2100mm

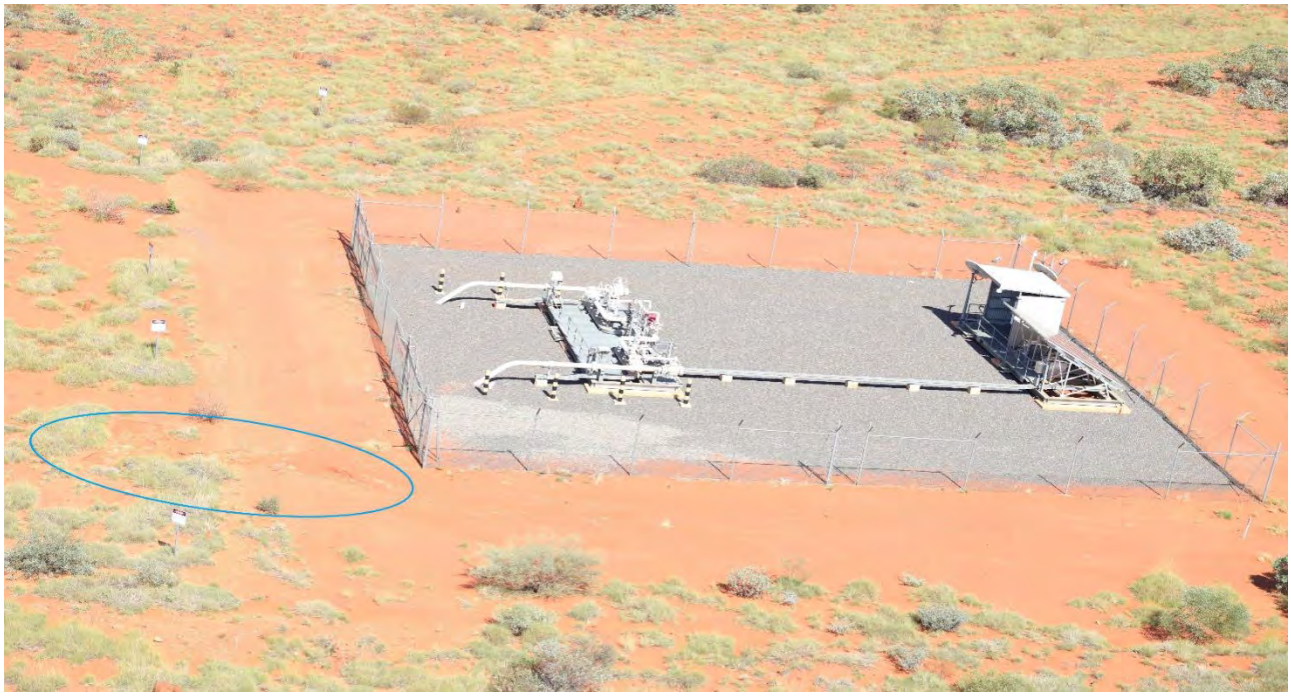
<p>SS2 Chilla Well KP 279.37</p>	<ul style="list-style-type: none"> • Appeared correct and secure at the facility. • No significant changes observed to the previously noted erosion; 400mm deep, 600mm wide and approximately 4 metres long.

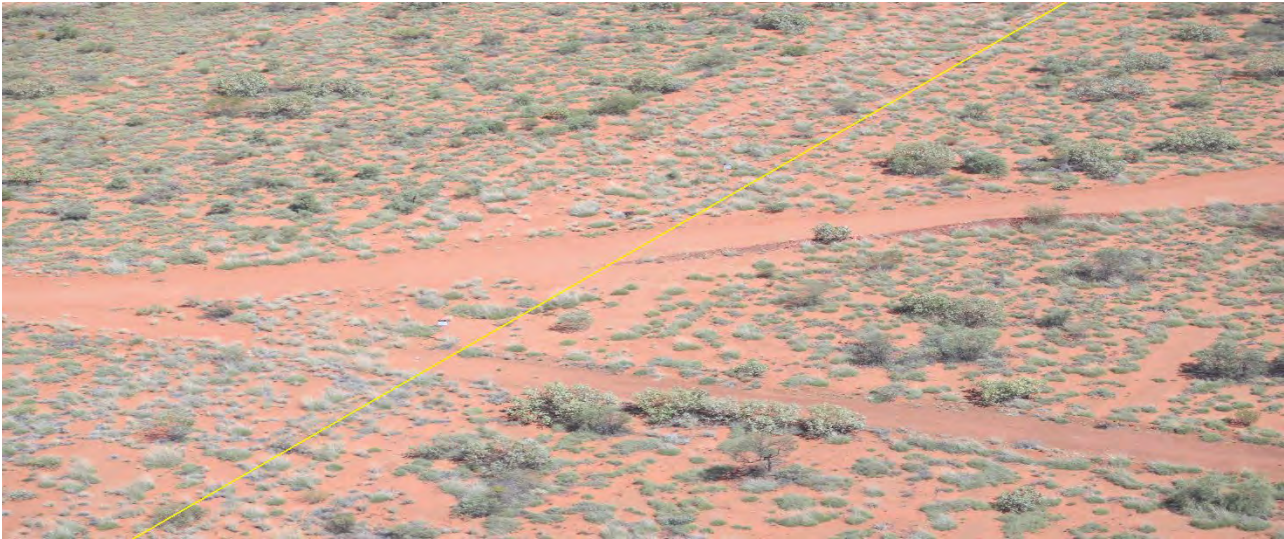
<p>KP 335.14</p>	<ul style="list-style-type: none"> • Access track to the gravel extraction site in proximity to the easement appears in good condition. • Moderate erosion observed just upstream of the track, remains unchanged.

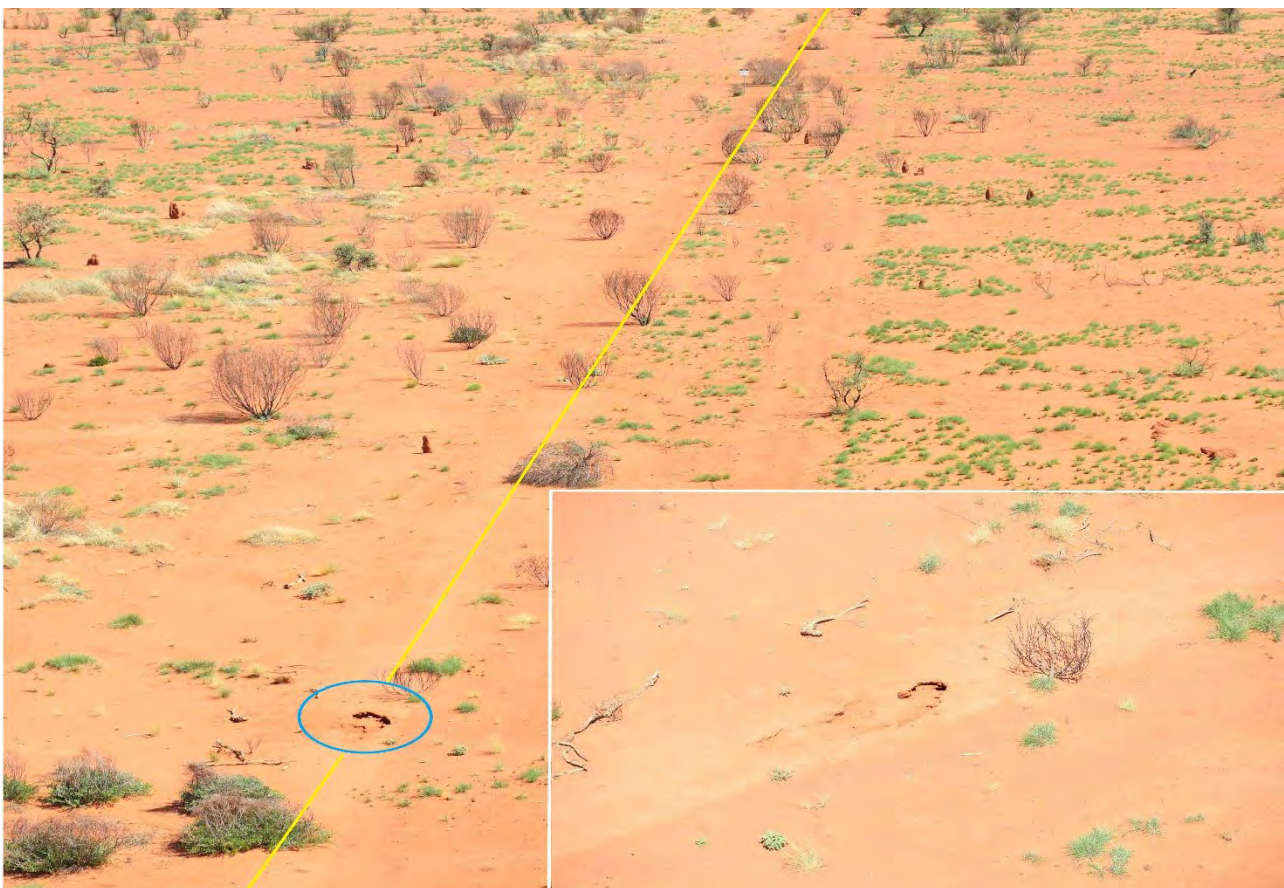
<p>KP 365.00</p>	<ul style="list-style-type: none"> • Below image details subsidence has occurred over the Tanami Pipeline. The NGL has dropped by approximately 200mm leaving an electronic DOC of 1500mm remaining. • ASO's to continue monitoring.

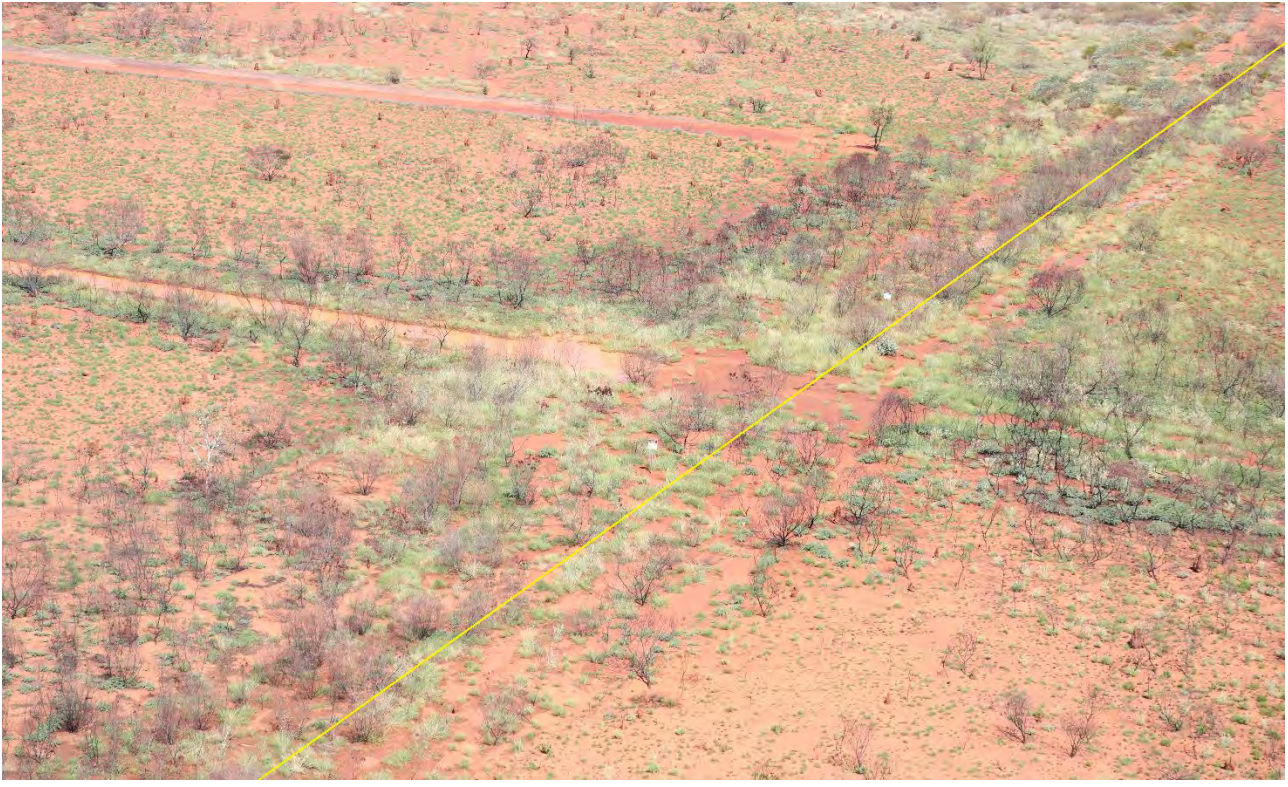
<p>KP 397.50 Granites Airstrip</p>	<ul style="list-style-type: none"> • Image below shows recently formed drainage channels from the airstrip directed to the pipe corridor. • Recent rain has increased vegetation in the area, line of sight issues developing.

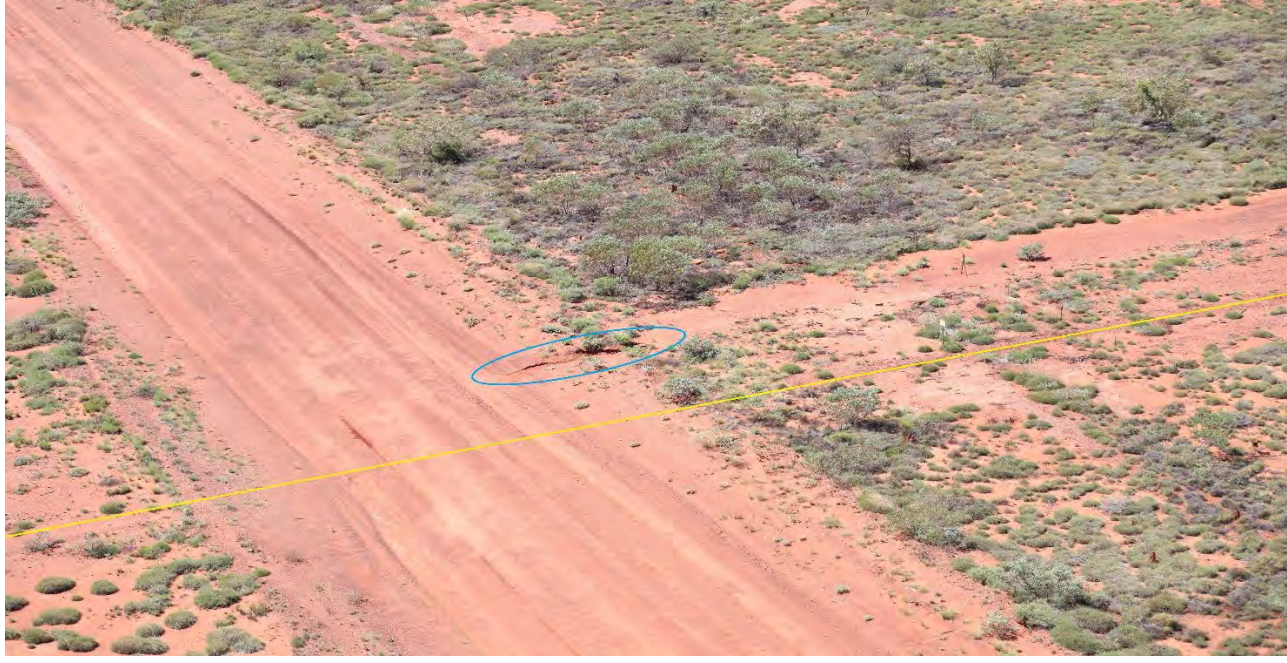
<p>Granites Lateral</p>	<ul style="list-style-type: none"> No change to the previously reported erosion observed on the easement. This does not pose a threat to the asset.

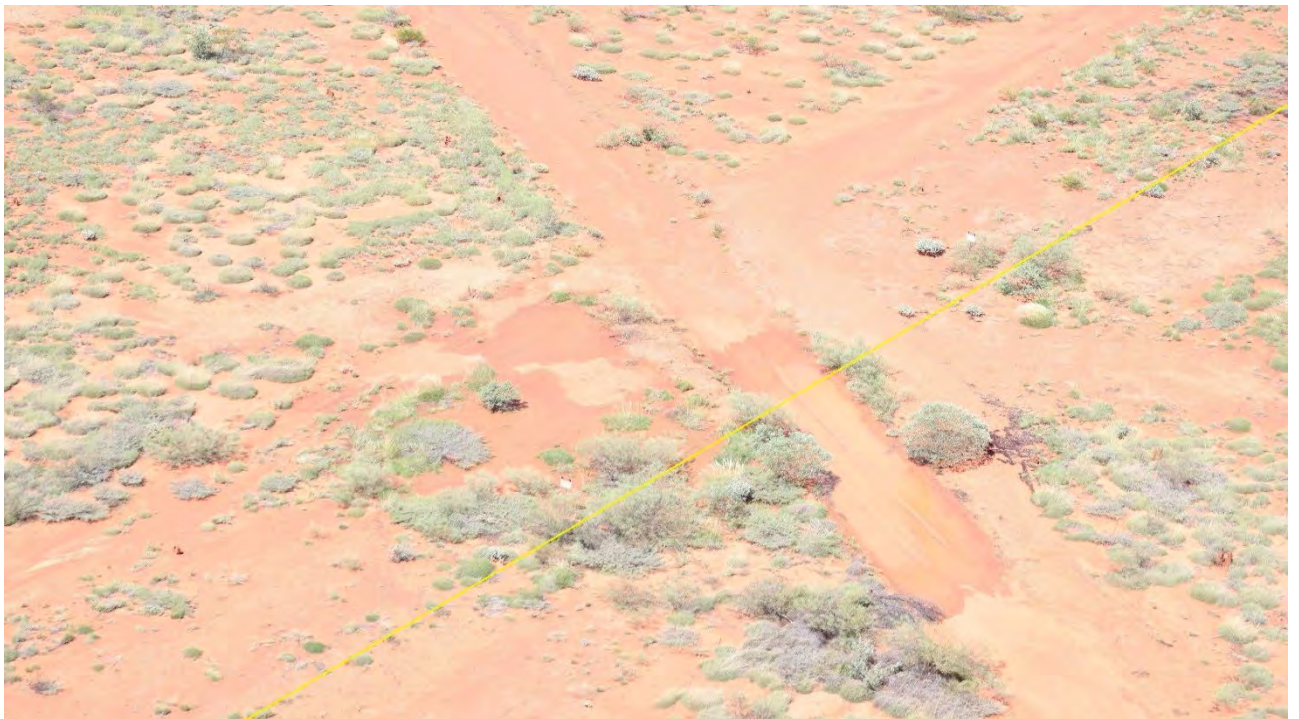
KP 402.77

- Below image depicts vehicle activity over the Tanami pipeline has occurred on an access track leading to the Granites mine site tailing ponds. Wheel ruts have occurred due to recent wet conditions.
- Full depth of ruts is unknown until water dissipates.

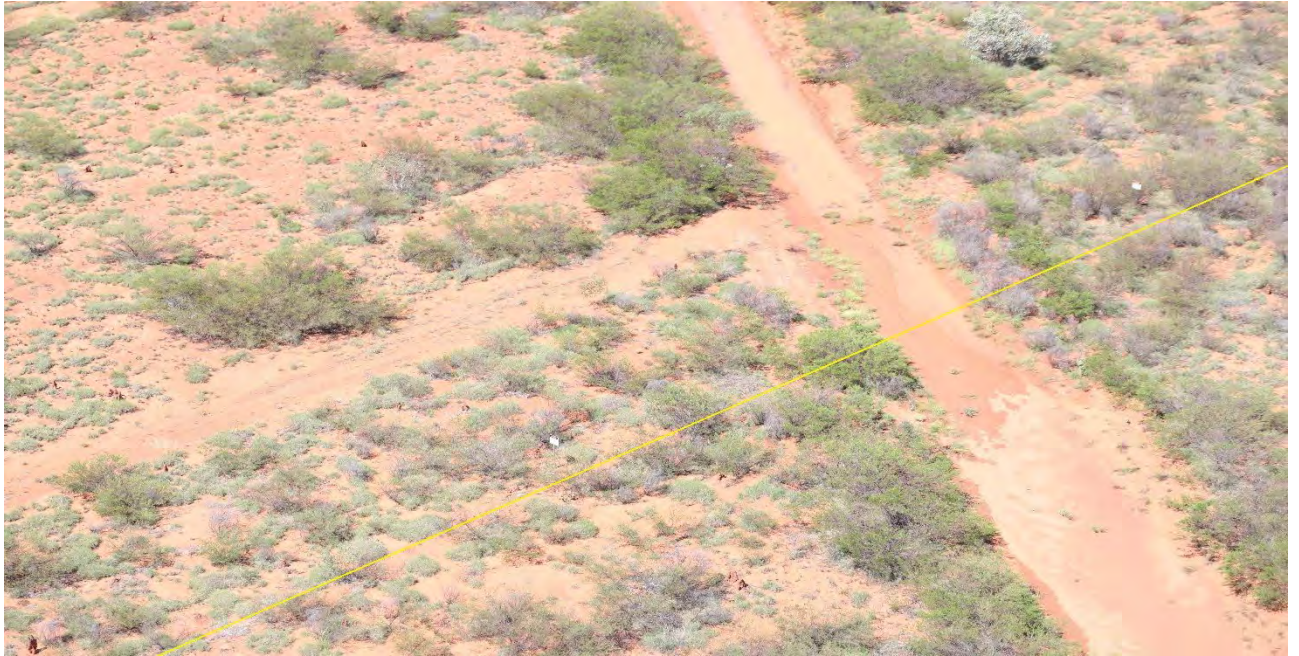
- Below image shows the current condition of the Swale Drain at this location.
- Vegetation either side of the drain is hindering line of sight as previously reported.
