Tanami Gas Pipeline
Annual Compliance Assessment Report
EBPC 2017 / 7997 – 2023/24

E-REP-089

Revision: 1
Date: 6 August 2024

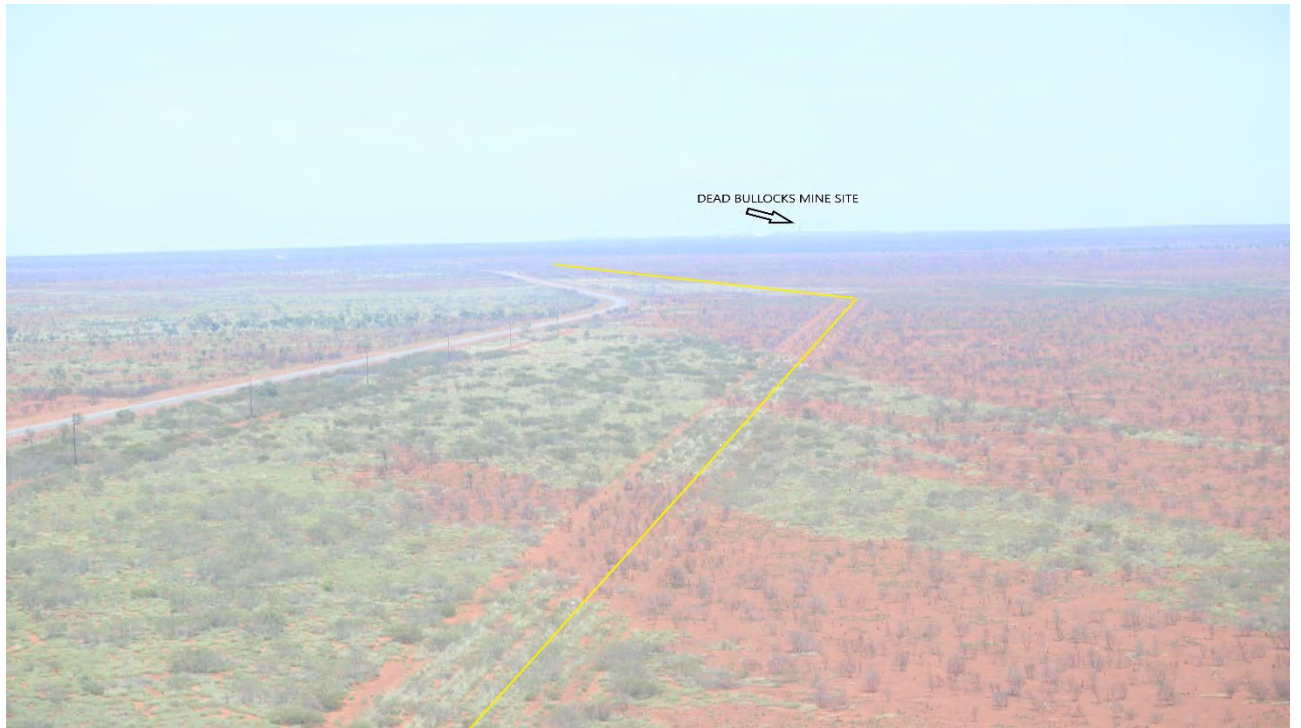
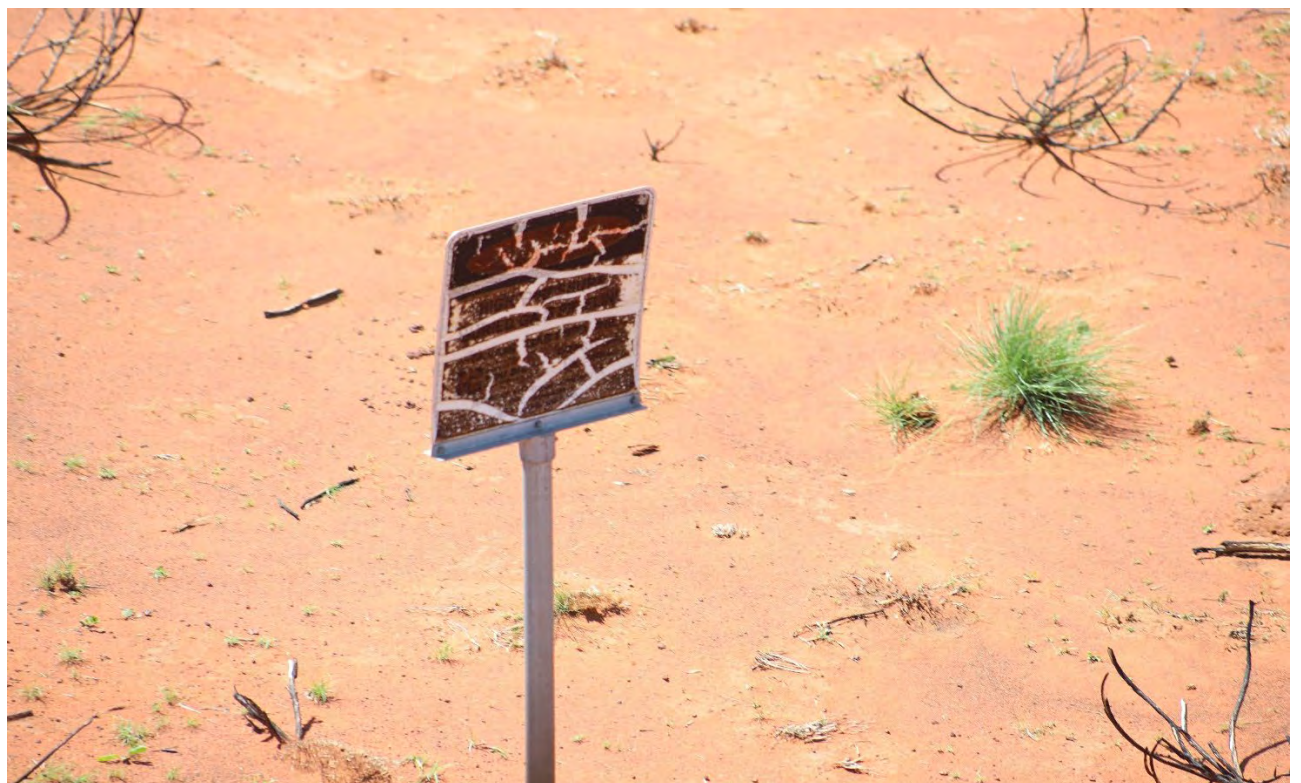
- Previously reported significant scrub fire that burnt through the area between KP 414.00 and KP 437 has sporadically damaged approximately 89 Danger signs through this area, leaving only one side of the signage readable.
- A W/O will be raised for the signage requiring replacement.

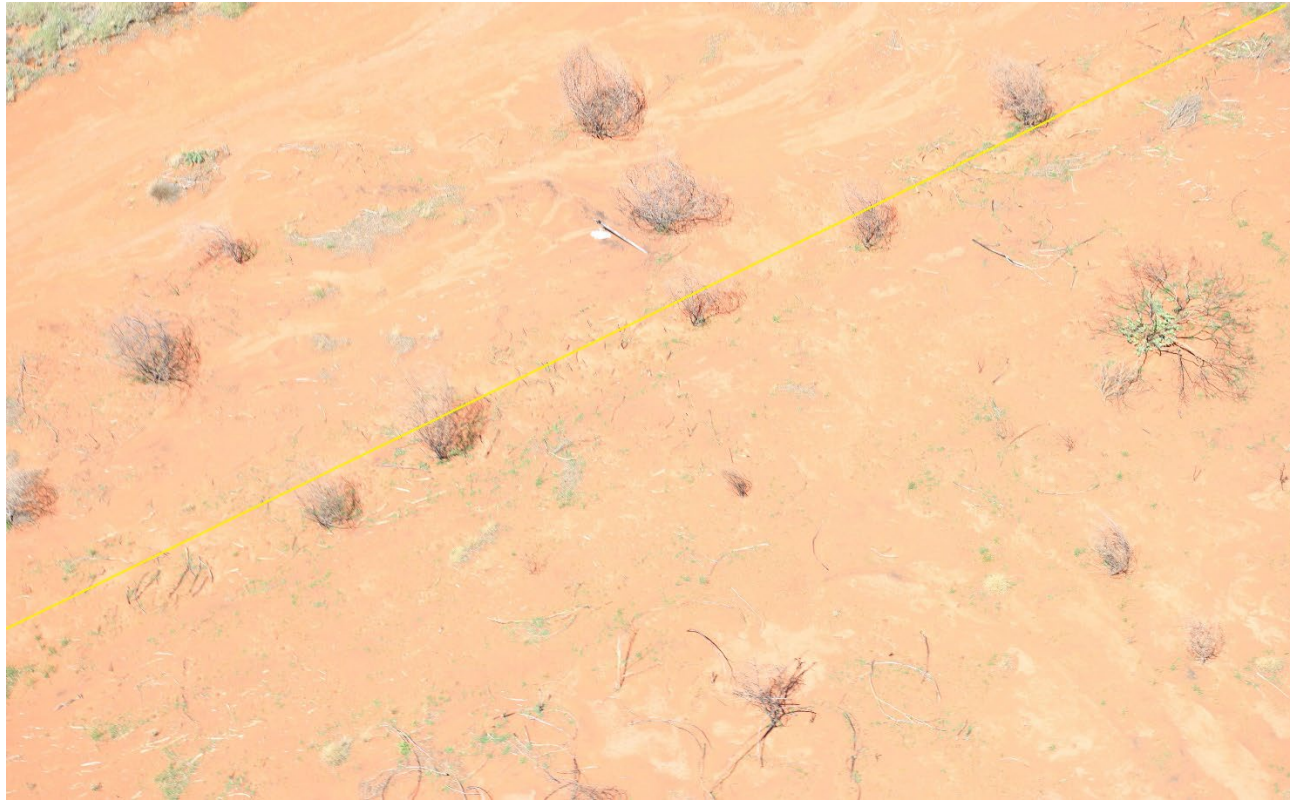
- Below image details a fallen Danger sign, this will be rectified as part of the burnt signage plate replacement works.

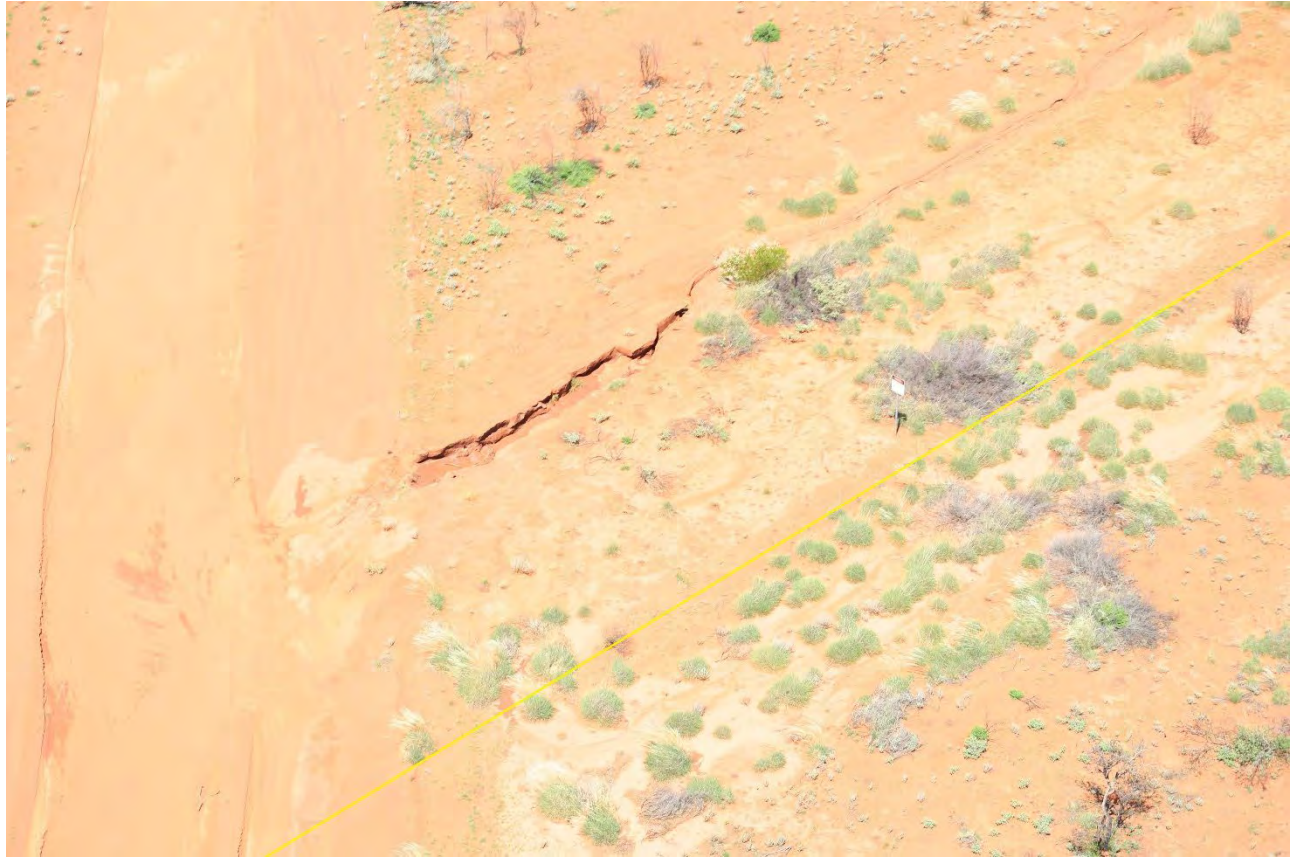
- Below image shows the Mine Road crossing the pipeline remains in good condition.
- Previously reported water erosion on the easement remains clear of pipeline. This poses no threat to the asse at this stage.

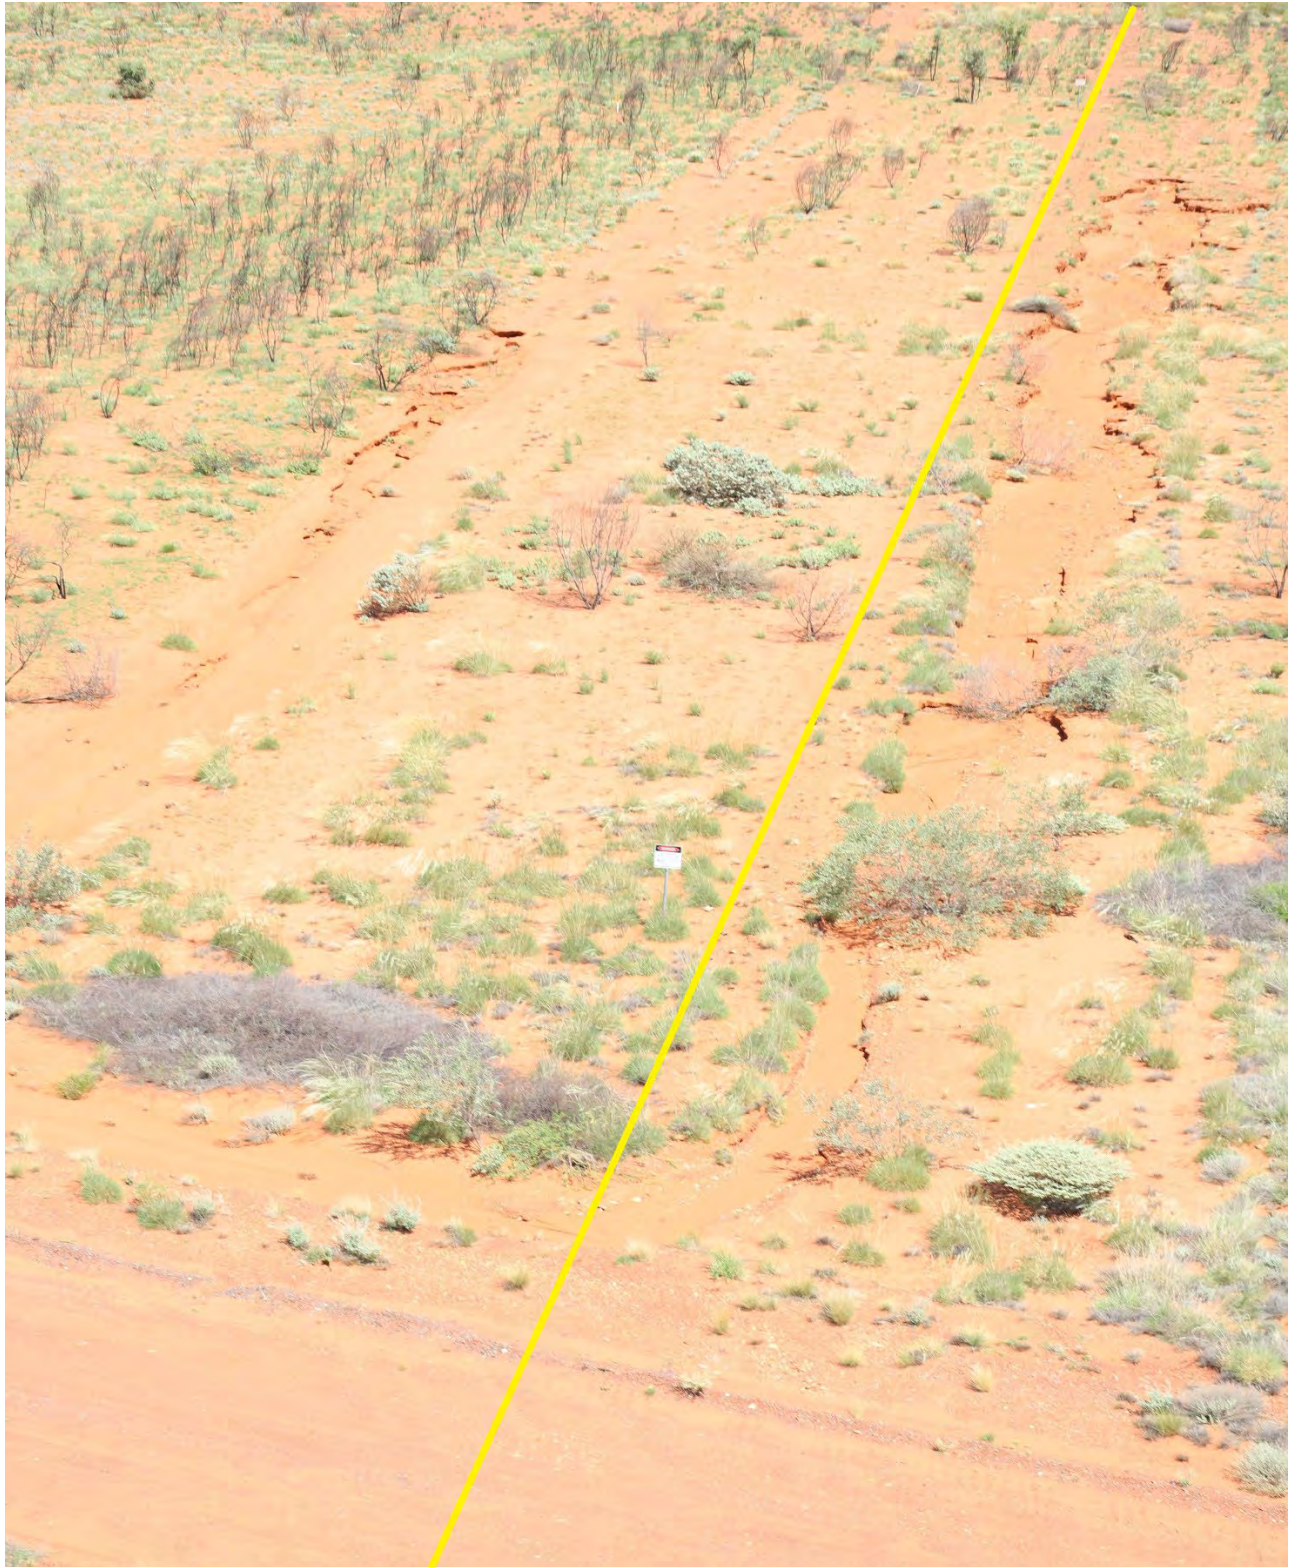
- No significant changes observed to the previously reported significant erosion confirmed at 670mm in depth.
