TANAMI GAS PIPELINE
ANNUAL COMPLIANCE ASSESSMENT REPORT
EPBC 2017 / 7997

E-REP-069

Rev 1

AERIAL SURVEILLANCE REPORT

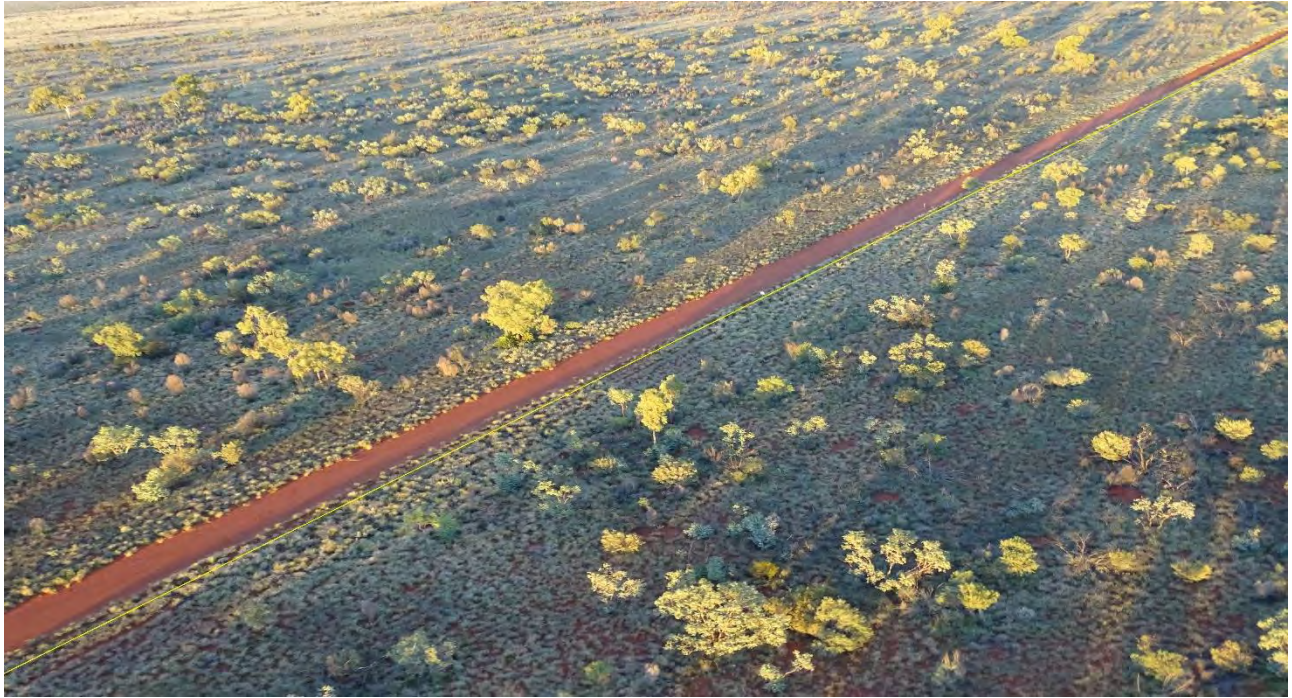
Location	Comment
KP .080	<ul style="list-style-type: none"> Previously noted minor erosion to the crown of the pipeline trench is no longer visible in this location due to vegetation cover.
KP 0.605 – 1.897	<ul style="list-style-type: none"> Below images show the current condition of the corridor and access track between KP 0.605 – KP 1.897 Corridor is thickly covered in Buffel Grass

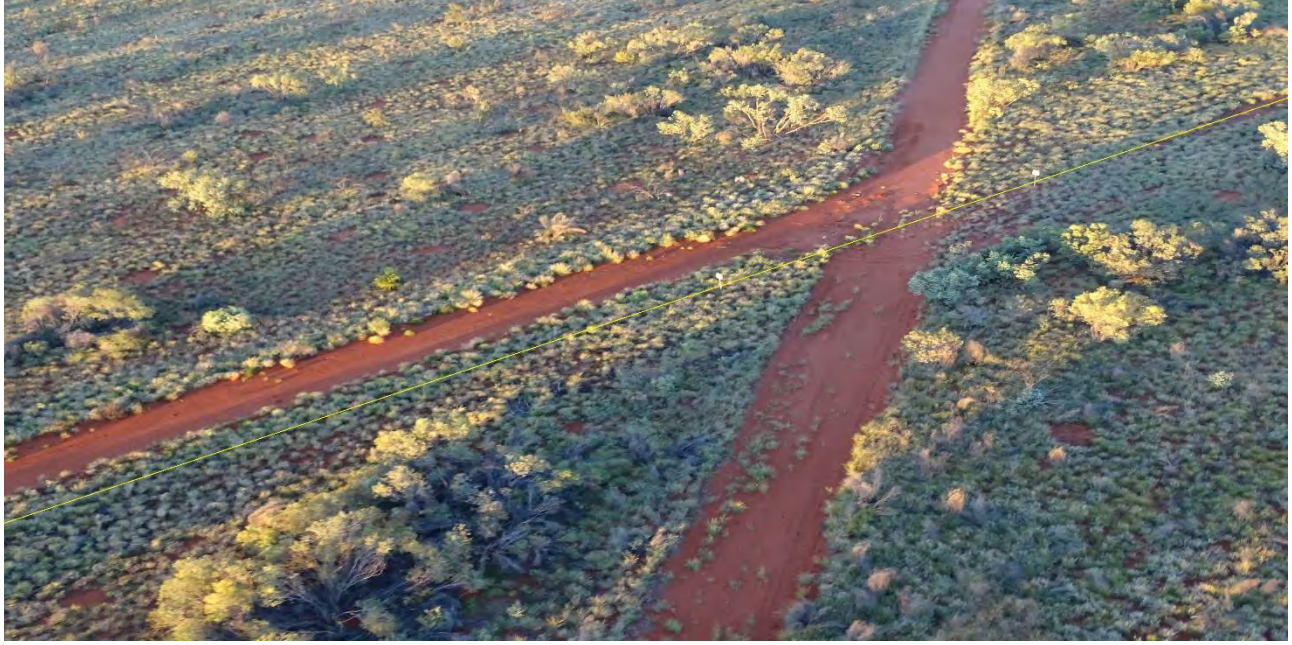
Gravel Rd to No.26 Bore	<ul style="list-style-type: none"> No significant changes to the road crossing.

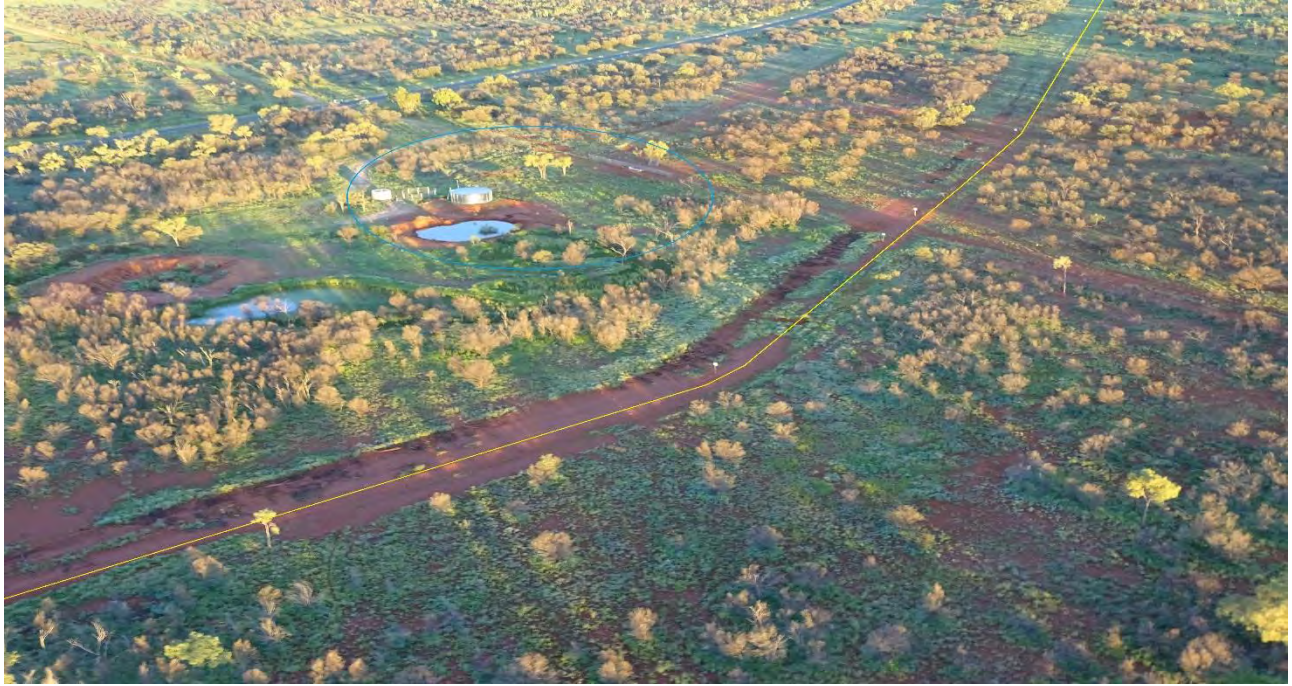
Location	Comment
KP 8.200	<ul style="list-style-type: none"> • The corridor at this location is heavily covered in vegetation and the erosion sight was not visible. • Yellow danger tape exposed for approx. 1m. • Depth of Cover to the top of the pipe at the lowest point of erosion; 800mm. • Depth of erosion 400mm.
KP 8.250	<ul style="list-style-type: none"> • Below image shows the previously reported water tank built on the Western side of the corridor.

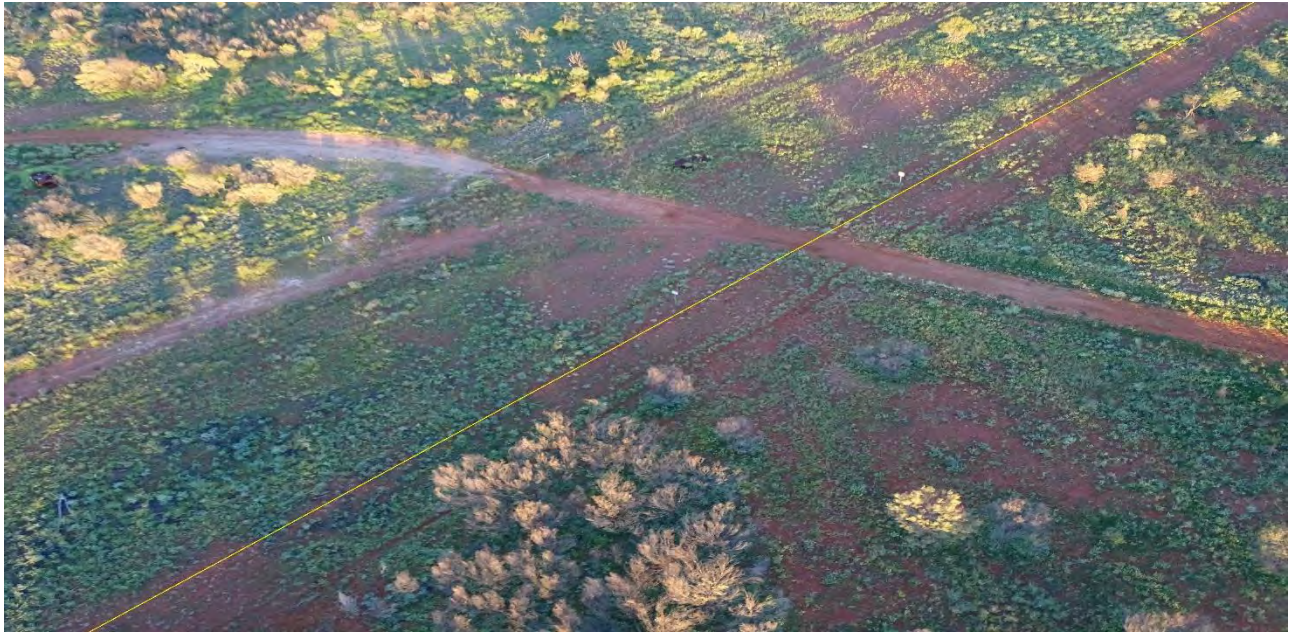
New Well Rd KP 13.438	<ul style="list-style-type: none"> • The road crossing appeared to remain in good condition.

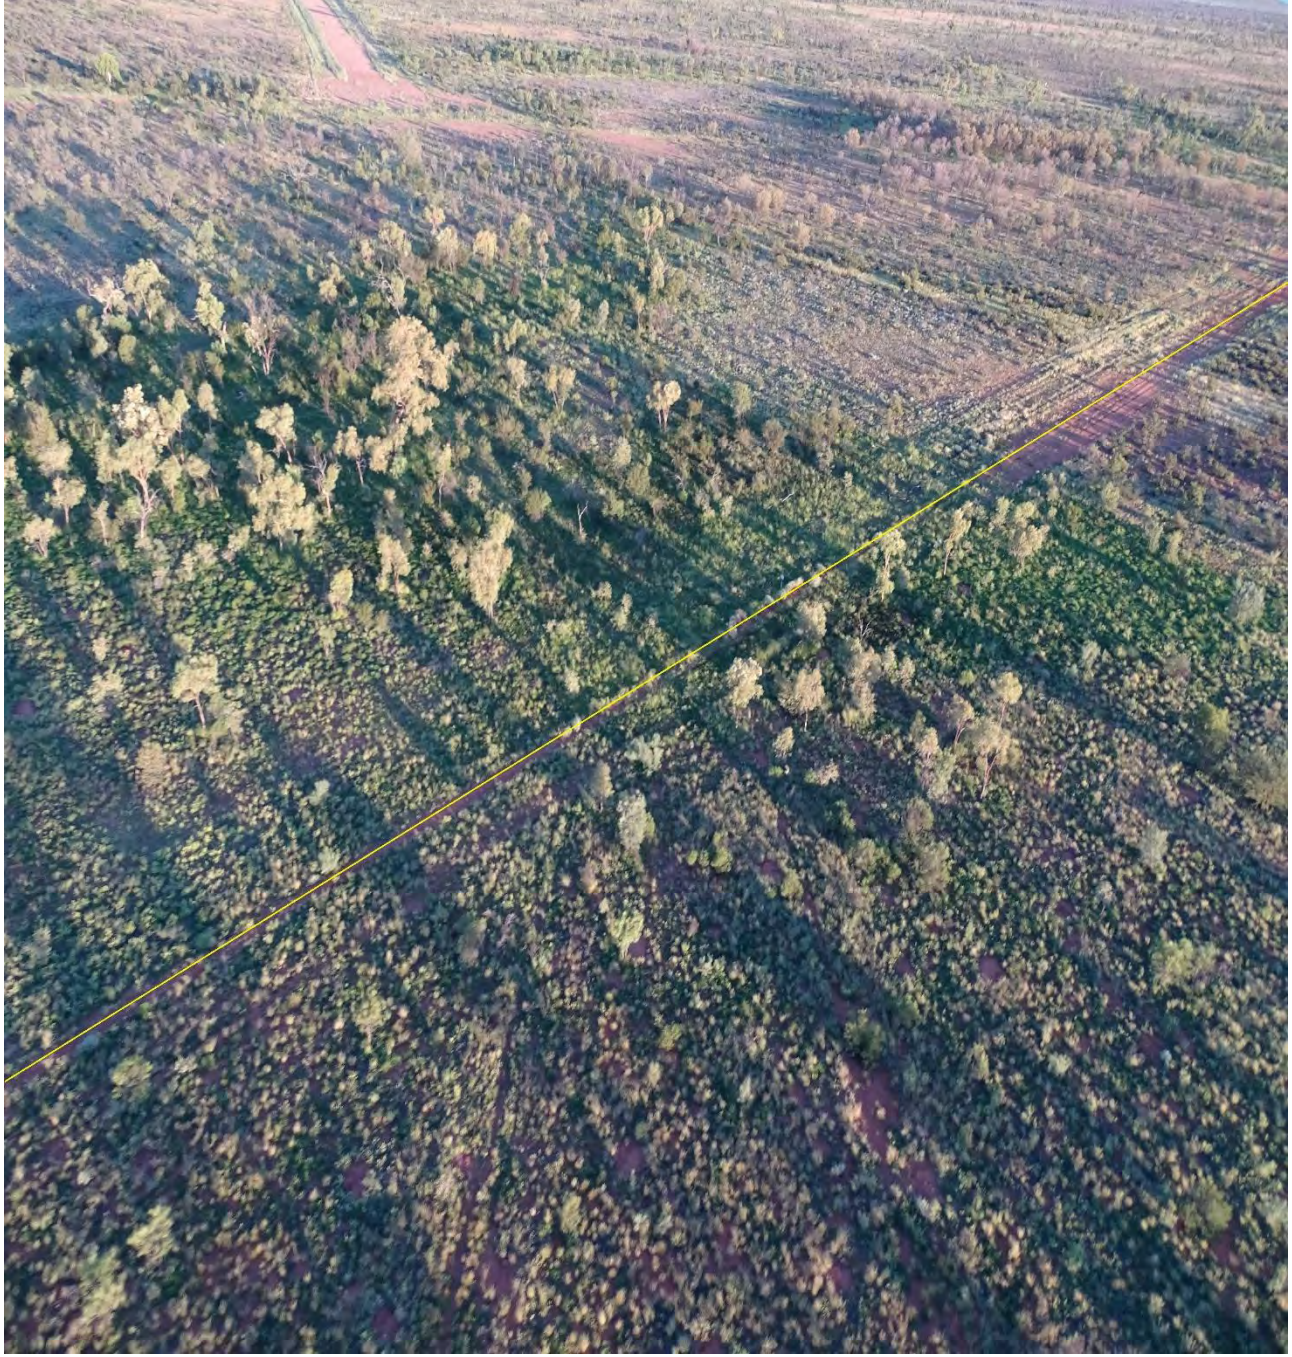
Location	Comment
KP 29.170	<ul style="list-style-type: none"> • The significant erosion noted at this KP was no longer visible or easily observed due to overgrowth. • 550mm depth of cover in the lowest point of erosion/washout. • Erosion deepest point 600mm.
KP 29.17 - KP 34.72	<ul style="list-style-type: none"> • Moderate erosion spots between KP 29.17 and KP 34.72 are no longer visible due to vegetation cover. • It was not evident that the recent rains caused any further damage to the existing erosion areas.

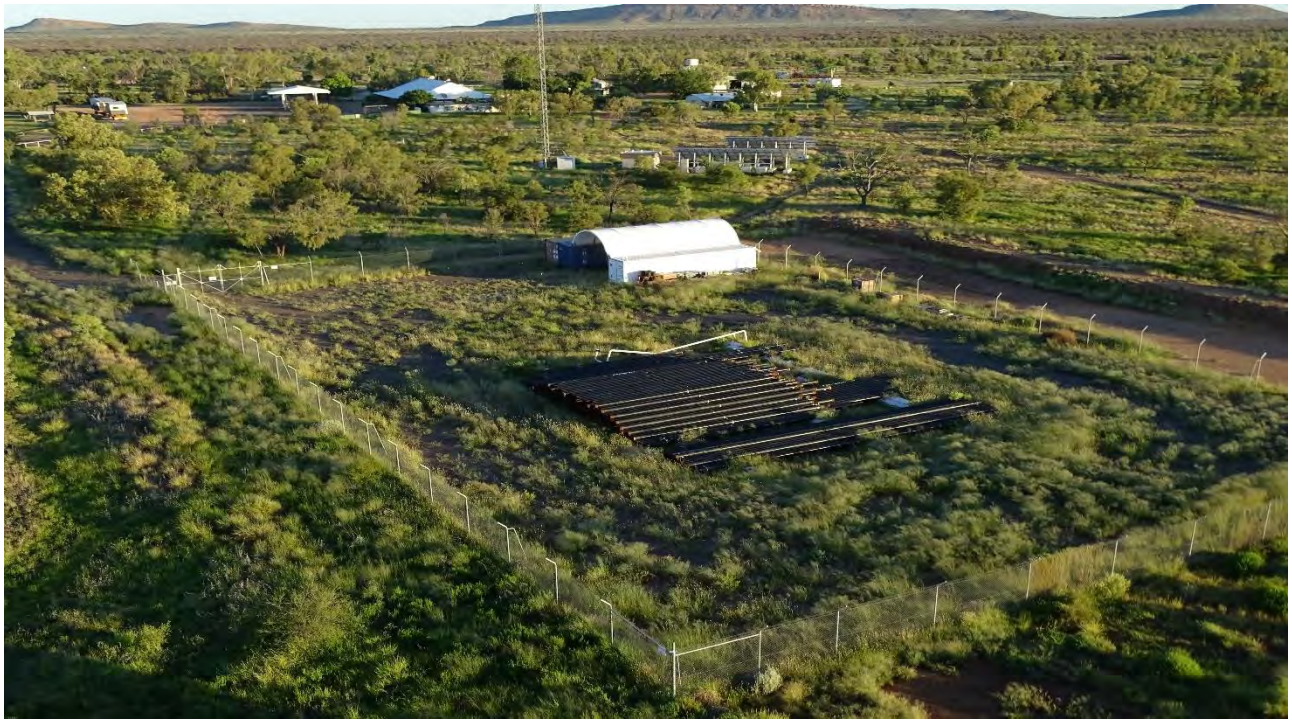
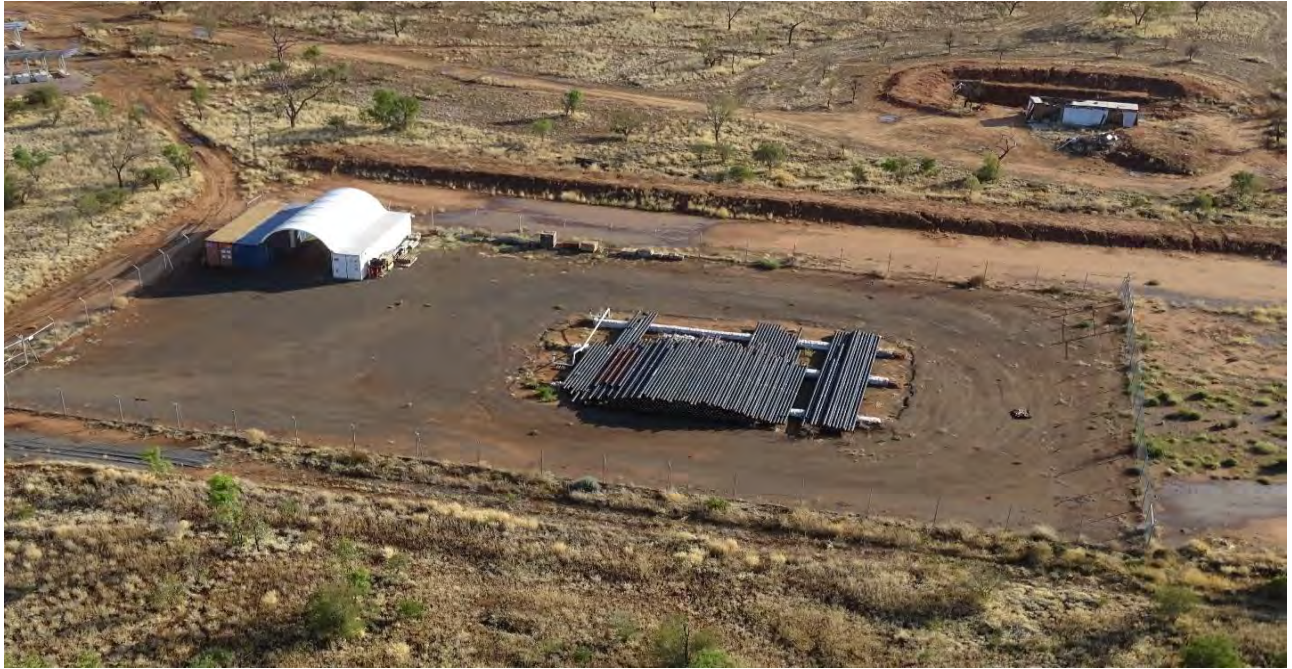
Location	Comment
<p>Tilmouth Road House Compound</p>	<ul style="list-style-type: none"> All appeared correct and secure at Tilmouth compound. Significant amount of vegetation has grown within the compound since the previous flight. <p>Feb 2022</p>

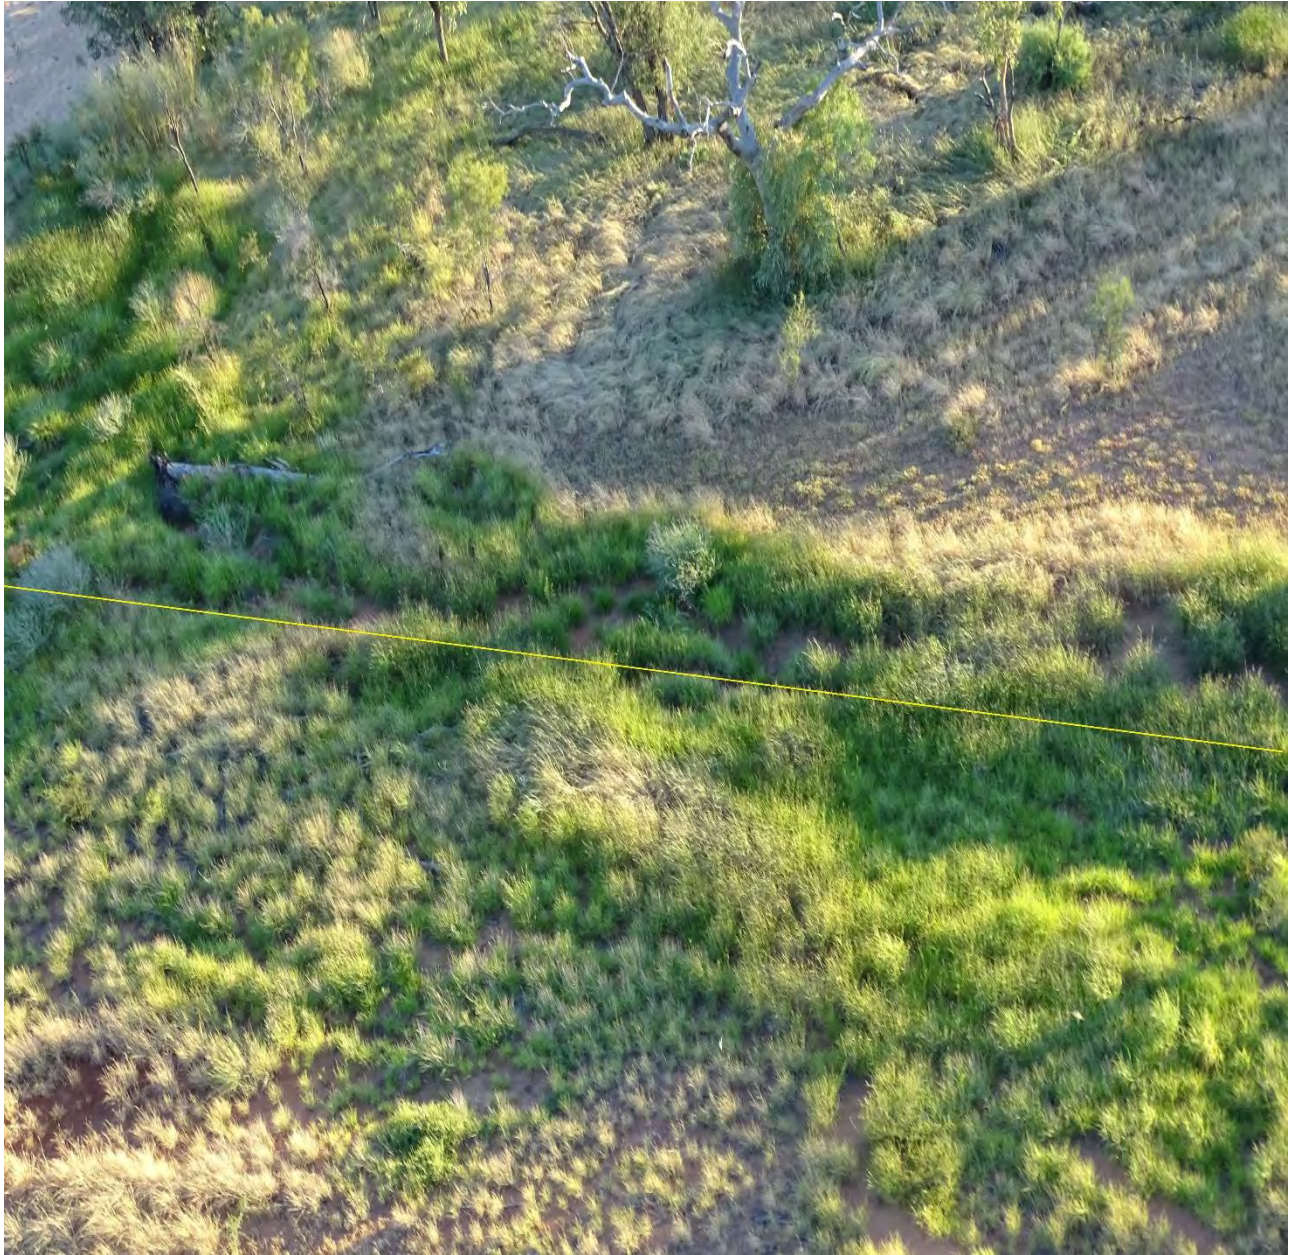
Location	Comment
KP 34.300	<ul style="list-style-type: none"> Previously reported significant erosion in this location is no longer visible due to vegetation cover. The surrounding area has had large growth of Buffel grass. Deepest erosion: 500mm. Depth of cover at lowest point 600mm.
KP 34.620	<ul style="list-style-type: none"> Buffel grass has covered the erosion and banks of Napperby Creek; unable to see if it has changes in depth due to vegetation cover. Average 400mm wash out over pipeline and 35m long 700mm depth of cover at lowest section.

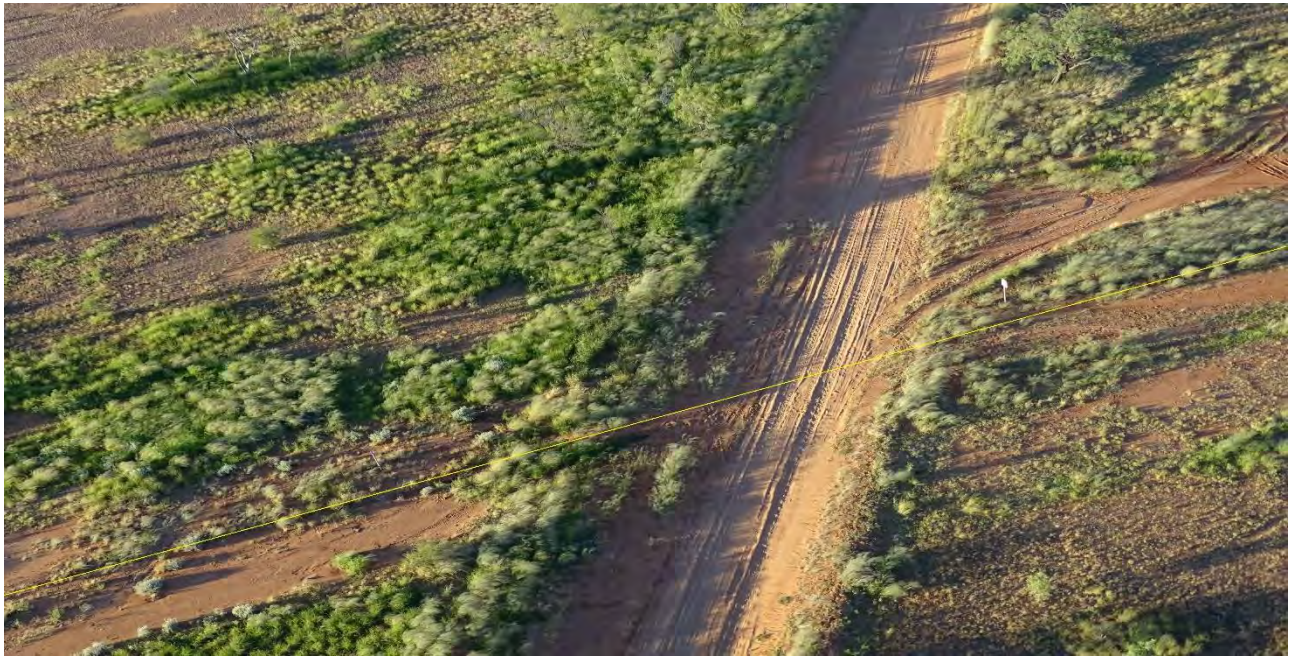
Location	Comment
<p>Napperby Creek KP 34.655</p>	<ul style="list-style-type: none"> Below image shows the current condition of the creek. Upstream bank has significant damage but no major changes since Feb 2021.  
<p>Napperby Station Access Road</p>	<ul style="list-style-type: none"> Below image shows the current condition of the access road. Minor water erosion damage across pipeline area.

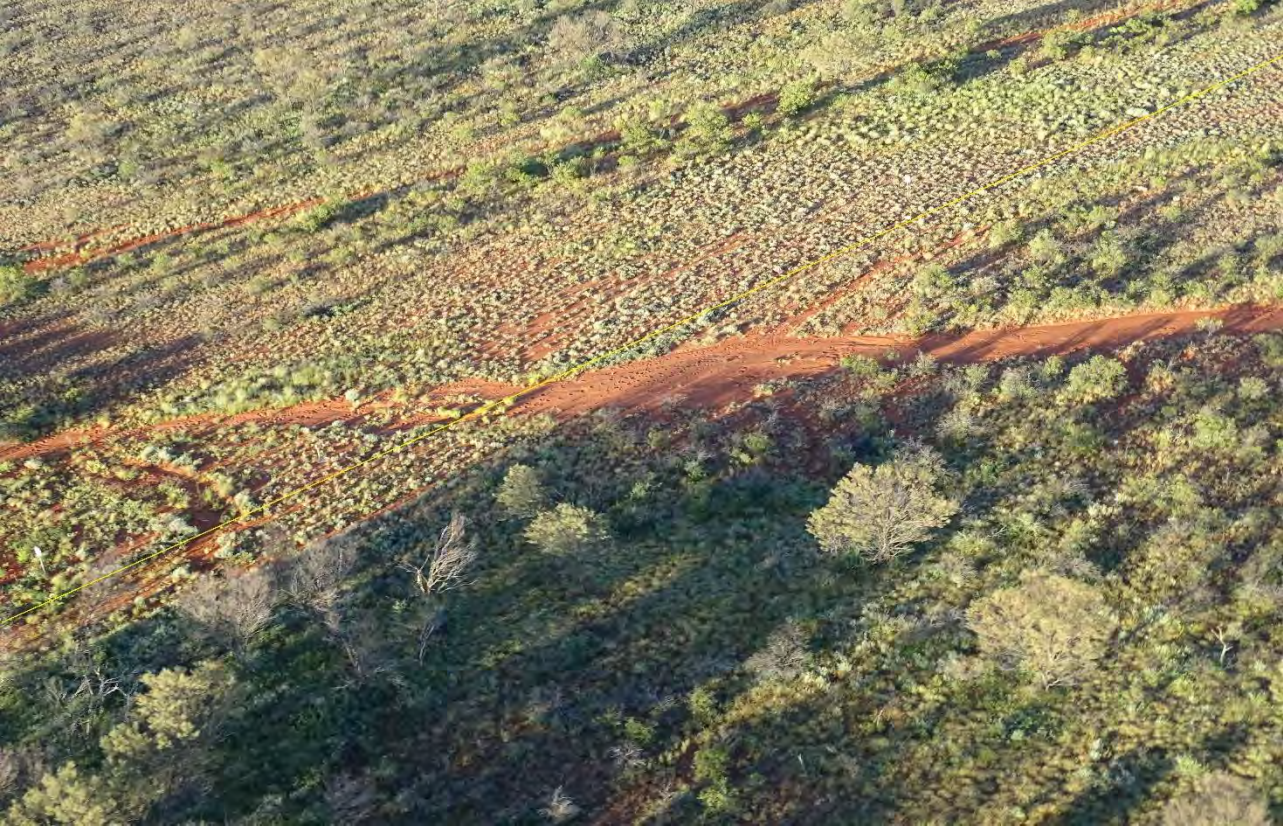
Location	Comment
<p>KP 40.014</p>	<ul style="list-style-type: none"> Below image shows existing water erosion to a known T3 water crossing.

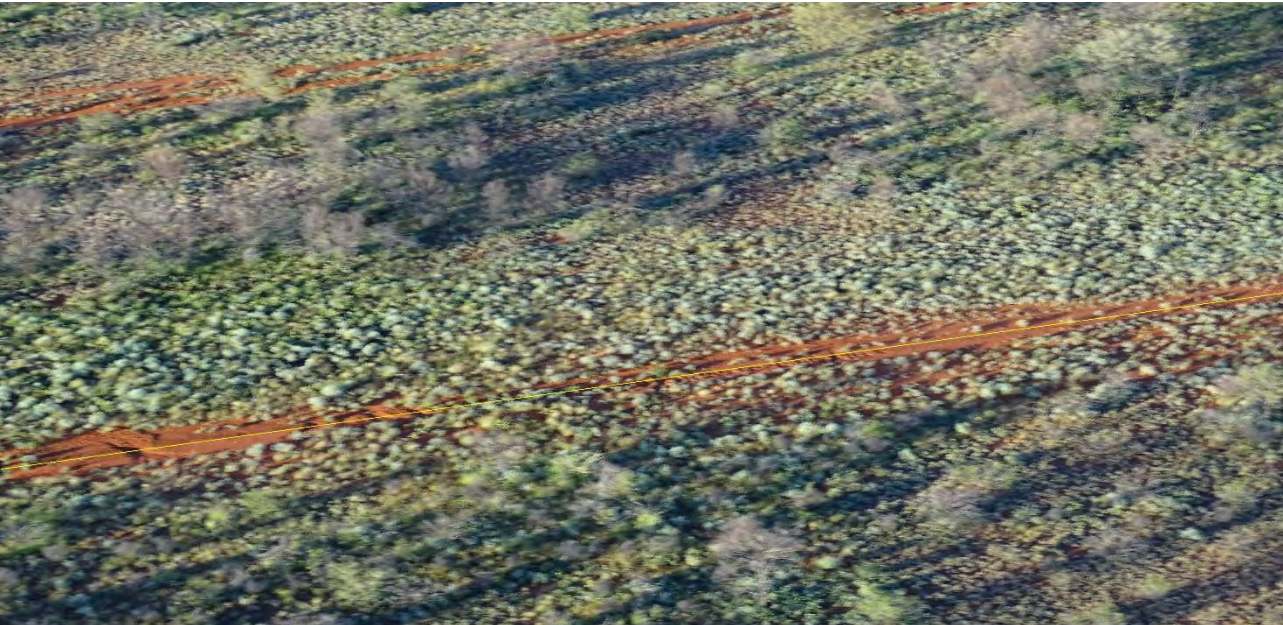
<p>KP 42 - 46</p>	<ul style="list-style-type: none"> Below images provides an example of minor water erosion between KP 40 – KP 46. Most erosion through this section is now unable to be observed due to vegetation cover.

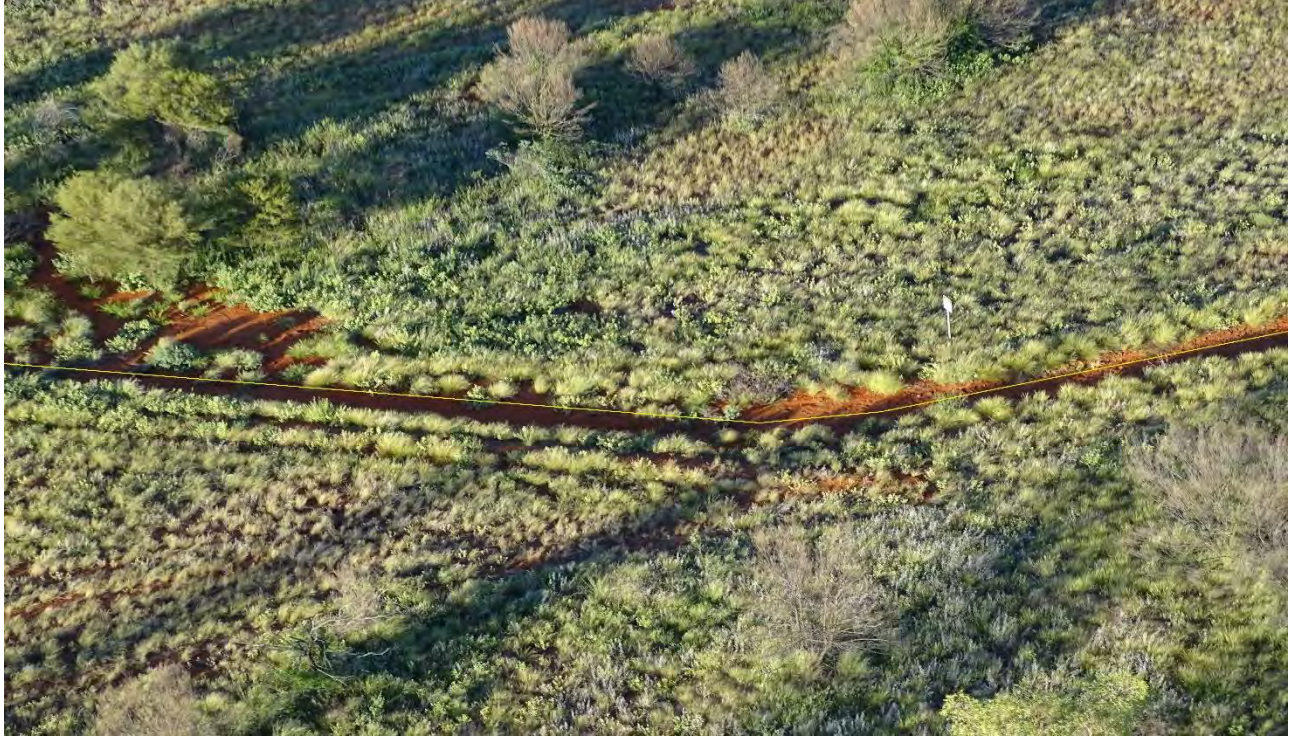
Location	Comment
<p>KP 46.500</p>	<ul style="list-style-type: none"> Below image shows moderate water course crossing the pipeline at KP 46.500

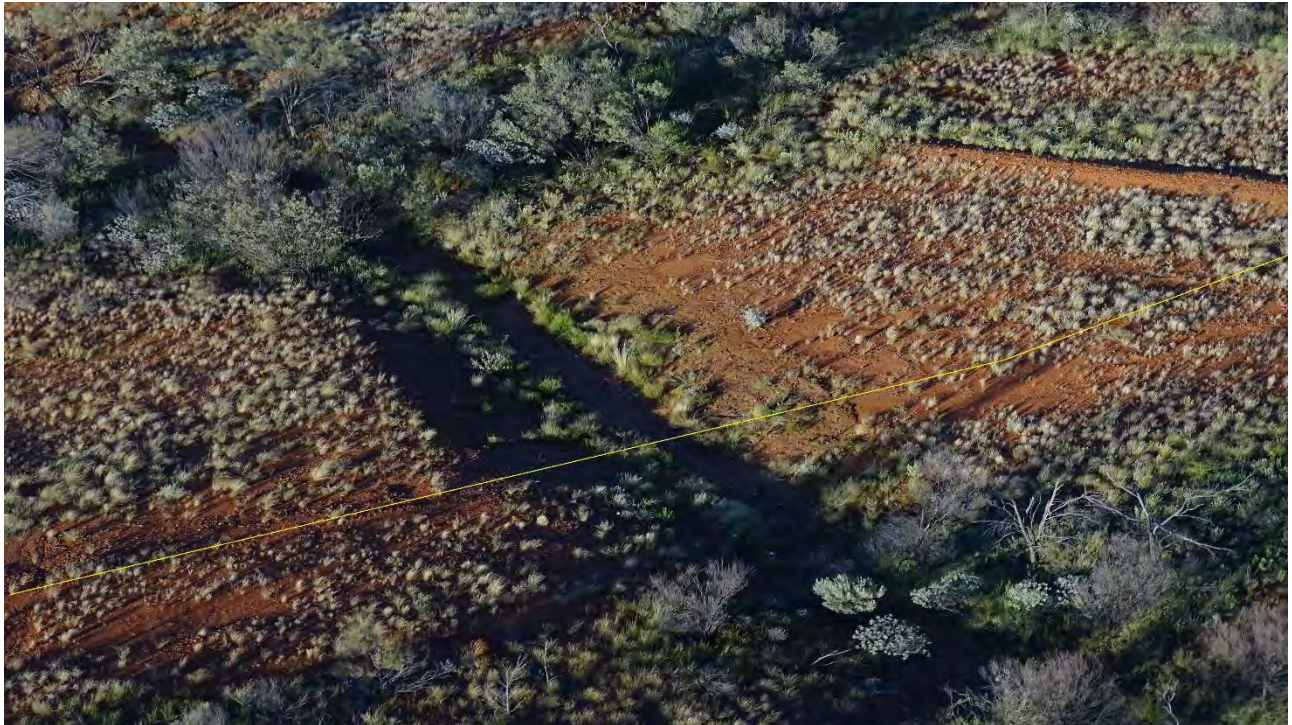
<p>KP 47.055</p>	<ul style="list-style-type: none"> Below image shows the current condition of the T2 water course crossing, minor water erosion damage to the bottom of the system.

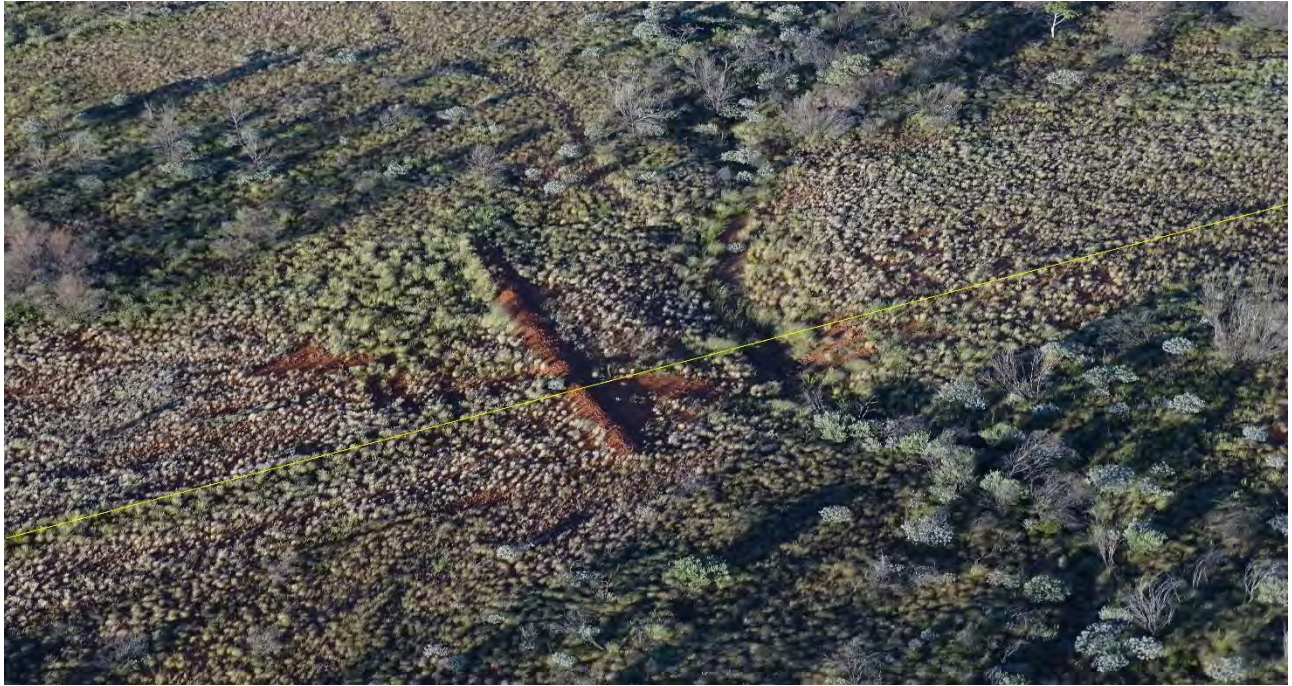
Location	Comment
<p>KP 47.497</p>	<ul style="list-style-type: none"> Below image shows the current condition of the T3 water course crossing, moderate water erosion damage to the bottom of the system covered by overgrowth.

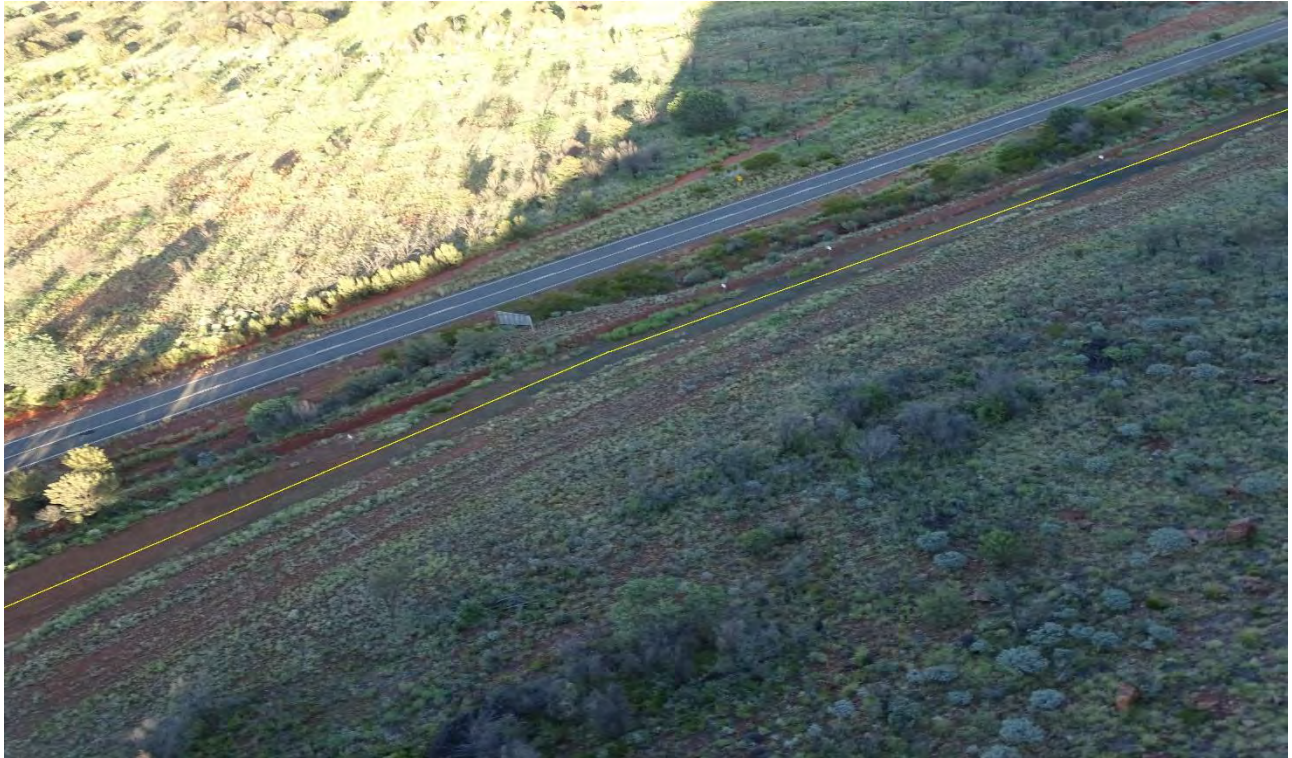
<p>KP 48.000</p>	<ul style="list-style-type: none"> Below image shows the condition of the easement at KP 48.000

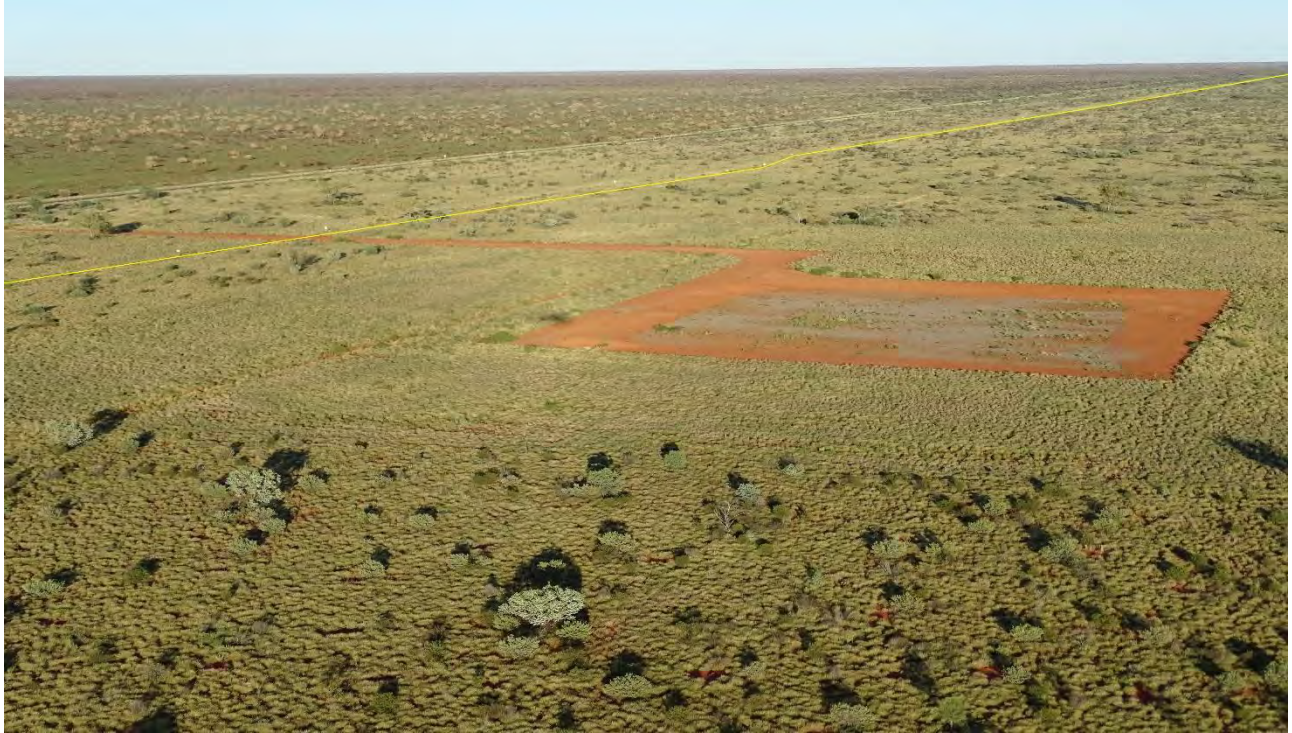
Location	Comment
<p>Camp 1/Laydown No.2 KP 65.503</p>	<ul style="list-style-type: none"> Below image shows the current condition of the previous camp/laydown yard.

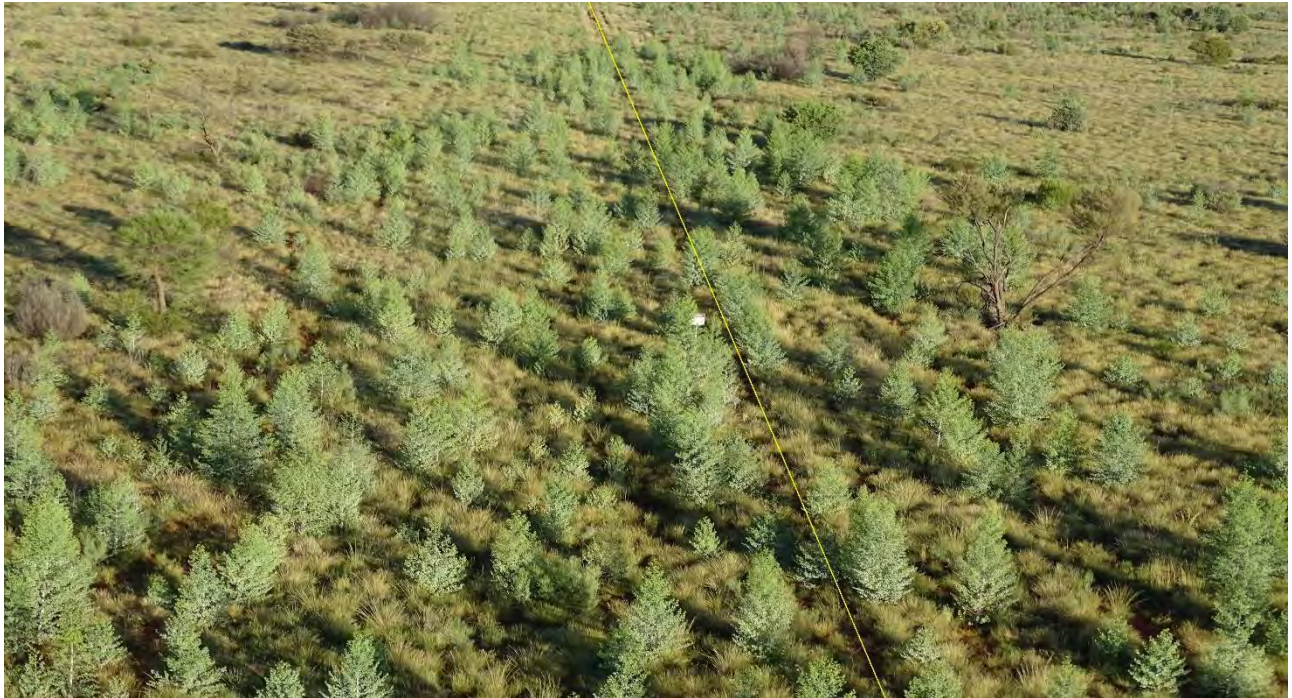
<p>KP 65.000 – KP 72.000</p>	<ul style="list-style-type: none"> Below image provides an example of the significant vegetation growth through this section of the easement. Line of sight is being obstructed through some sections within this KP range.

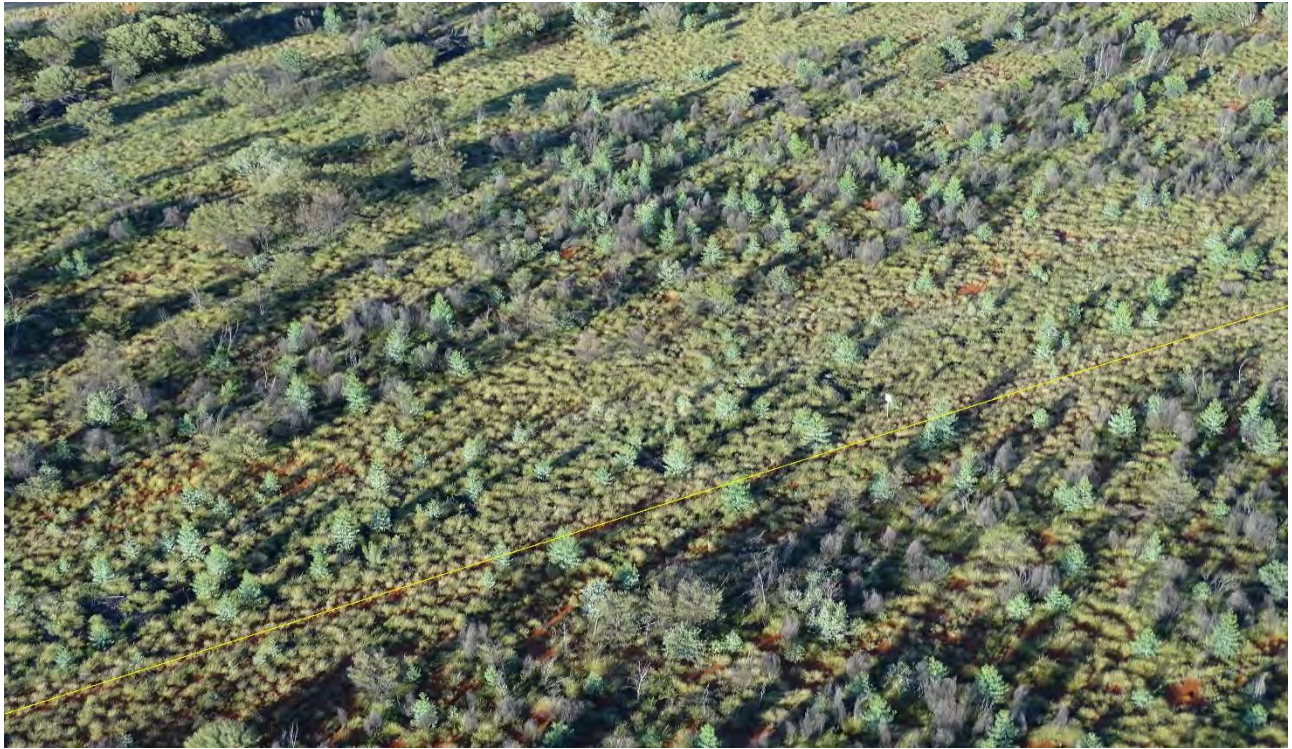
Location	Comment
<p>KP 65.000 – KP 72.000</p>	<ul style="list-style-type: none"> Below image provides an example of the significant vegetation growth through this section of the easement. Line of sight is being obstructed through some sections within this KP range.

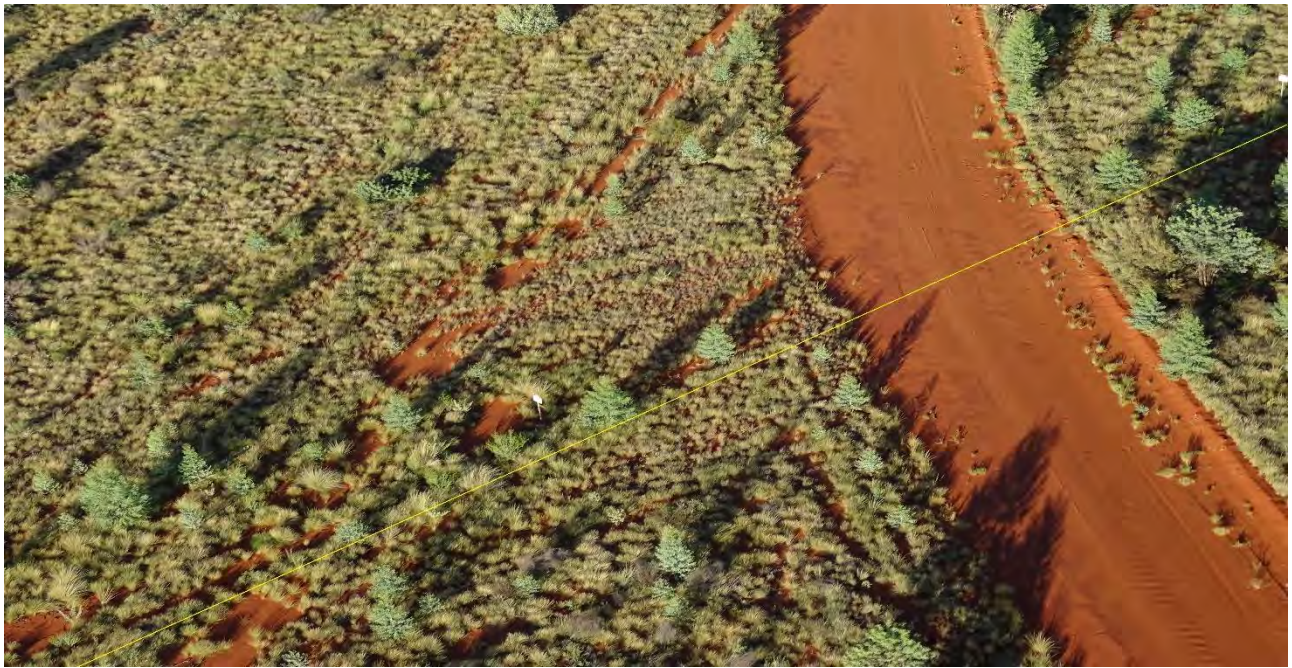
<p>Gravel Track to Pulardi KP 72.904</p>	<ul style="list-style-type: none"> Below image shows the current condition of the track to Pulardi; vegetation overgrowth blocking LOS.

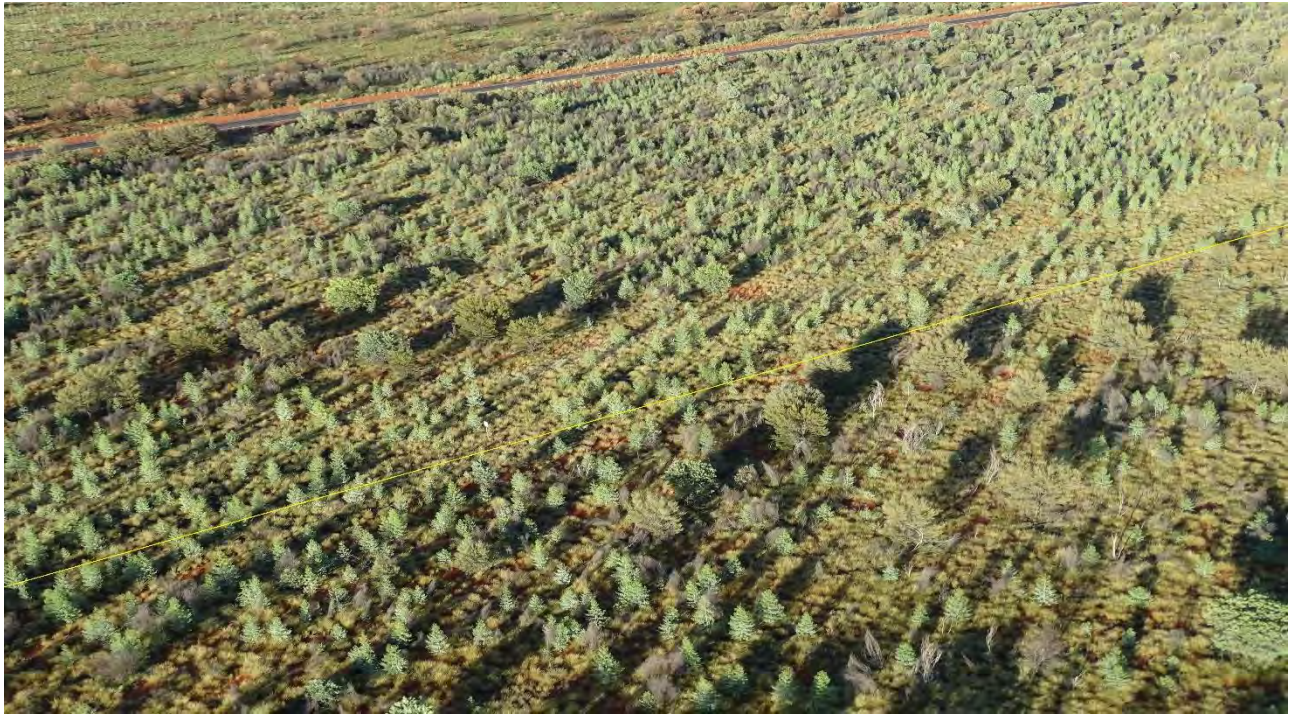
Location	Comment
<p>KP 73.000 – KP 78.000</p>	<ul style="list-style-type: none"> Below image provides an example of the significant vegetation growth through this section of the easement. Line of sight is being obstructed through some sections within this KP range.

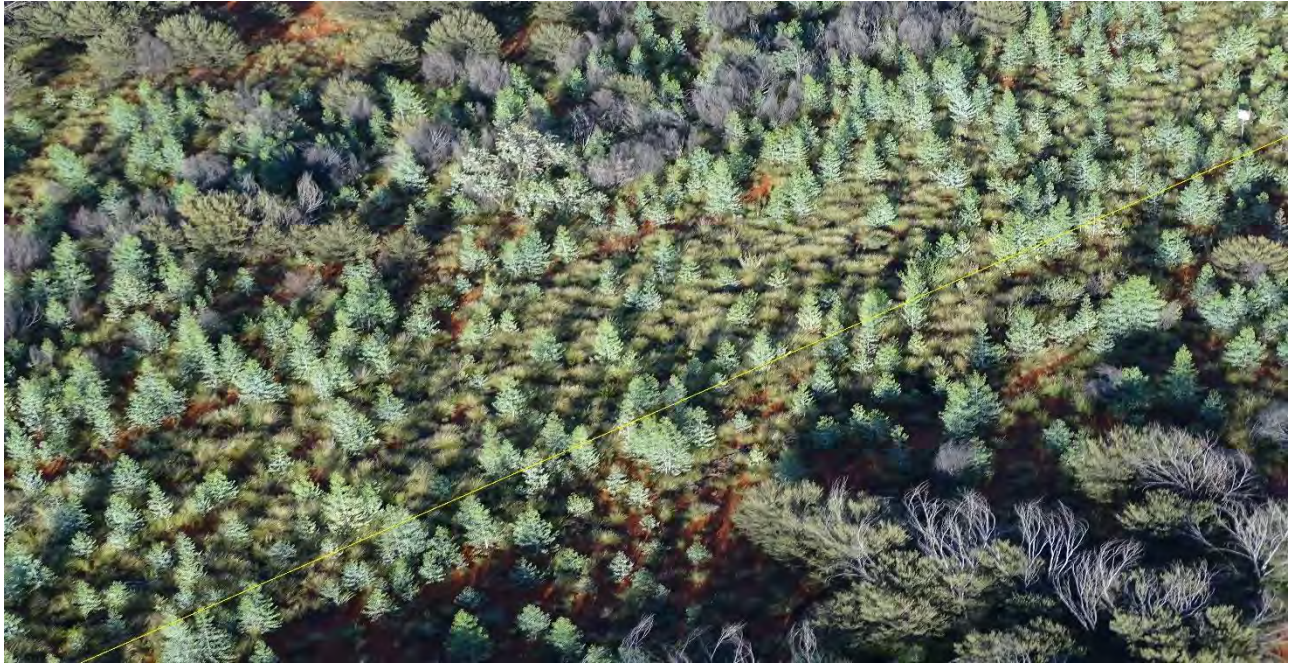
<p>KP 73.000 – KP 78.000</p>	<ul style="list-style-type: none"> Below image provides an example of the significant vegetation growth through this section of the easement. Line of sight is being obstructed through some sections within this KP range.

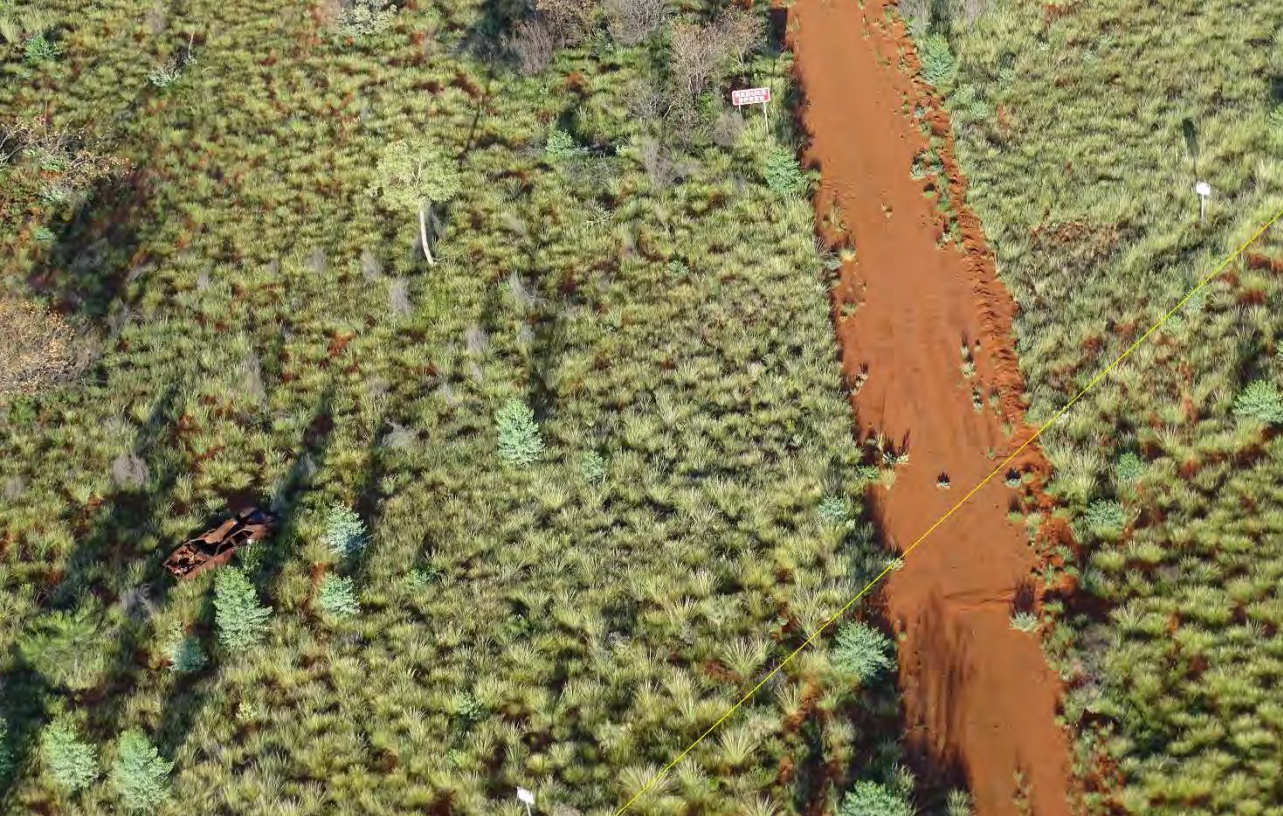
Location	Comment
<p>Pulardi Rd Gravel to Laramba KP 78.509</p>	<ul style="list-style-type: none"> Below image shows the current condition of the track.
