TANAMI GAS PIPELINE
ANNUAL COMPLIANCE ASSESSMENT REPORT
EPBC 2017 / 7997

E-REP-069

Rev 1

AERIAL SURVEILLANCE REPORT

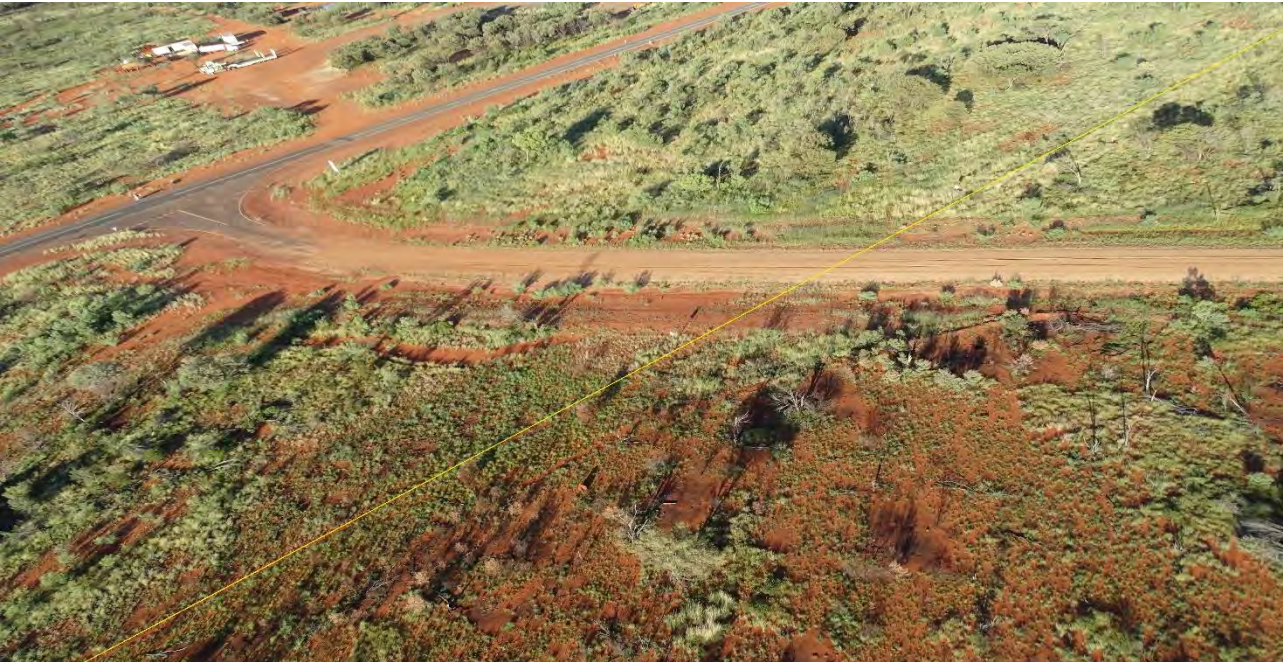
<p>Yeulamu Rd Gravel KP 100.150</p>	<ul style="list-style-type: none"> Below image shows the current condition of the track.

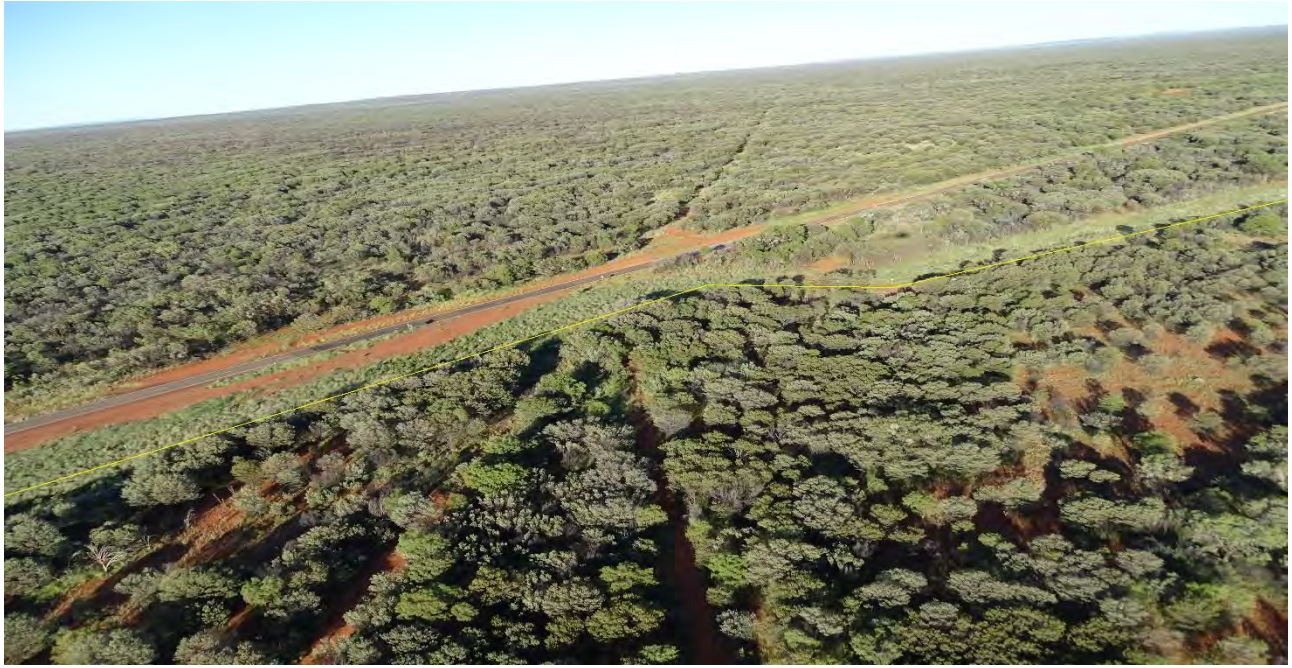
Location	Comment
<p>ROW KP 111.332</p>	<ul style="list-style-type: none"> Below image shows the ROW condition looking downstream. Corridor has thick Buffel grass cover at this location.

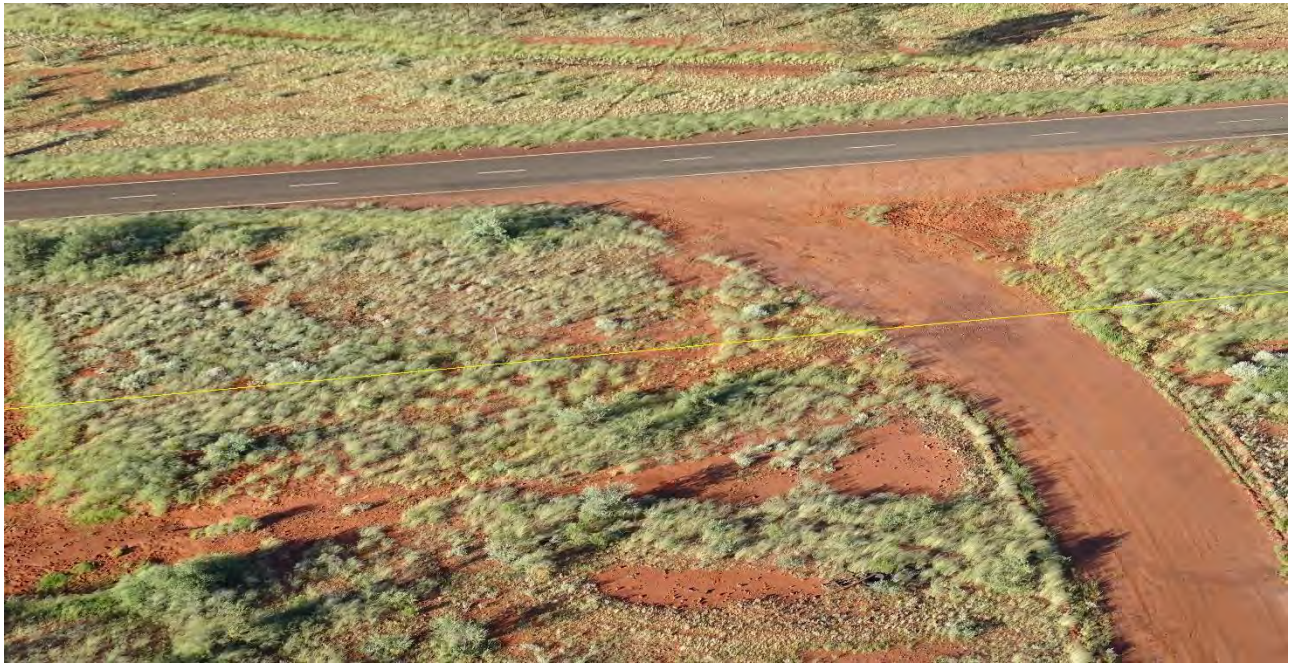
<p>KP 114.500</p>	<ul style="list-style-type: none"> Significant erosion at KP 114.500 no longer visible due to vegetation overgrowth. Erosion periodic for approx. 100m Thick cover of Buffel Grass
<p>Road to Bore & Gravel Pit KP 119.985</p>	<ul style="list-style-type: none"> Below image shows condition of the road to the Gravel Pit.

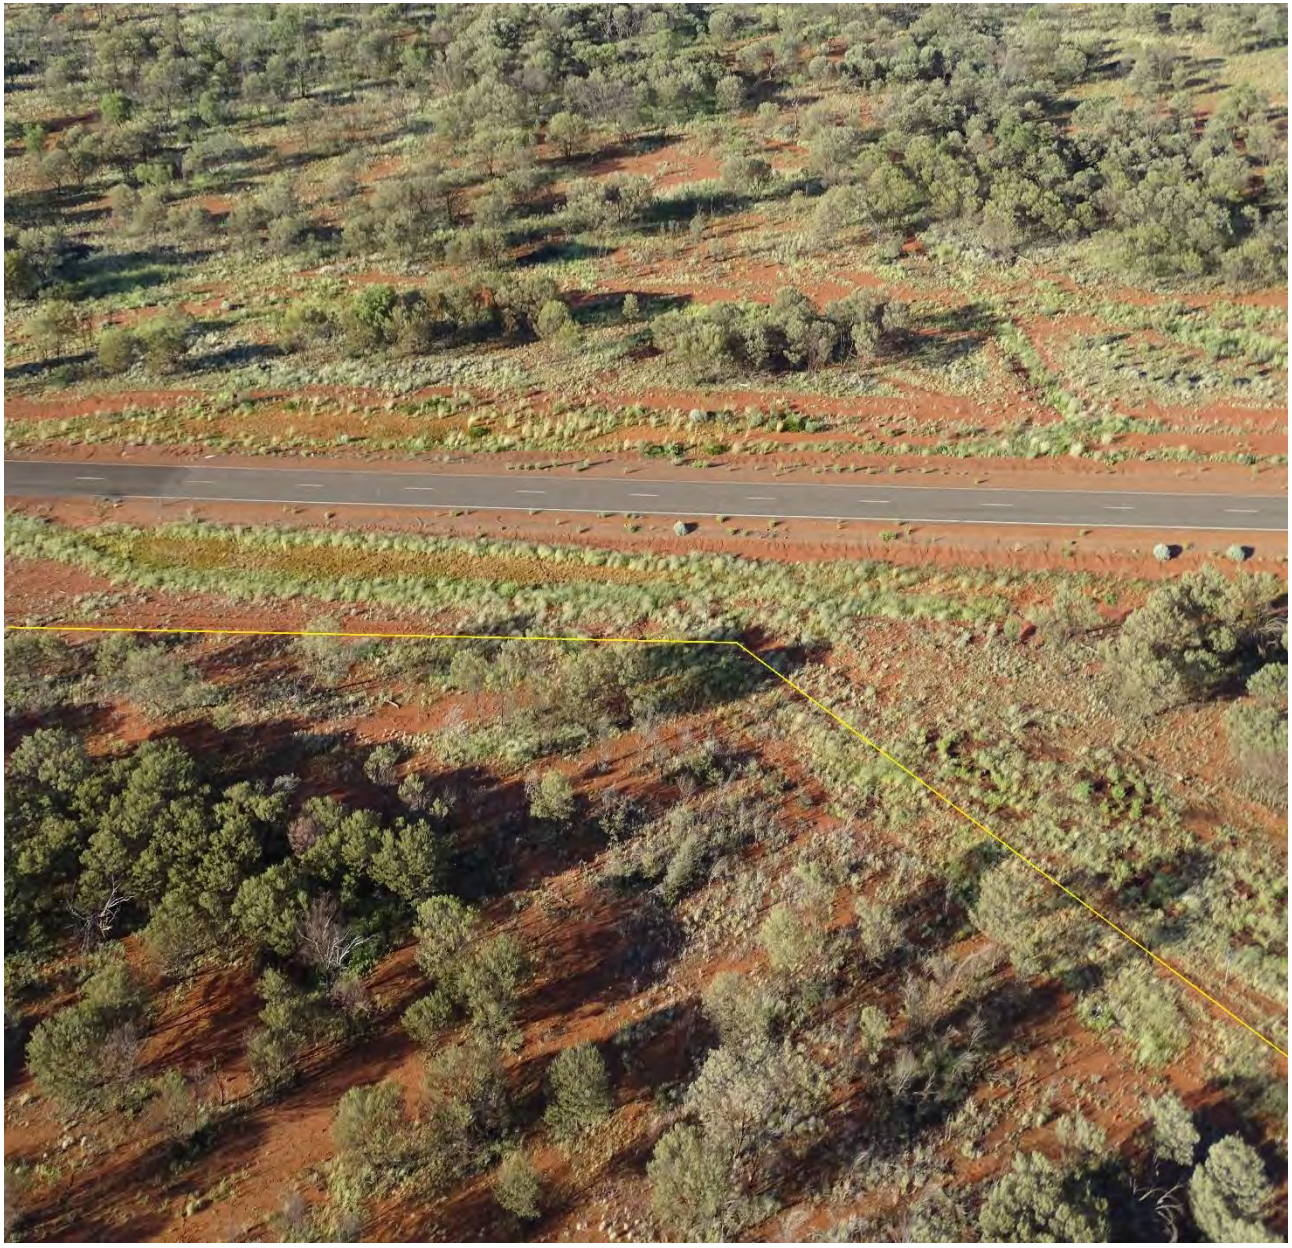
Location	Comment
<p>Road to Bore & Gravel Pit KP 119.985</p>	<ul style="list-style-type: none"> Below image shows a previous area of moderate water erosion at a bend in the pipeline. Thick cover of Buffel Grass makes the erosion difficult to observe.

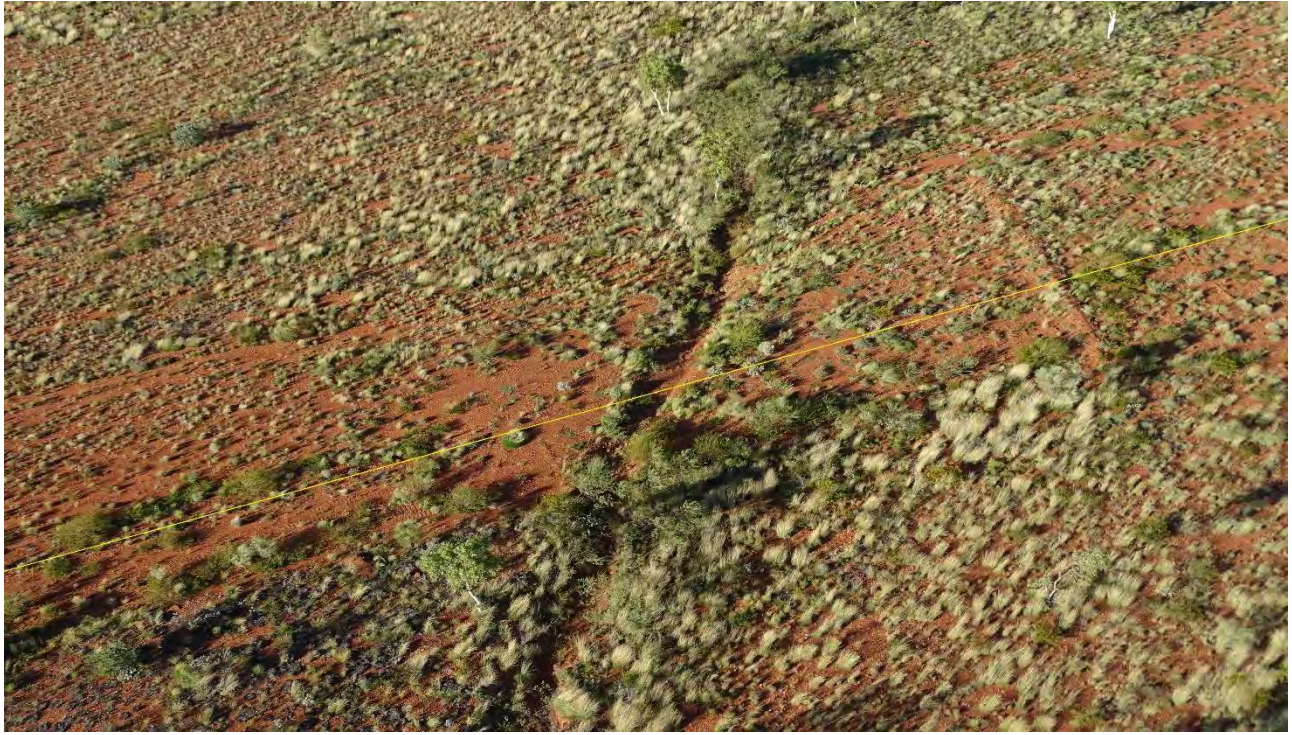
Location	Comment
<p>KP 136.864</p>	<ul style="list-style-type: none"> T3 water course crossing the pipeline has minimal damage to its banks; the hard clay appears to be exposed over the pipeline area.

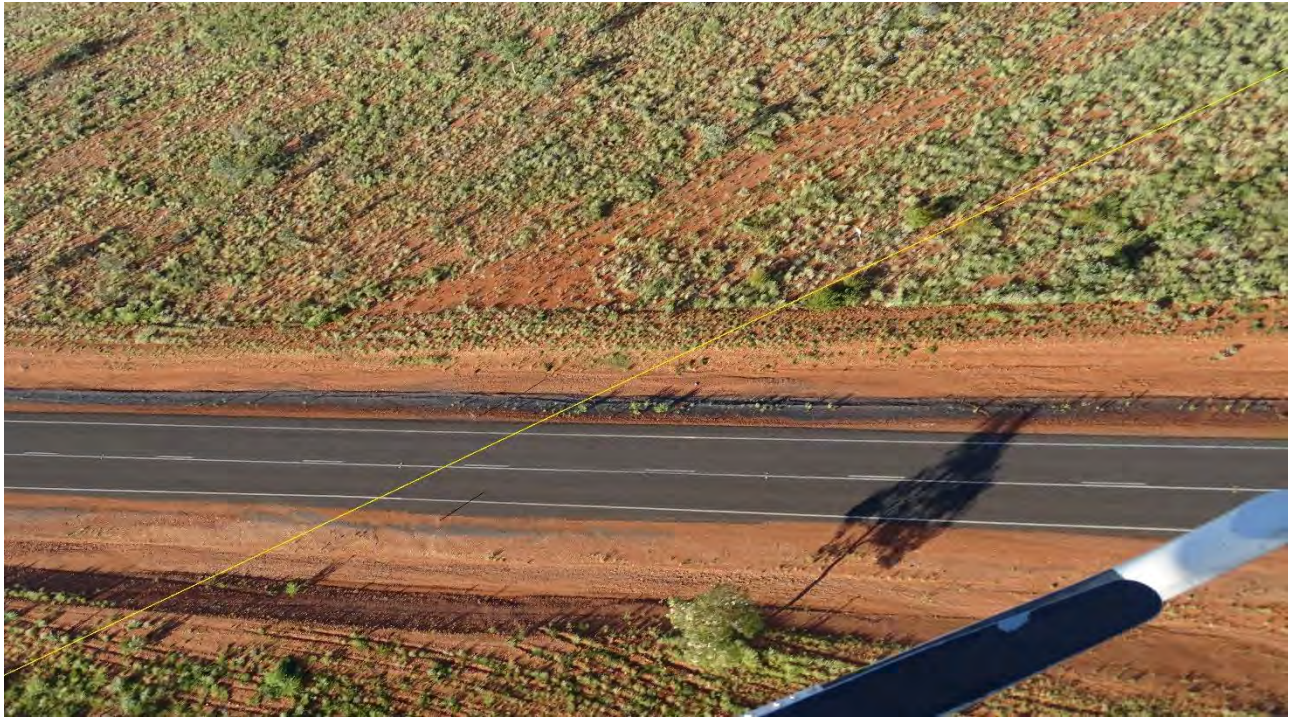
<p>Yuendumu Rd KP 137.916</p>	<ul style="list-style-type: none"> Road crossing appeared in good condition.

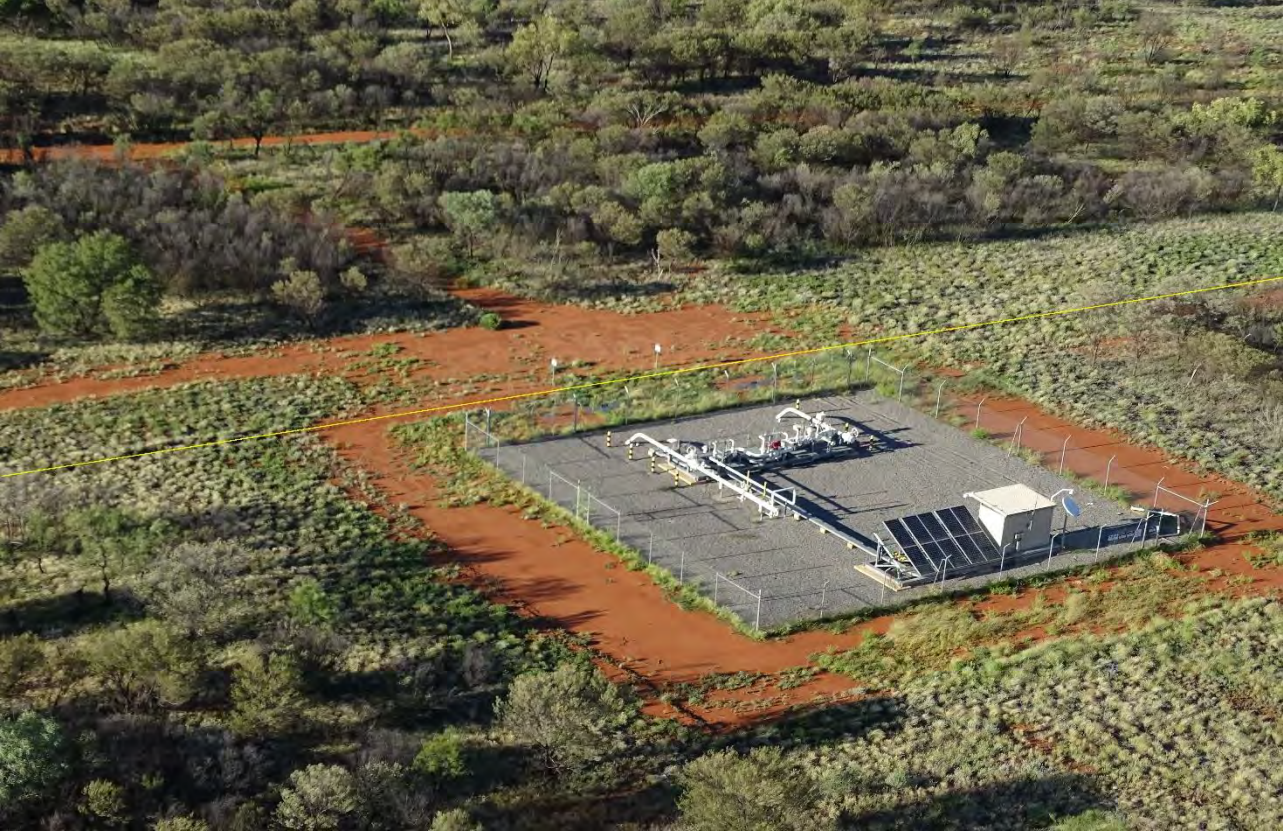
Location	Comment
<p>SS1 Yuendumu KP 144.906</p>	<ul style="list-style-type: none"> • Appeared correct and secure.

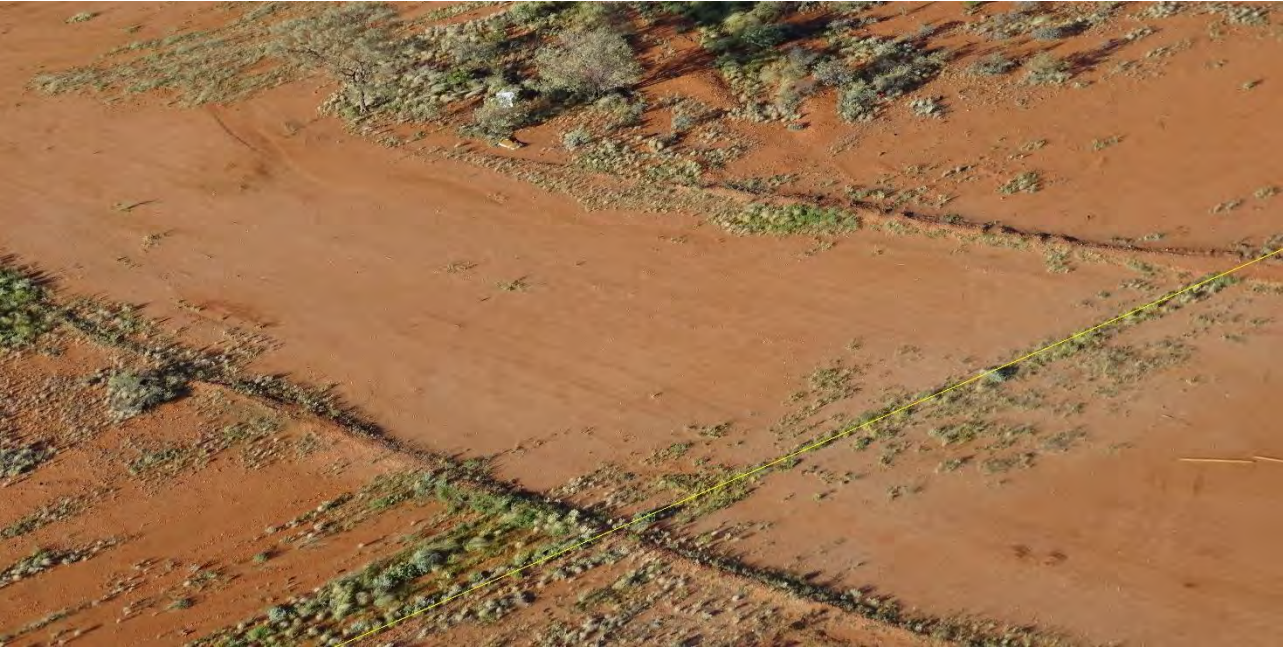
<p>KP 147.394</p>	<ul style="list-style-type: none"> • Below image shows the tracks current condition leading into the truck turn around point.

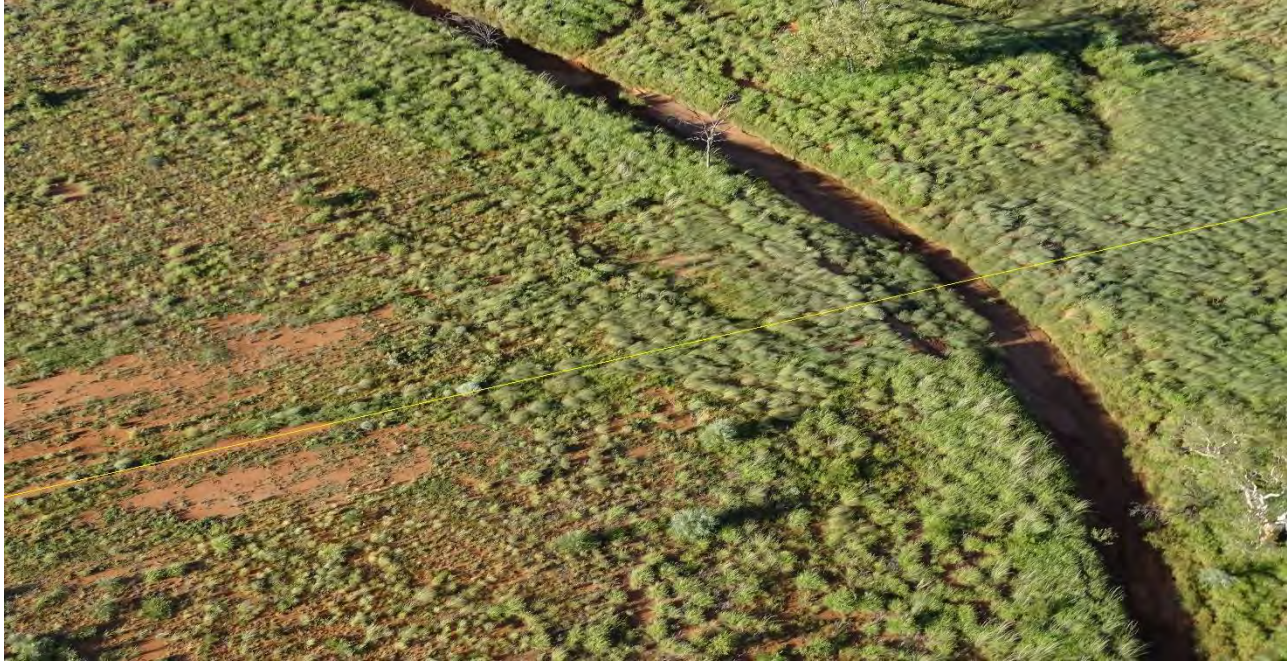
Location	Comment
Mission Creek T2 KP KP 153.038	<ul style="list-style-type: none"> • Appeared to remain in good condition; banks heavily covered in vegetation overgrowth.

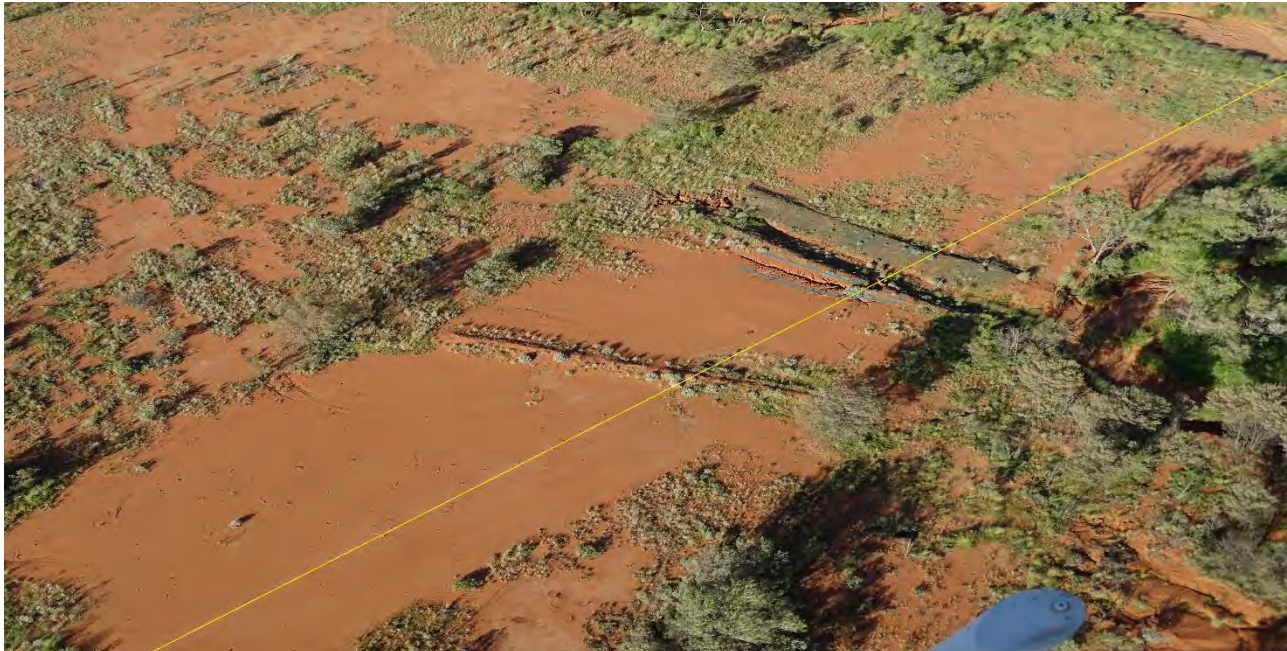
KP 153.565	<ul style="list-style-type: none"> • Previously reported significant erosion developing along the trench line in this location is covered by vegetation overgrowth.
Keridi Creek Tributary T2 KP 155.001	<ul style="list-style-type: none"> • Appeared to remain in reasonable condition and no significant change to erosion observed since time of last flight; the upstream bank has sustained significant water erosion damage. • The erosion appears to be at least 1m in depth.

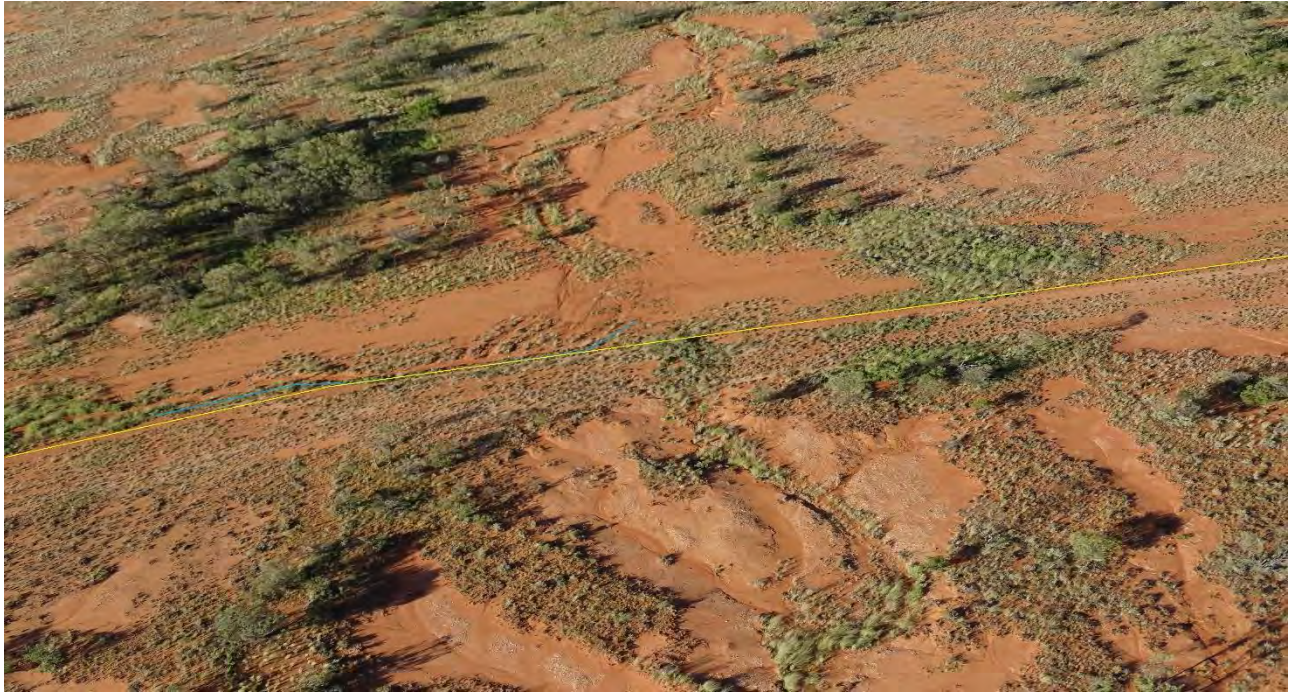
Location	Comment
<p>Keridi Creek T2 KP 155.371</p>	<ul style="list-style-type: none"> Below image shows moderate water erosion developing from the run off of a water course nearby channelling down the pipeline trench.

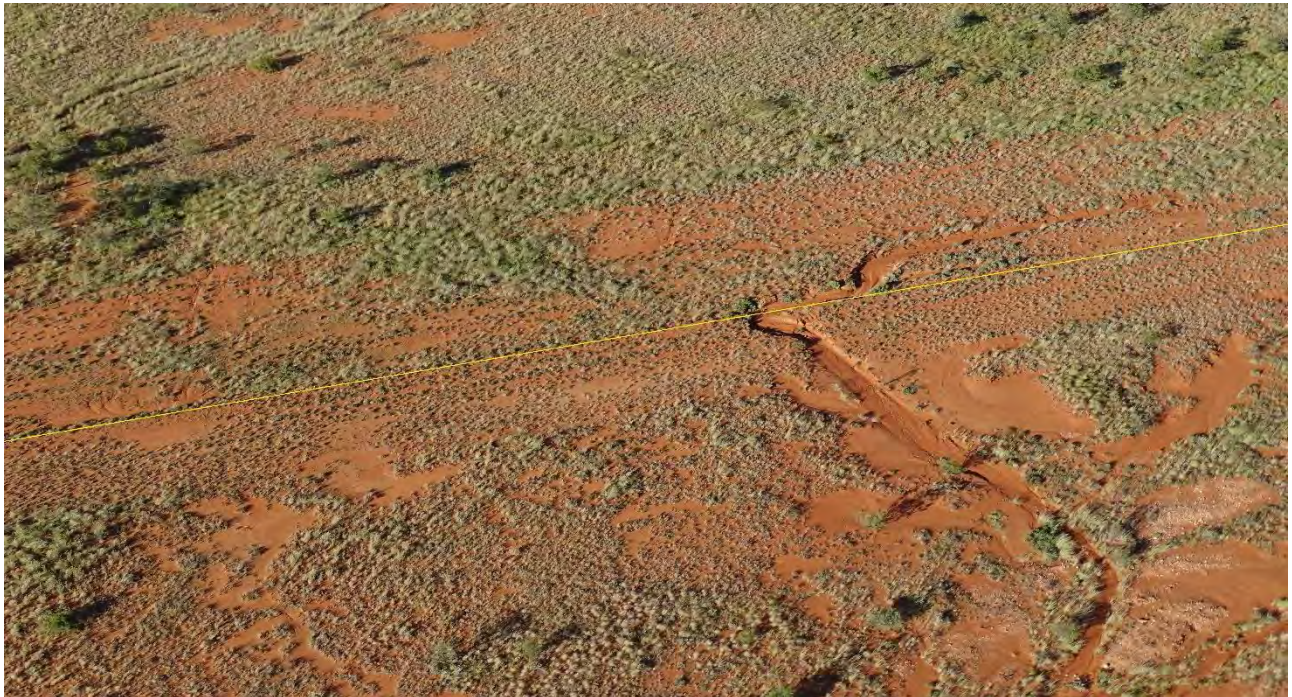
<p>KP 155.700</p>	<ul style="list-style-type: none"> Below image shows moderate water erosion developing across the pipeline, no changes since time of last flight. Appears to be approximately 300-400mm in depth.

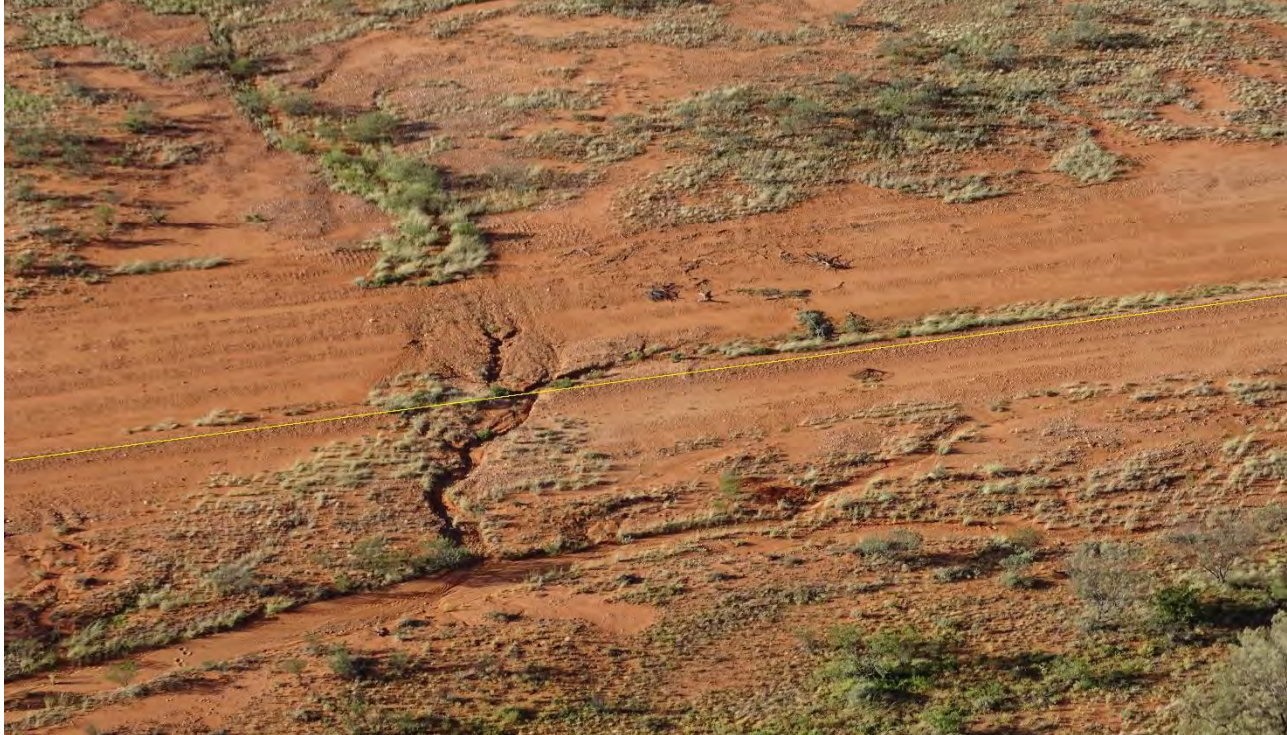
Location	Comment
<p>KP 156.074 Keridi Creek T3 Tributary</p>	<ul style="list-style-type: none"> Below image shows increasing erosion in this crossing; 300-400mm in depth.

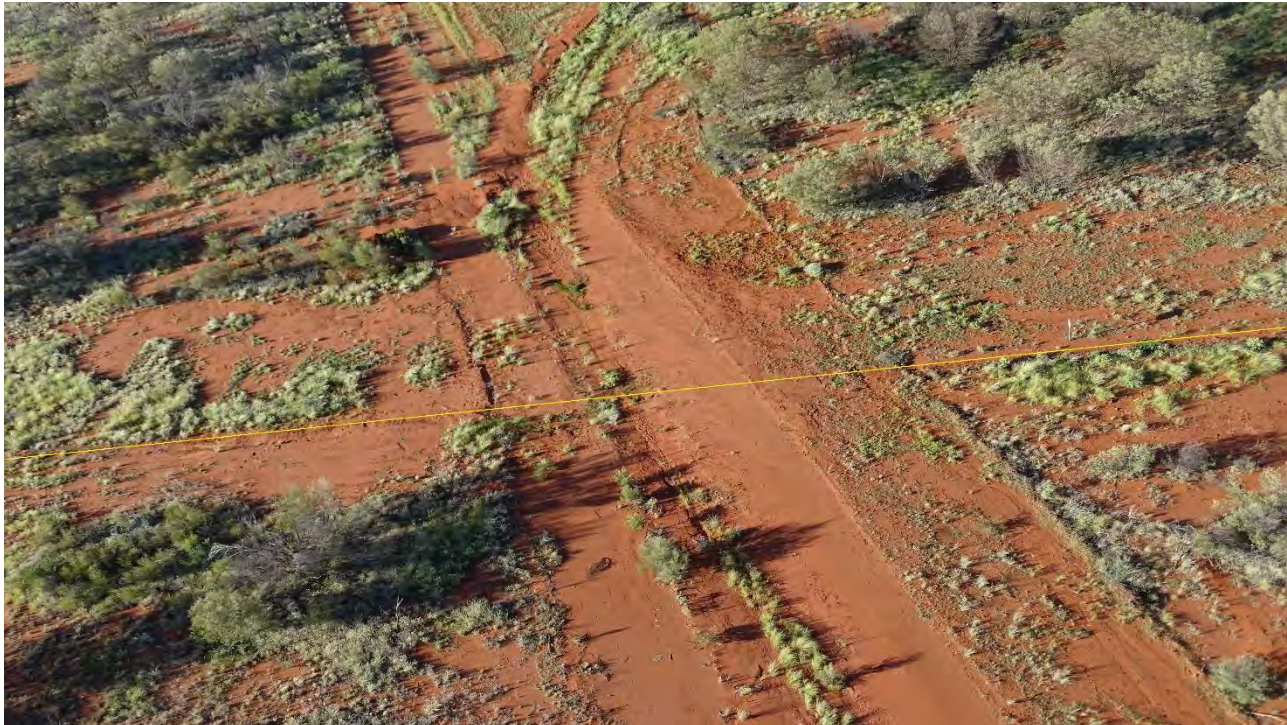
<p>Mount Doreen Station Rd KP 159.927</p>	<ul style="list-style-type: none"> No change to the road crossing.

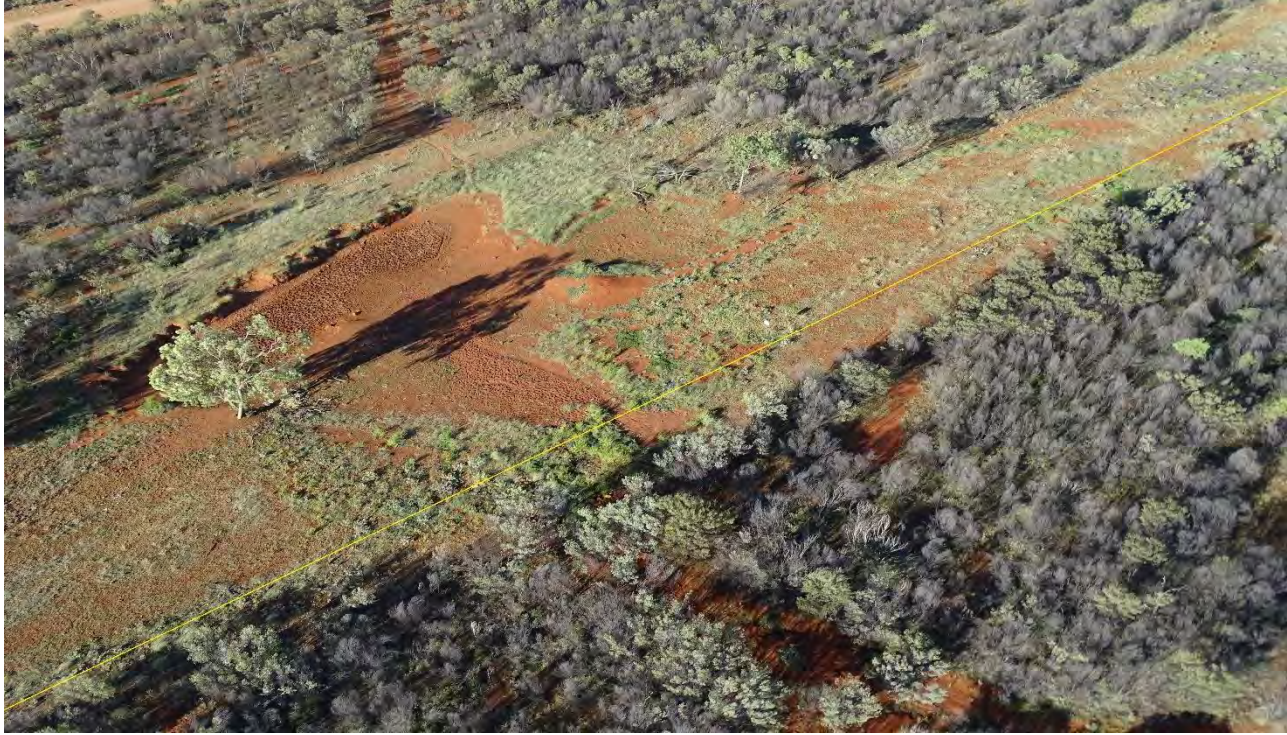
Location	Comment
<p>KP 160.886 – KP 161.496</p>	<ul style="list-style-type: none"> Below image shows a dry water catchment on the corridor.

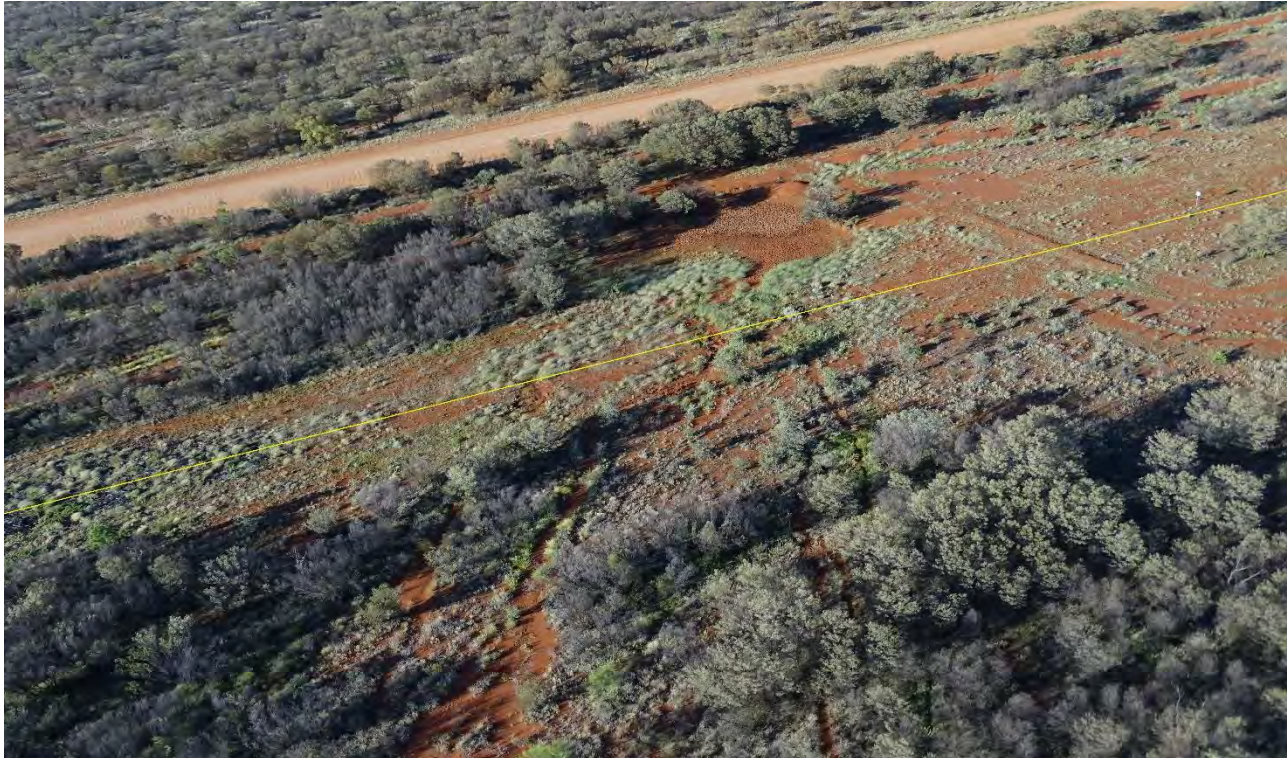
<p>KP 162.612</p>	<ul style="list-style-type: none"> Below image shows moderate water erosion leading to a water catchment area; pipe crown eroding.

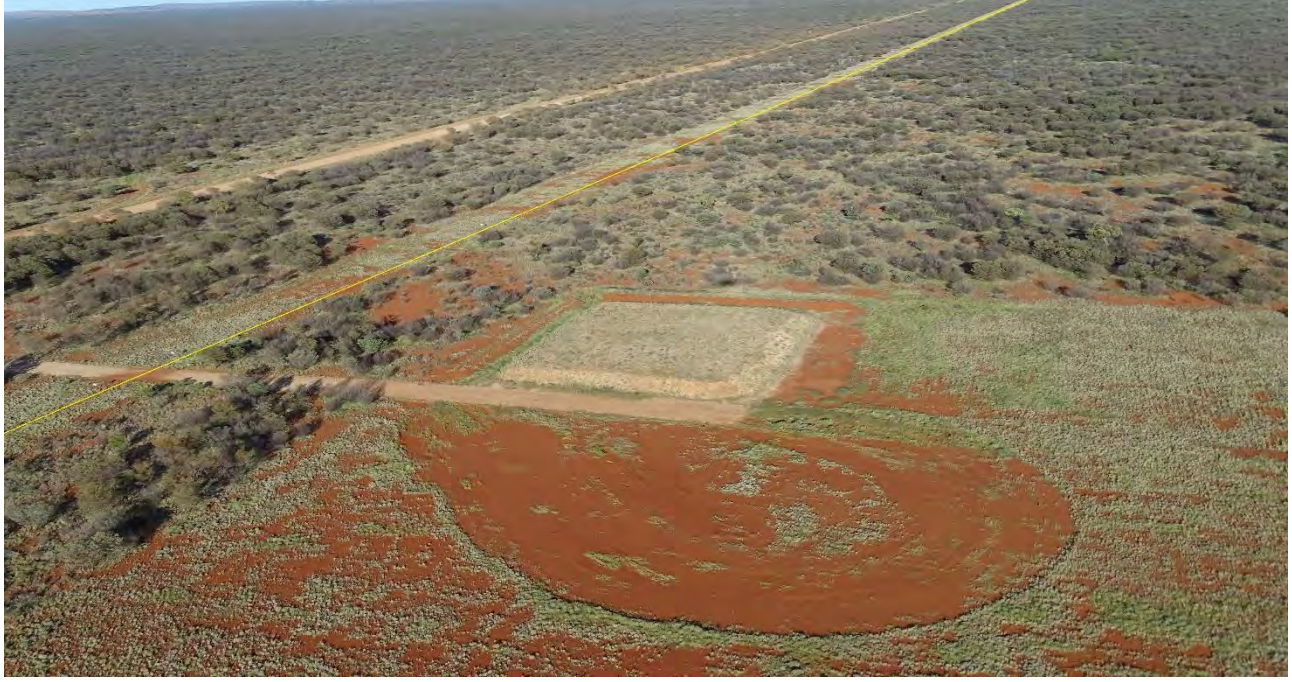
Location	Comment
<p>Camp 2/Laydown No.3 KP 170.616</p>	<ul style="list-style-type: none"> Below image shows the previous laydown/camp area.

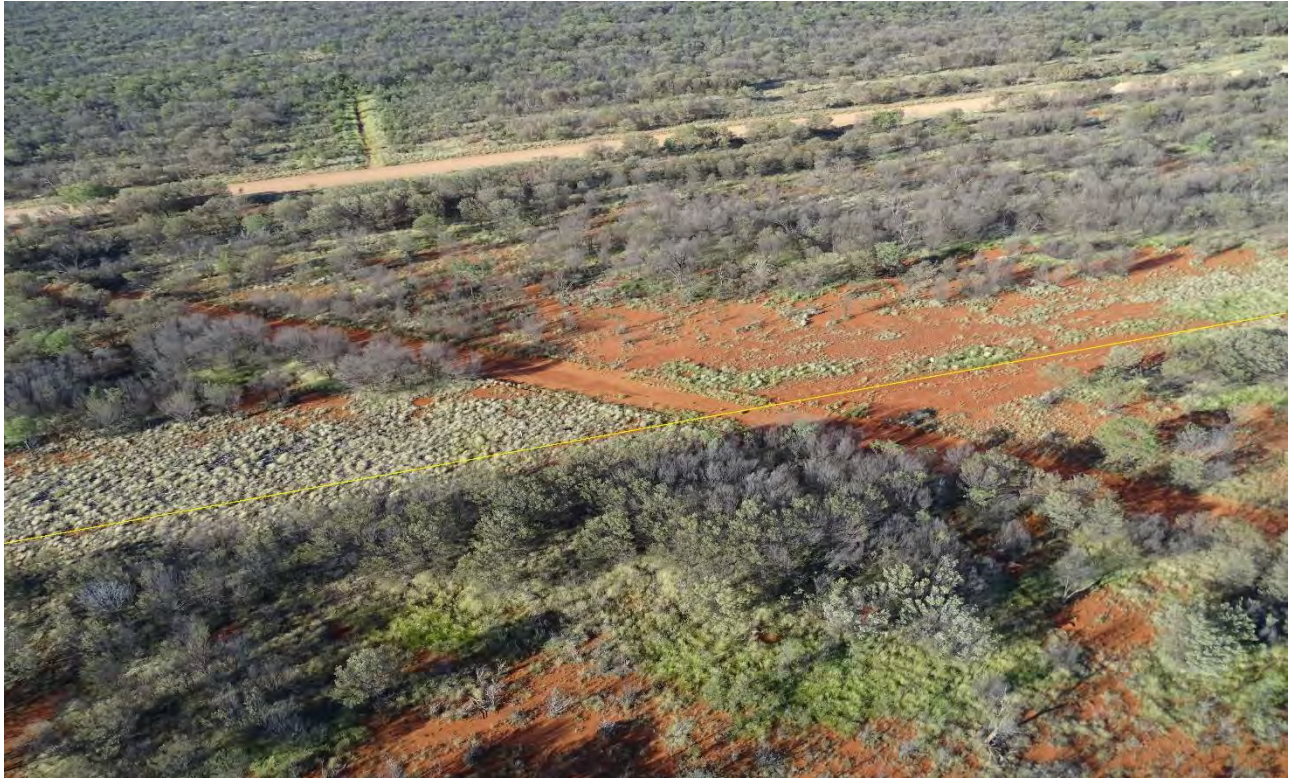
<p>Gintys Bore Access Road KP 173.100</p>	<ul style="list-style-type: none"> No change to the current condition of the road crossing.

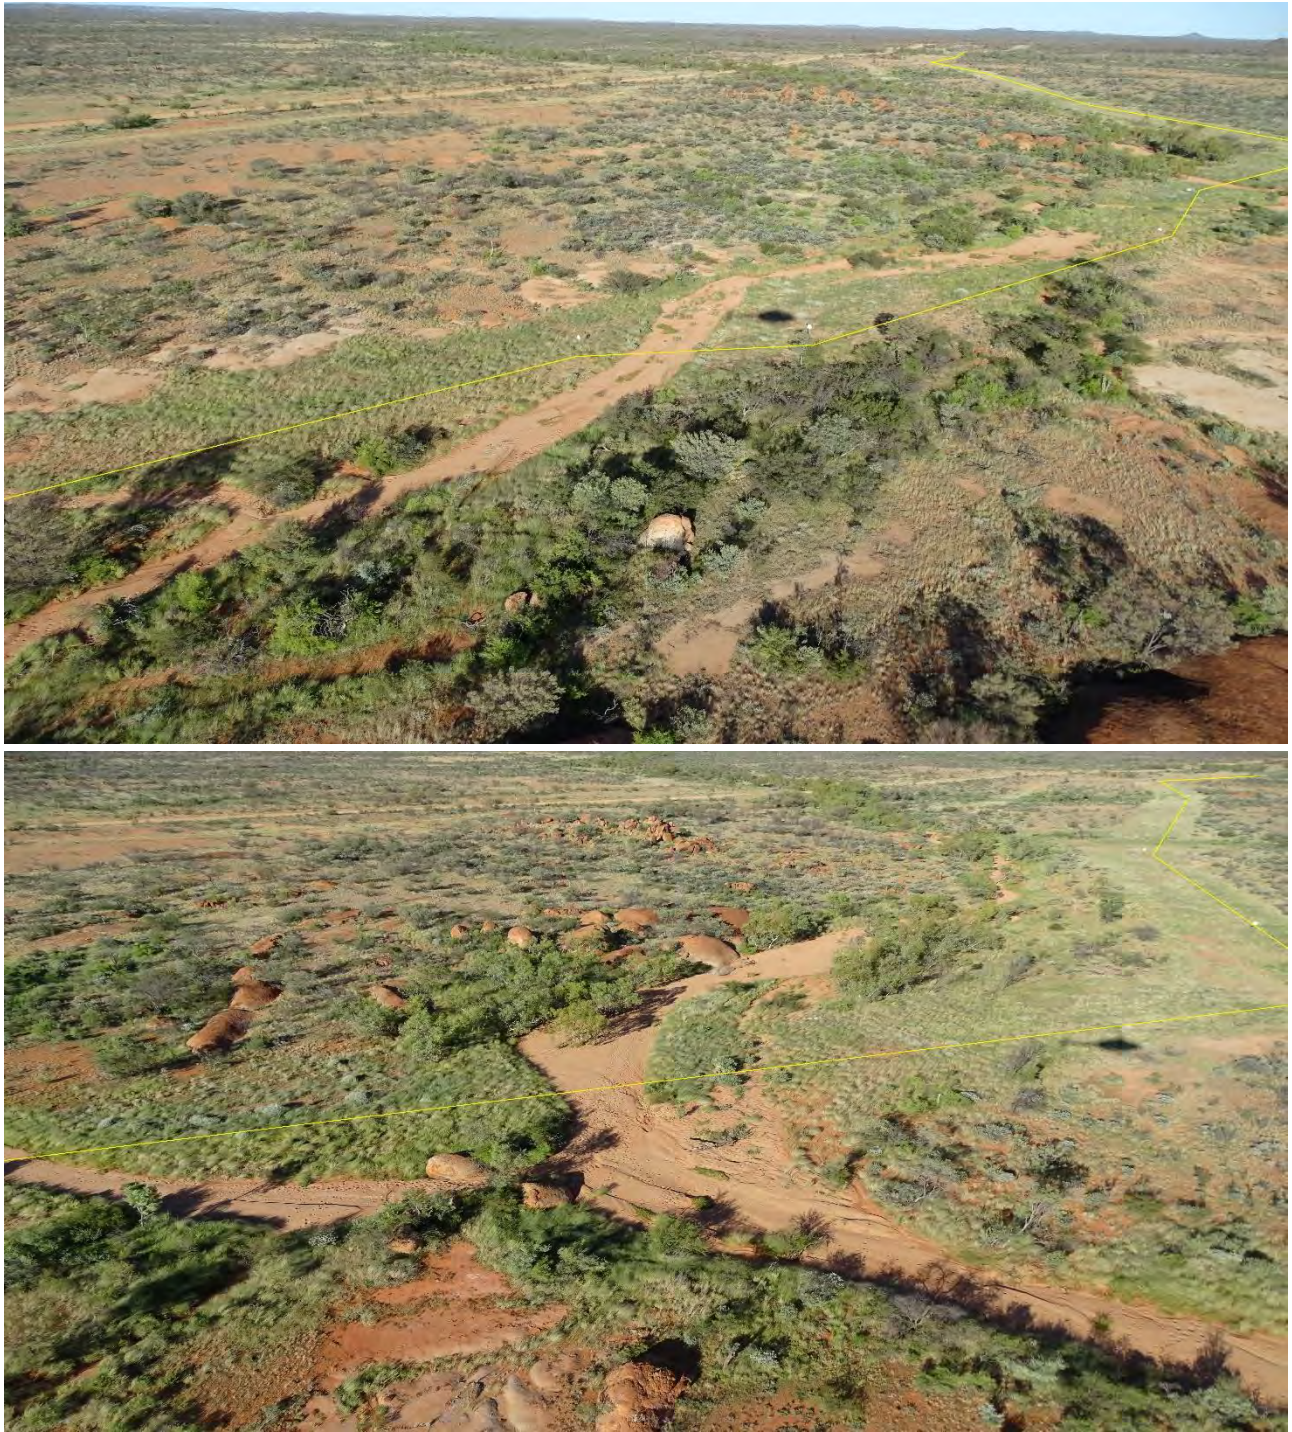
Location	Comment
KP 180.213 Watercourse T3	<ul style="list-style-type: none"> • Condition of water course has not changed slightly since recent heavy rains. • Moderate erosion in close proximity to the banks, covered in overgrowth. • Approx. 300-400mm deep and 10m long.
Yaloo garrie Creek T1 & Tributaries KP 179.962 – KP 181.364	<ul style="list-style-type: none"> • No significant changes observed to the creek and its tributaries.

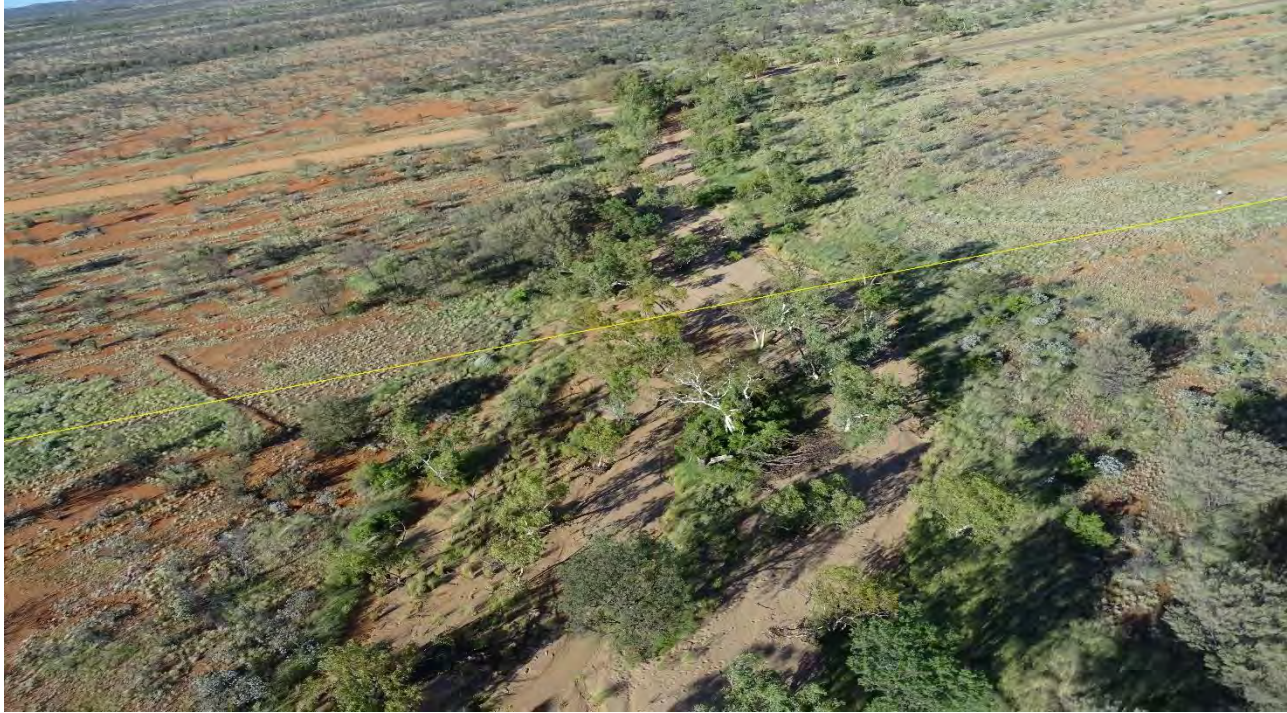
Location	Comment
<p>Yaloogarrie Creek Tributaries KP 184.200 KP 185.000</p>	<ul style="list-style-type: none"> No change observed to the creeks tributaries, rock pitching areas covered by vegetation overgrowth.

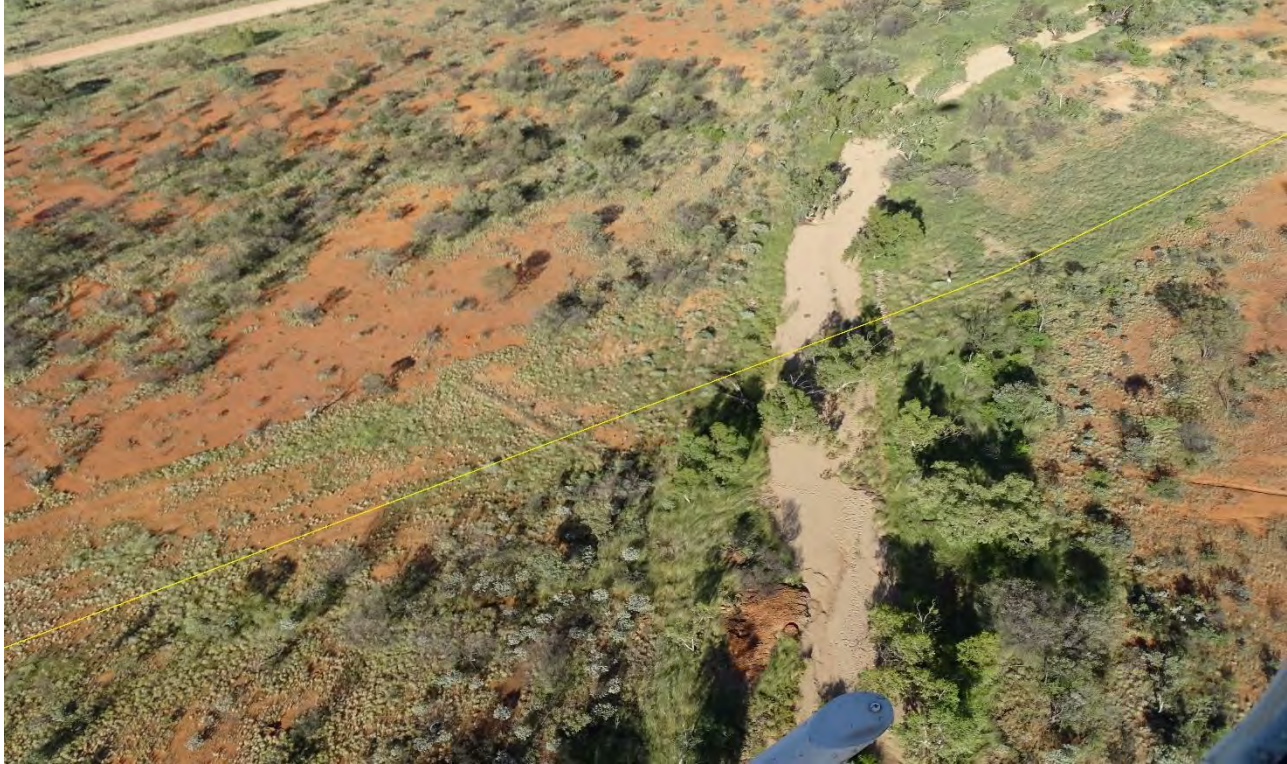
<p>Yaloogarrie Creek Tributaries KP 188.900</p>	<ul style="list-style-type: none"> The water crossing at this location appeared in good condition; rock pitching covered by overgrowth.
