TANAMI GAS PIPELINE
ANNUAL COMPLIANCE ASSESSMENT REPORT
EPBC 2017 / 7997

E-REP-069

Rev 1

AERIAL SURVEILLANCE REPORT

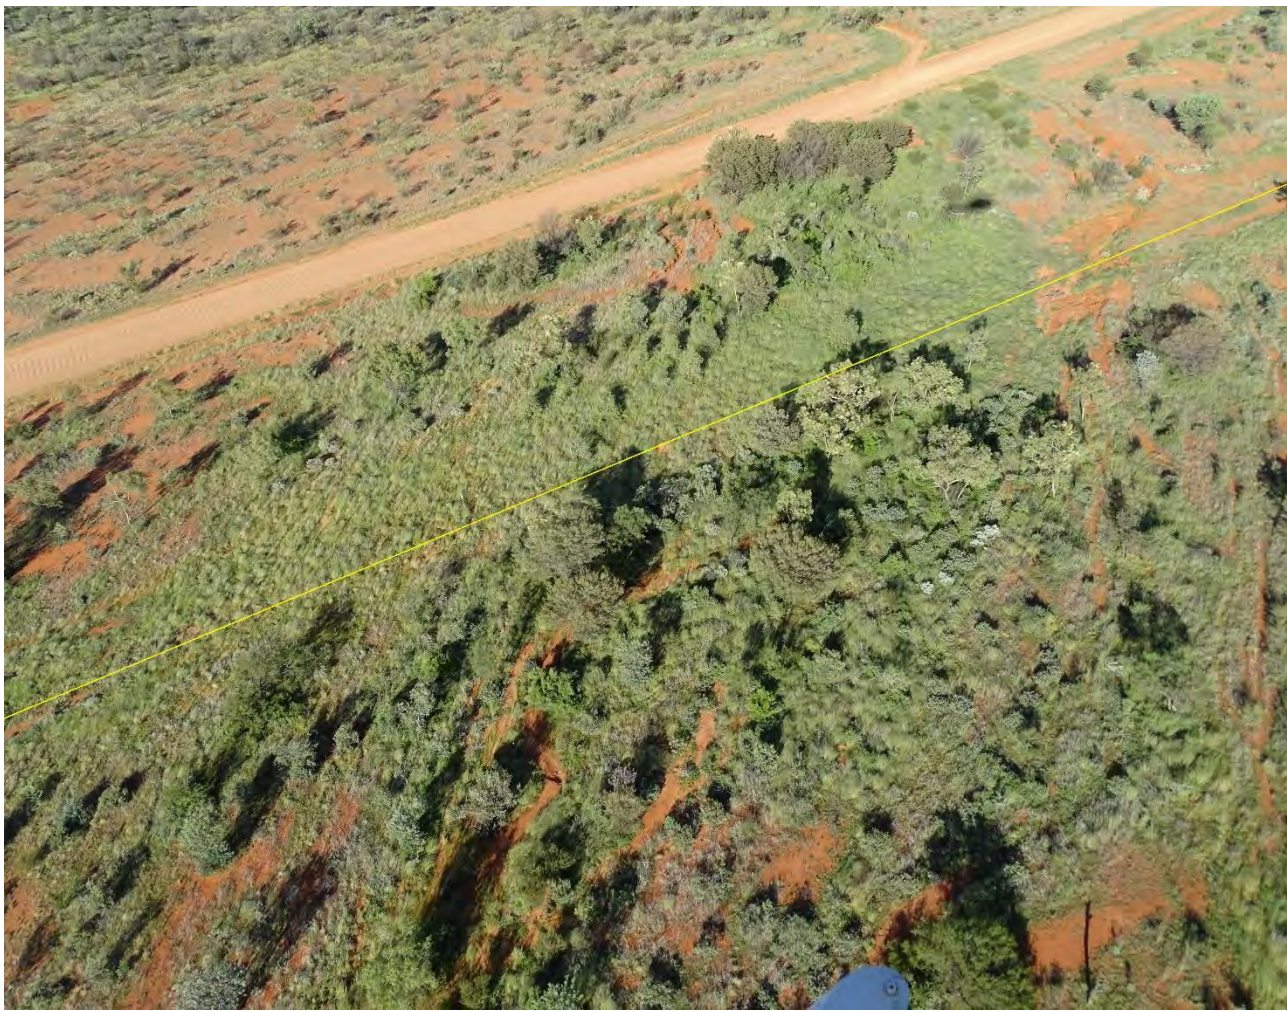
Location	Comment
KP 191.119	<ul style="list-style-type: none"> Previously reported minor water erosion developing in this location and flowing around the diversion bank across the pipeline crown; unable to be observed due to vegetation cover.
KP 191.829	<ul style="list-style-type: none"> Below image shows some moderate erosion developing close to a known T3 water crossing.

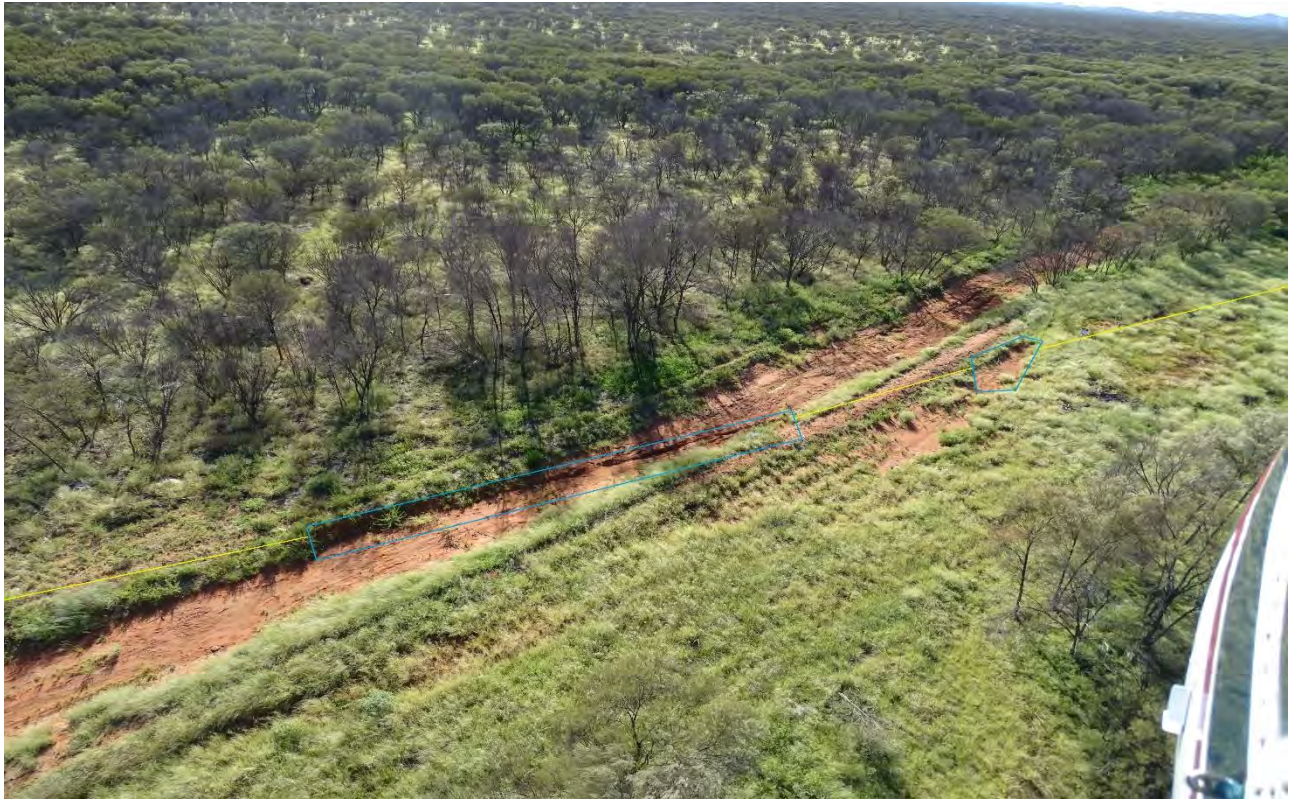
Location	Comment
<p>KP 206.110</p>	<ul style="list-style-type: none"> • Below image shows previously reported major erosion and washout over the pipeline. • No major changes observed since previous inspection. • Helicopter landed; only a small section of marker tape was visible this time. • Erosion is likely 500mm in depth from the actual NGL and the silt left behind from the last flows appear to have filled in some of the deeper holes.

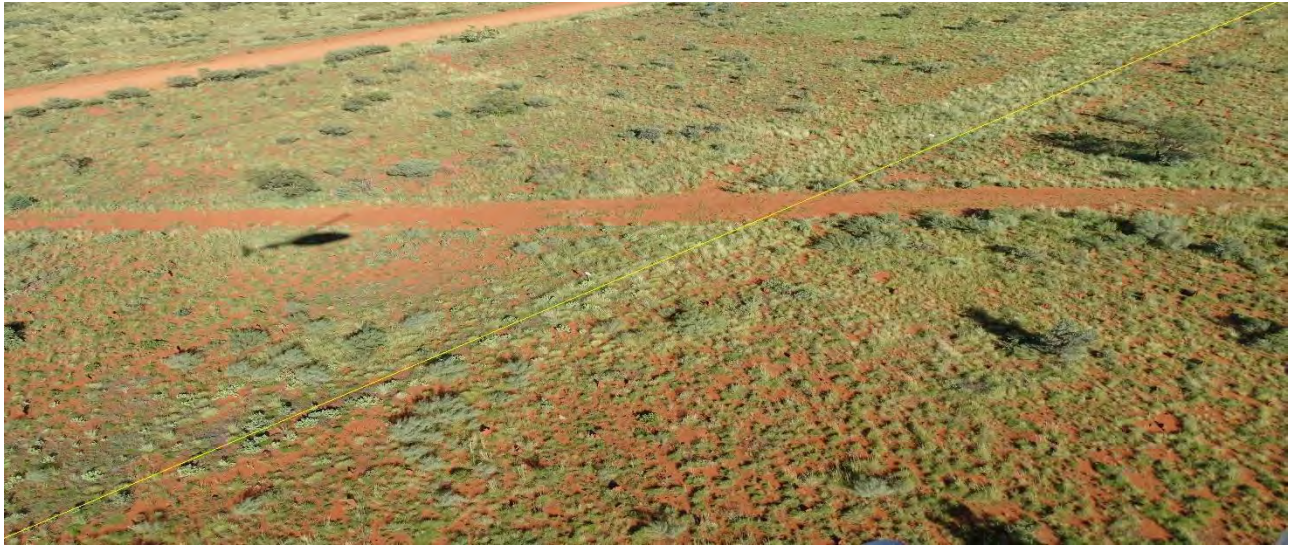
<p>Gravel Road KP 218.100</p>	<ul style="list-style-type: none"> • No change observed to the current condition of the road crossing.

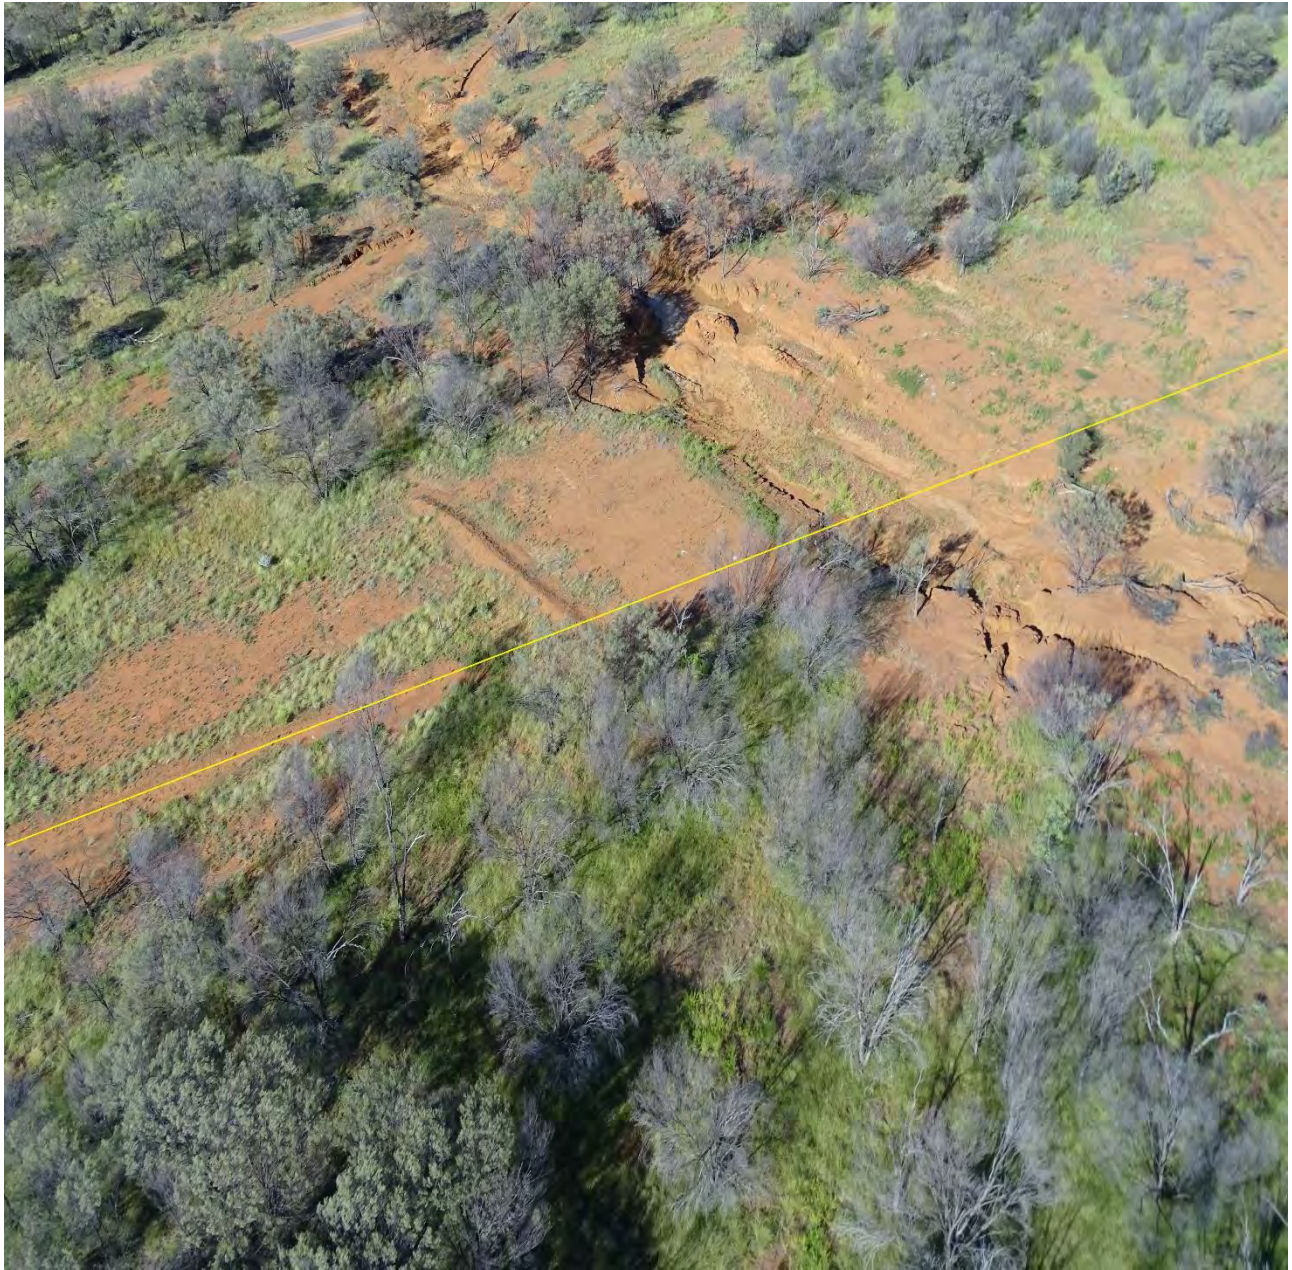
Location	Comment
Flood Out Creek T2 KP 228.158	<ul style="list-style-type: none"> All appeared correct at Flood Out Creek crossing.
KP 229.607 Water Course T3	<ul style="list-style-type: none"> Below image shows minor to moderate damage to the banks of this creek.

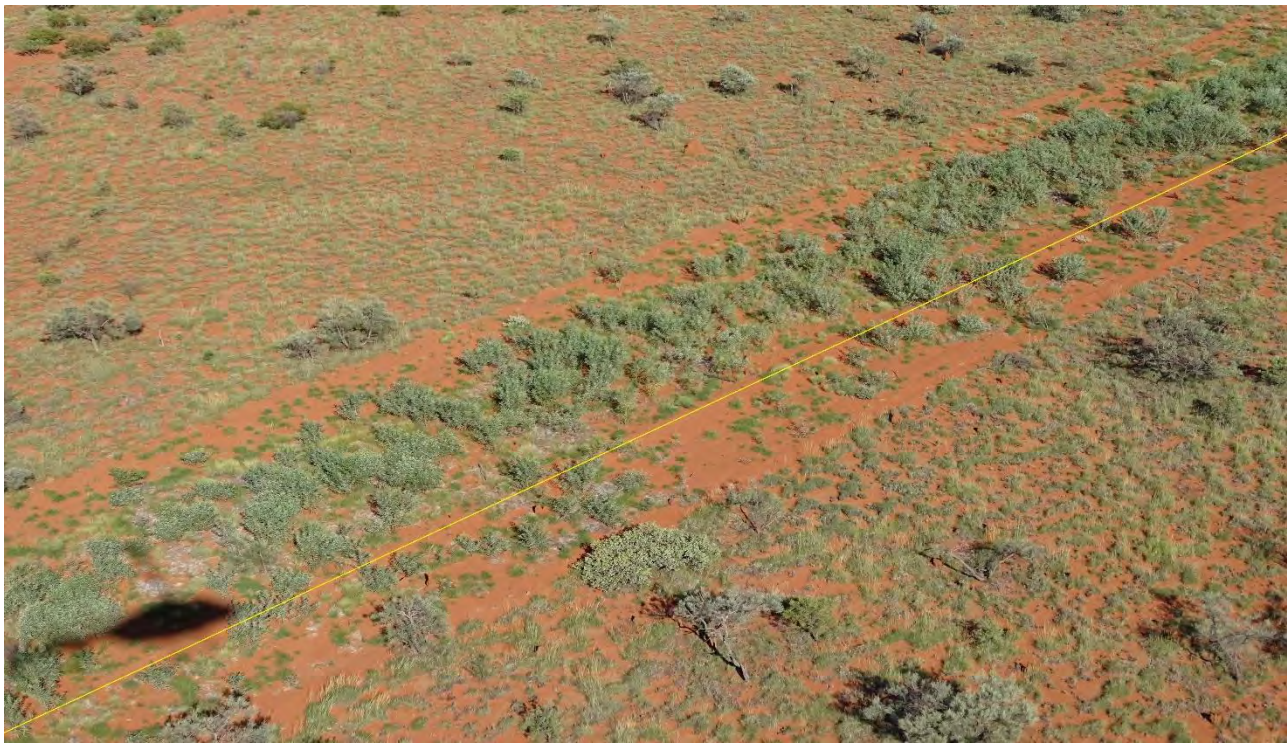
<p>KP 252.000 KP 254.000</p>	<ul style="list-style-type: none"> Below image shows vegetation overgrowth in this section is starting to block line of sight.

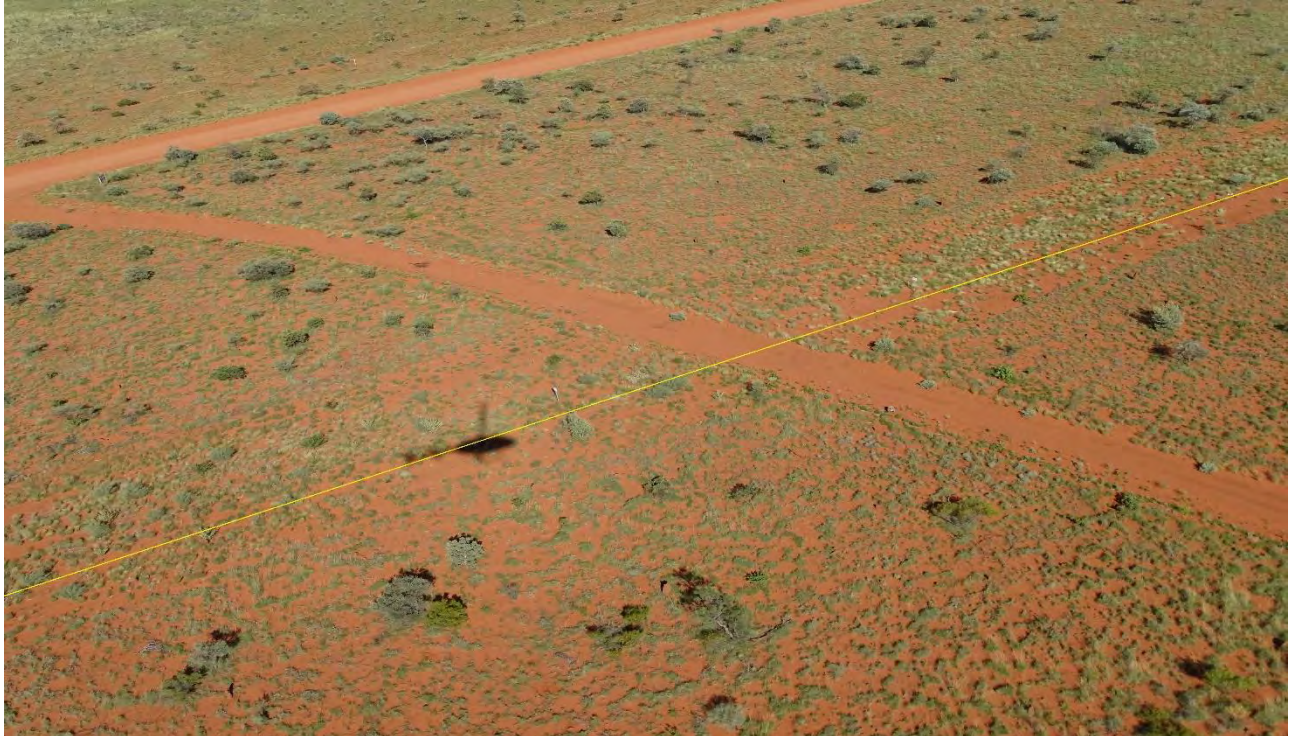
<p>Mount Theo Rd KP 263.239</p>	<ul style="list-style-type: none"> Mount Theo Road Crossing is in good condition.

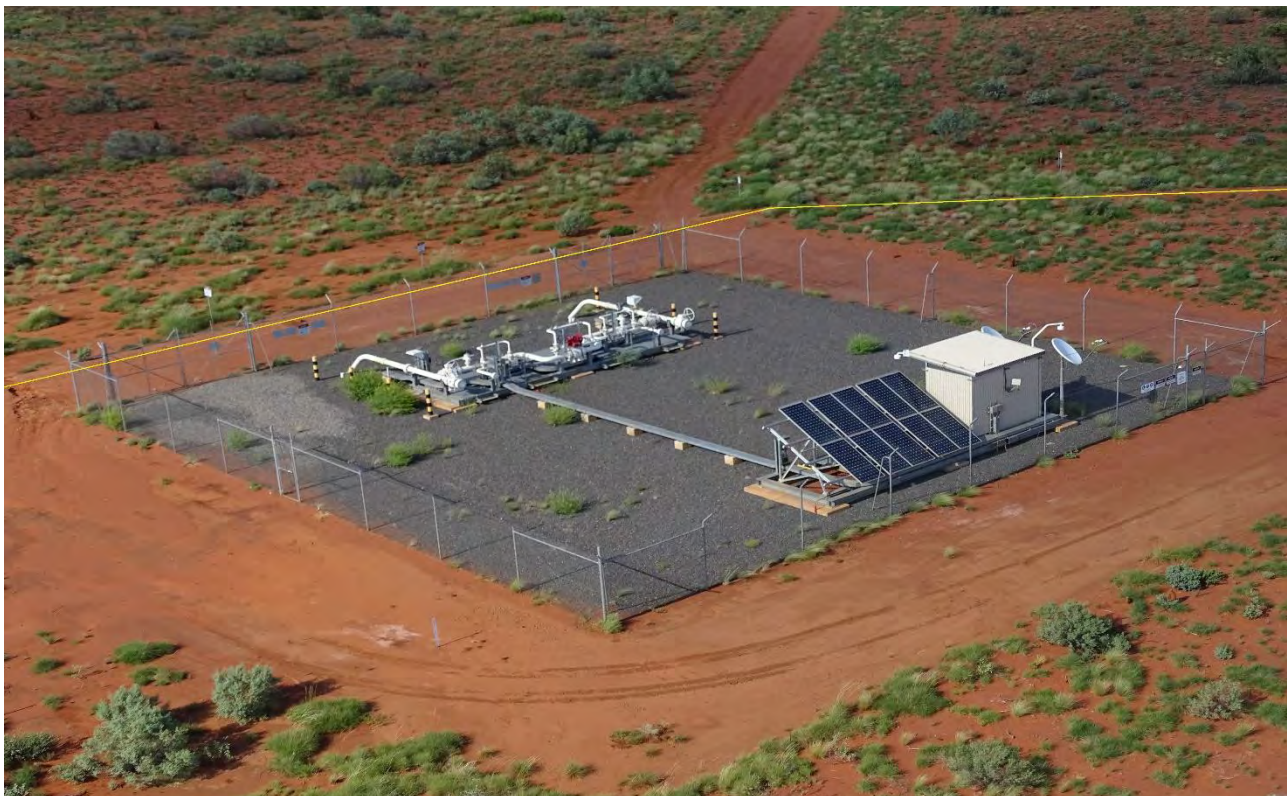
<p>SS2 Chilla Well KP 279.374</p>	<ul style="list-style-type: none"> Appeared correct and secure.

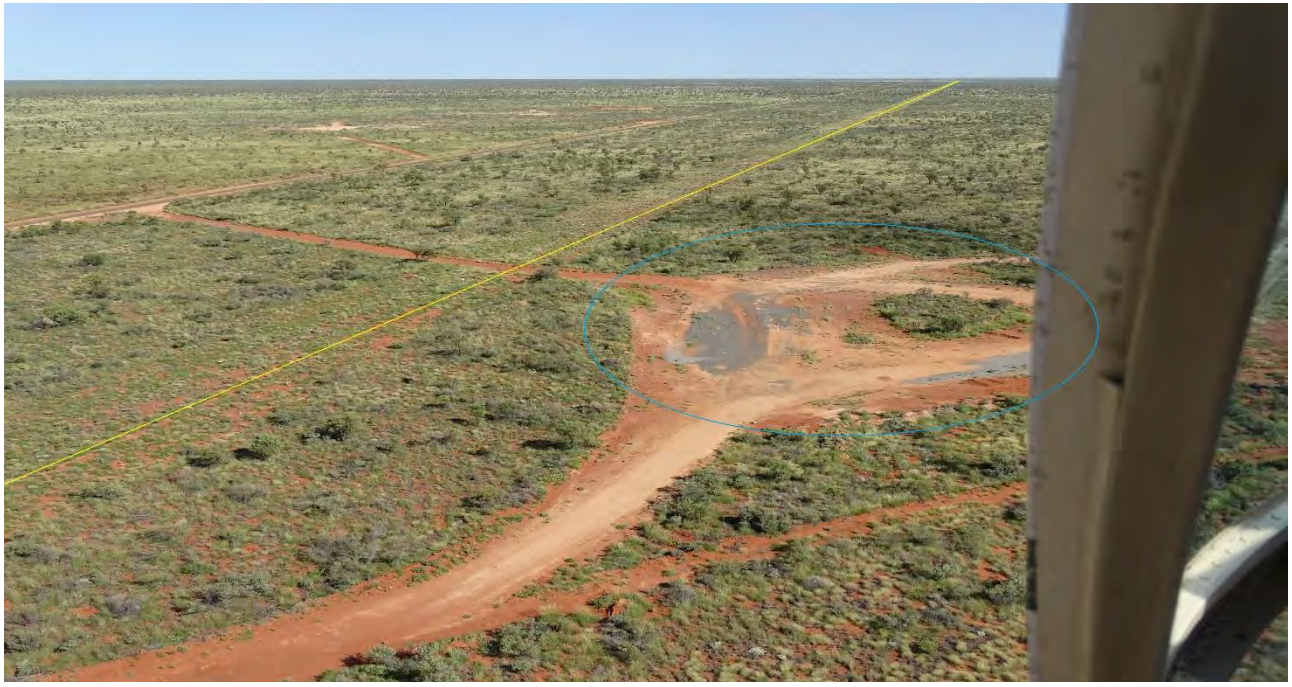
<p>KP 287.634</p>	<ul style="list-style-type: none"> No changes to significant erosion to the bank of a known swale drain crossing point at KP 287.634
<p>KP 323.830</p>	<ul style="list-style-type: none"> The previously observed Tanami Road Crew camp set up on the east side of the corridor is no longer in place.

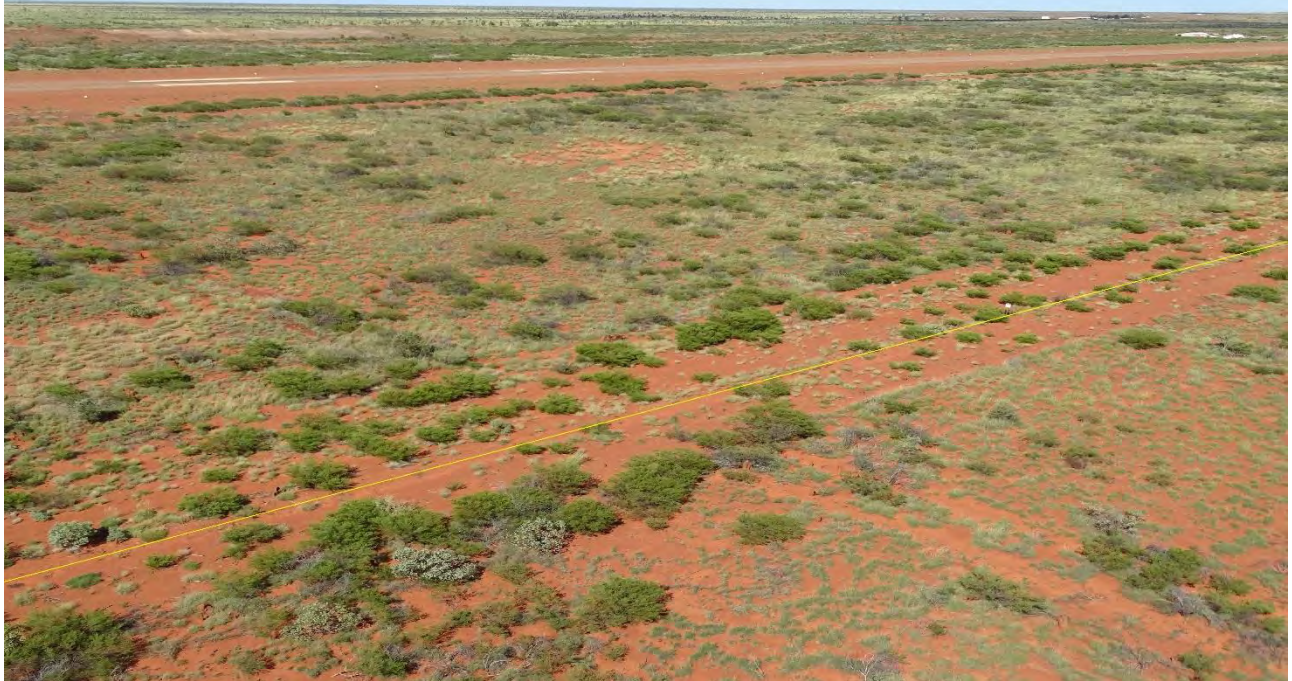
KP 395.100 Granites Airstrip	<ul style="list-style-type: none"> Thick regrowth has occurred on the corridor and will start to impact line of sight in the near future.

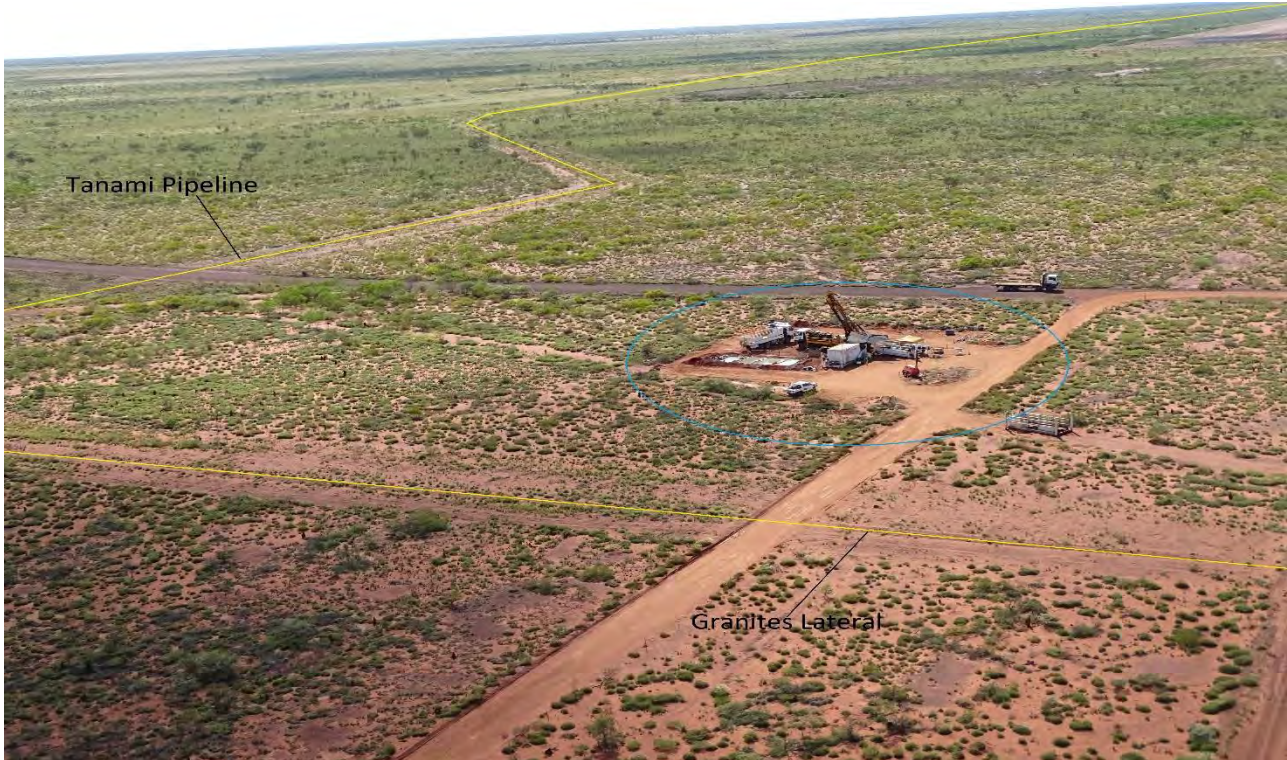
<ul style="list-style-type: none"> Below image shows a drill crew from the mine operating in proximity to the lateral.

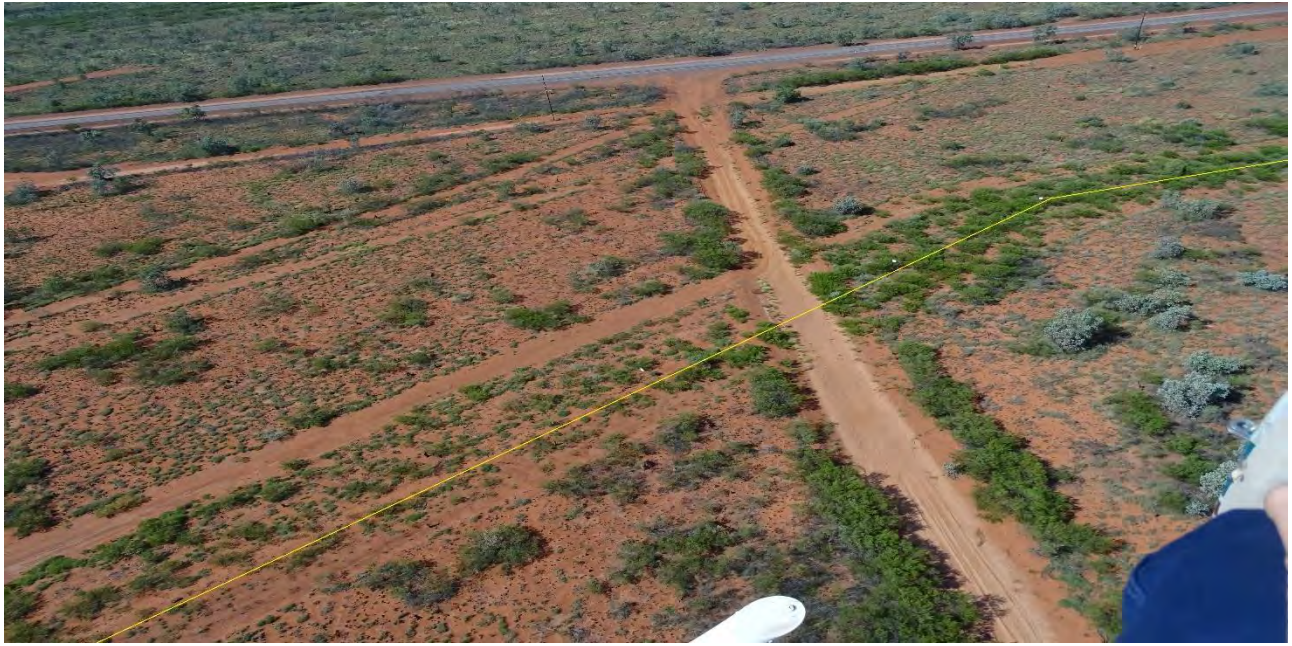
<p>Swale drain KP 403.980</p>	<ul style="list-style-type: none"> No further water erosion damage observed since previous flight.

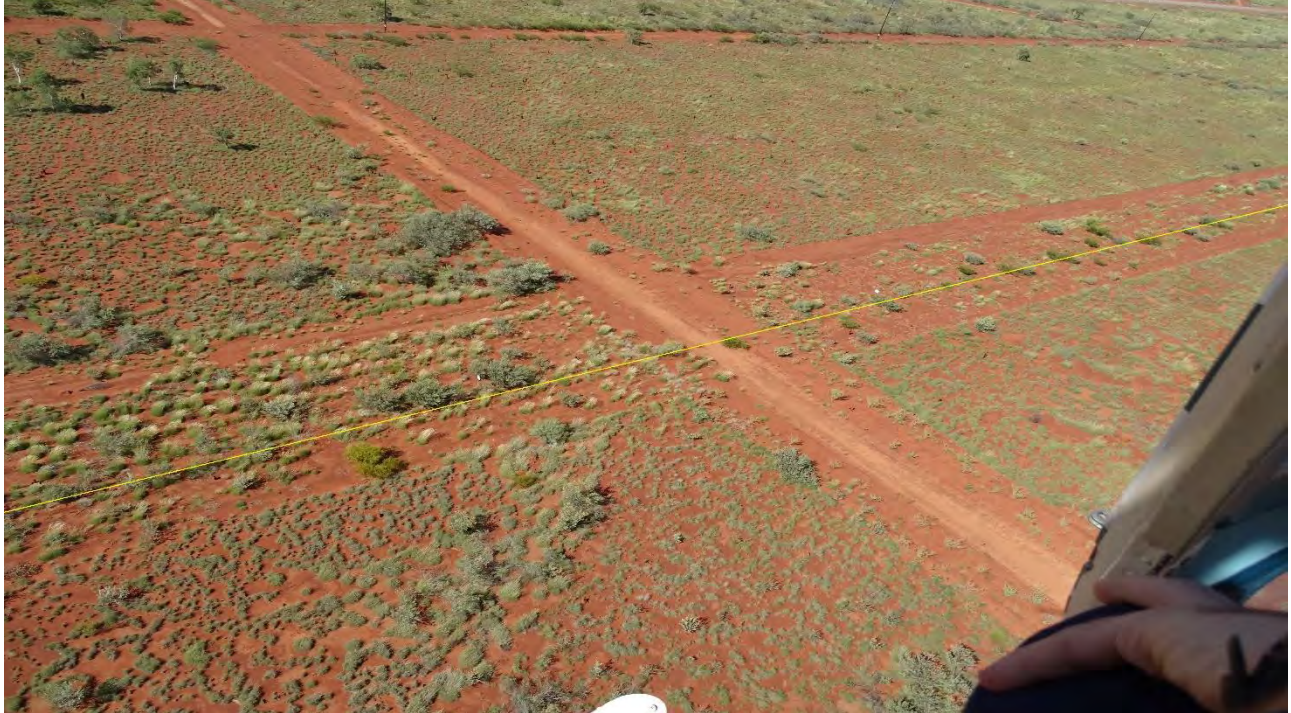
Location	Comment
<p>KP 436.070</p>	<ul style="list-style-type: none"> No further water erosion damage to the Swale Drain outside the corridor at KP 436.070

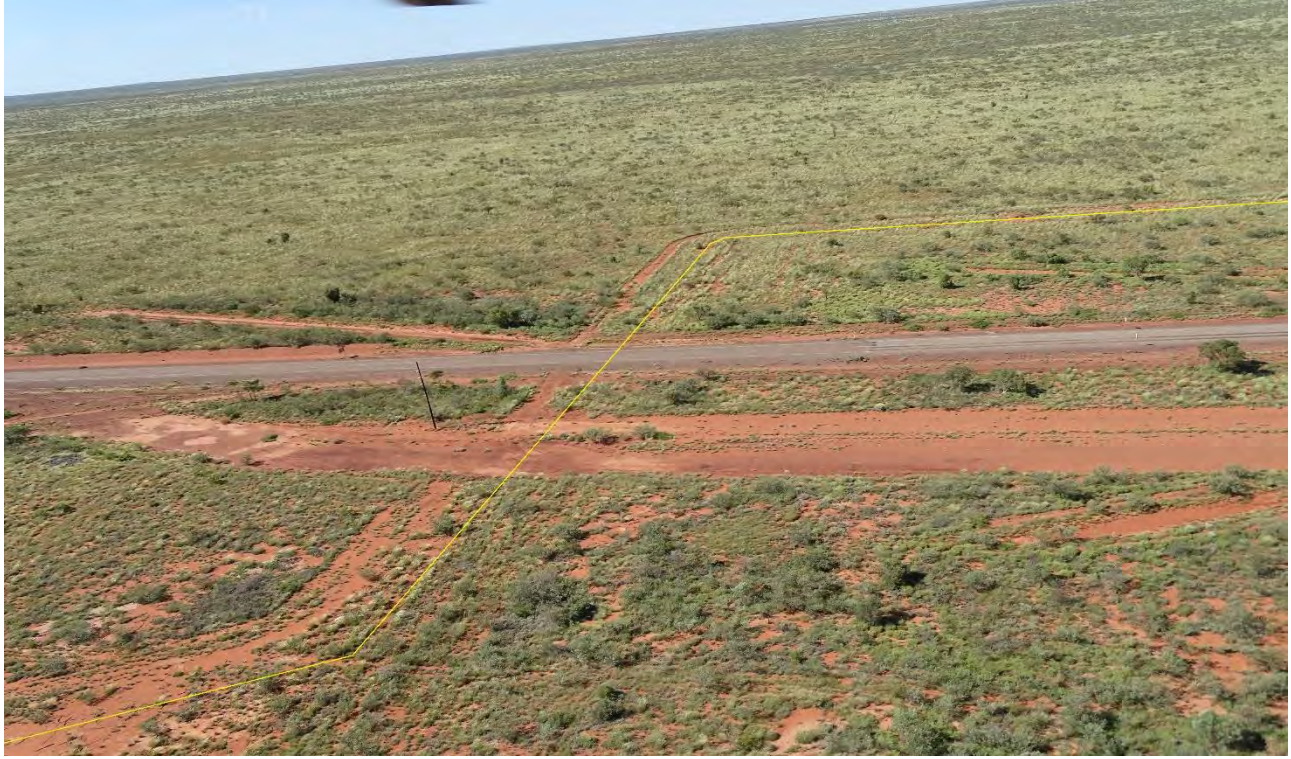
<p>DBS Haul Road KP 436.992</p>	<ul style="list-style-type: none"> Below image shows the current condition of the haul road crossing point.

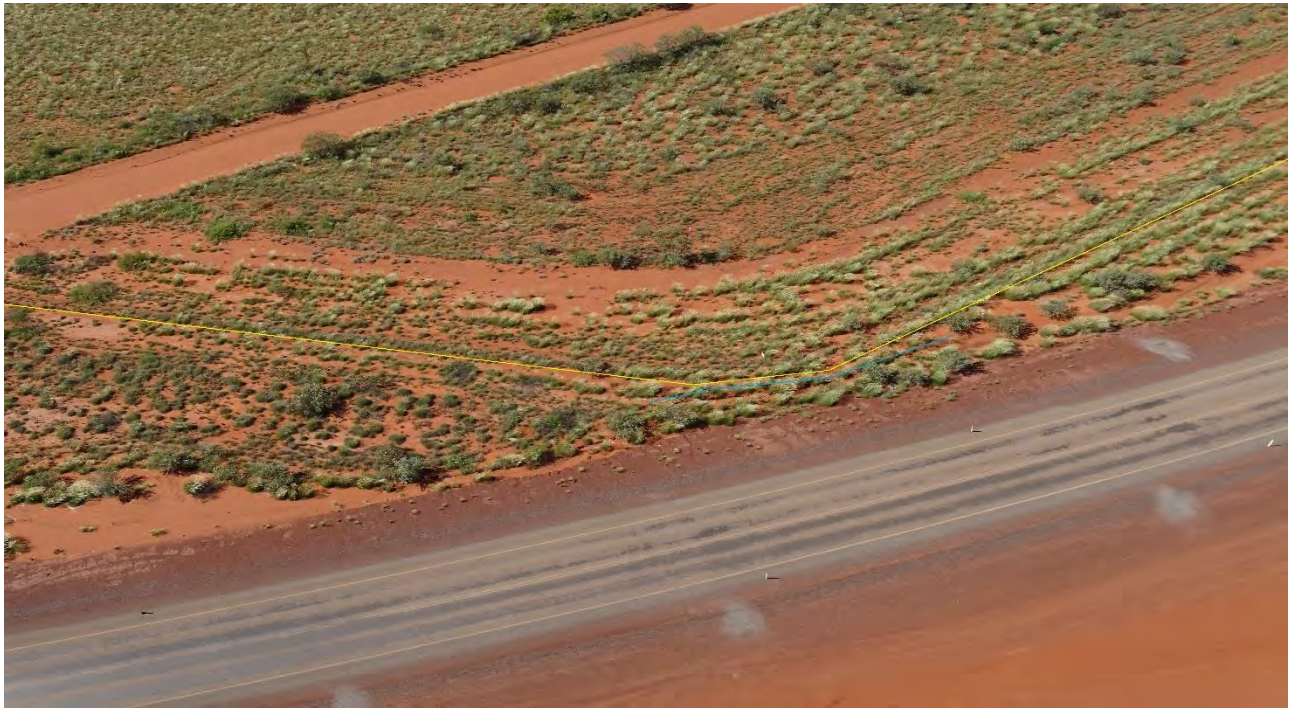
Location	Comment
<p>Mine Road KP 437.447</p>	<ul style="list-style-type: none"> Below image shows the Mine Road crossing the pipeline remains in good condition. Water erosion is developing approximately 80m from the crossing at the pipeline bend.

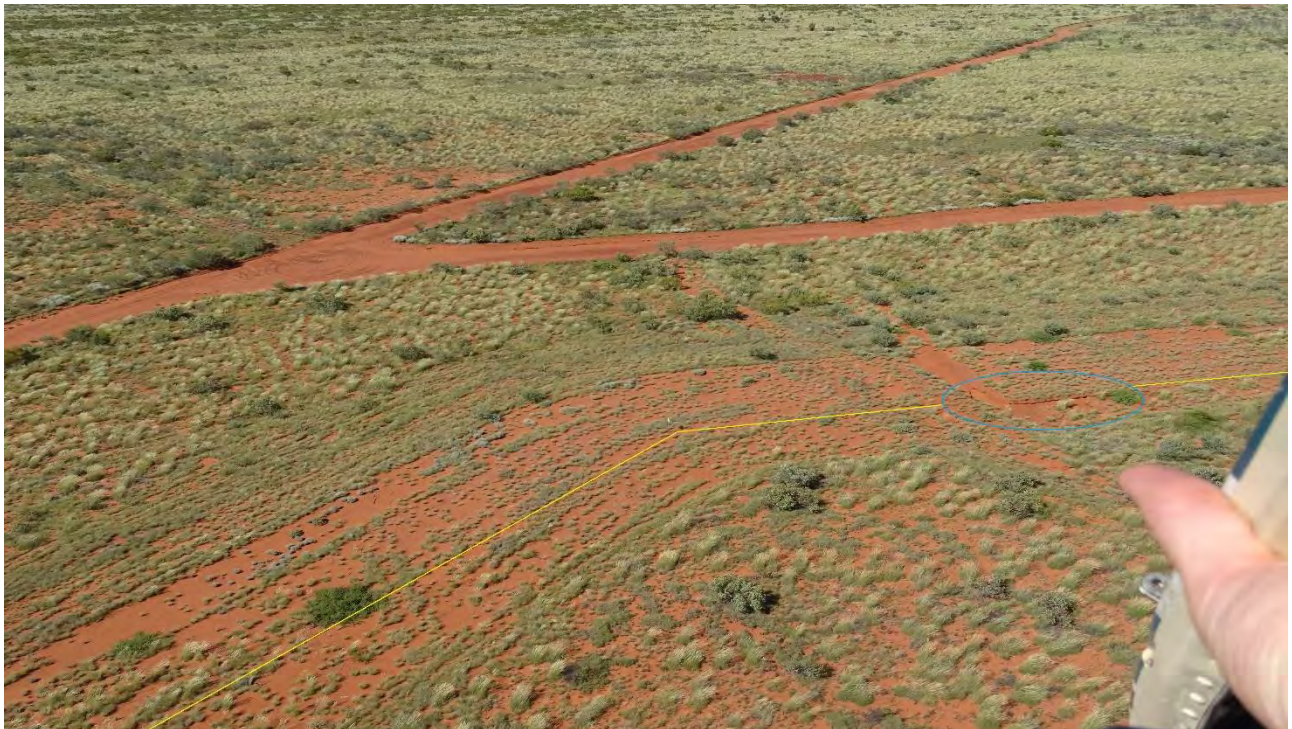
<p>KP 438.715</p>	<ul style="list-style-type: none"> Below image shows significant water erosion at the crossing point of a T3 Water Course. No significant changes to the erosion since the time of the last flight; estimated 500mm in depth.

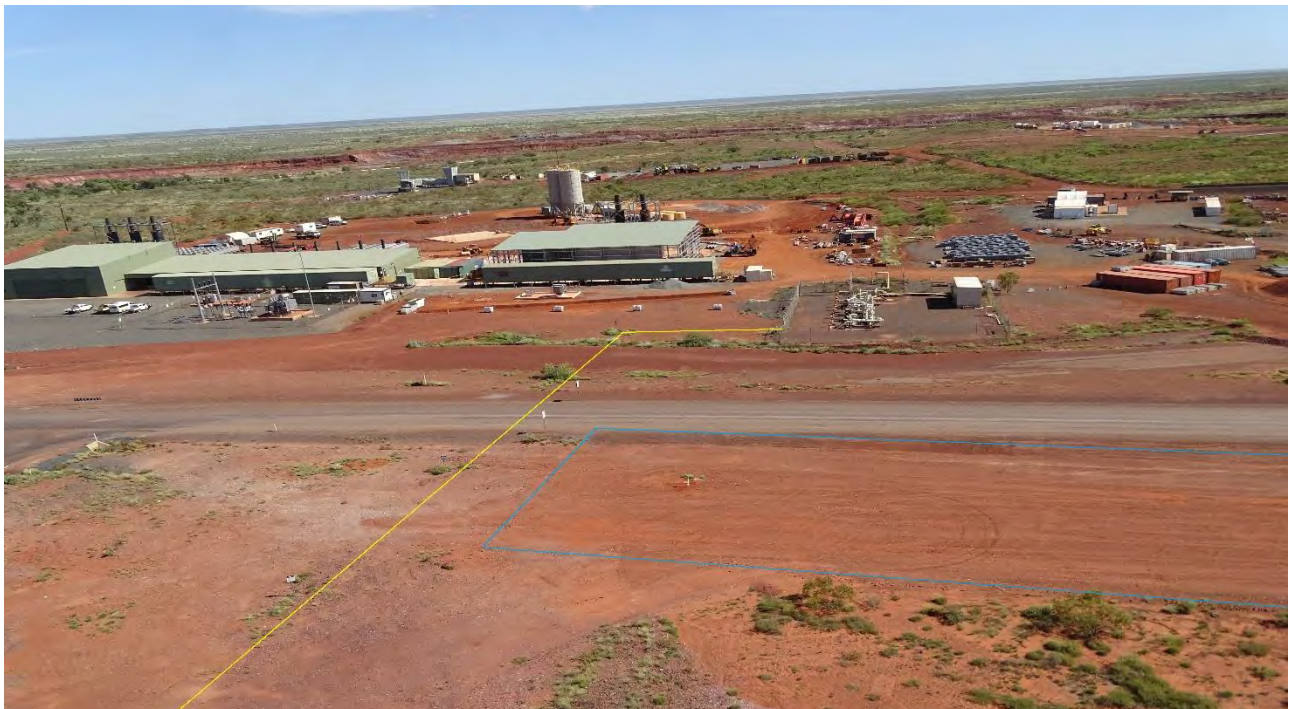
<p>DBS Haul Road KP 439.760</p>	<ul style="list-style-type: none"> • All appears correct. • Known major works occurring in close proximity to the pipeline easement along the Haul Road appear to now be complete.
