Tanami Gas Pipeline

EPBC 2017/7997

COMPLIANCE ASSESSMENT REPORT 2019-2020

E-REP-047

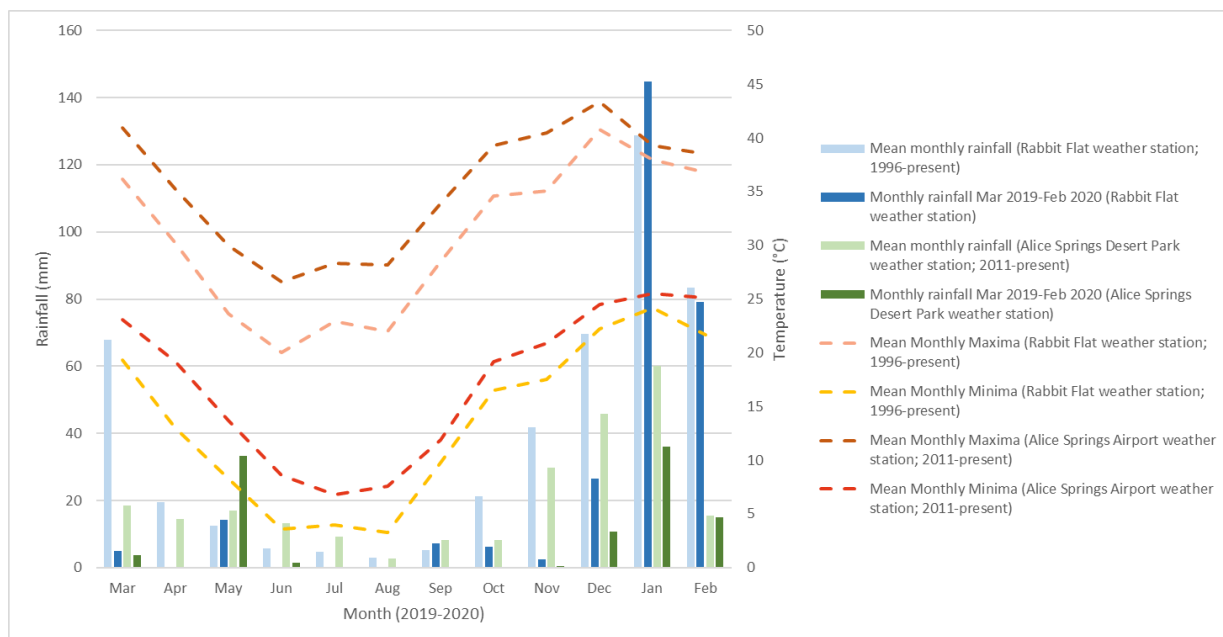
Rabbit Flat weather station (station number 15666; climate data 1996-present) and Alice Springs Desert Park weather station (station number 15679; climate data 2011-present) are the nearest Bureau of Meteorology (BoM) weather stations to either end of the TNP with active, complete and uncompromised rainfall data sets. In the 12 months preceding the field survey in March 2020, the areas received a total of 285.5 millimetres (mm) and 100.4 mm of rainfall (Rabbit Flat and Alice Springs Desert Park, respectively) which is below the long-term average of 462.7 mm and 242.5 mm for the same areas. In the three months prior to the field survey, the area received a total of 250.4 mm of rainfall in the north (Rabbit Flat), which is comparable to the long-term average of 281.8 mm for the same time period, and 61.6 mm of rainfall in the south (Alice Springs Desert Park), which is less than the long-term average of 121.4 mm for the same time period (BoM 2020).

Temperature data was not available at Alice Springs Desert Park station. The next nearest weather station with a complete temperature dataset was Alice Springs Airport (station number 15590, climate data 1996-present). Mean maximum temperatures in the region range from 20°C in June to 40.8°C in December in the north (Rabbit Flat) and 26.6°C in June to 43.4°C in December in the south (Alice Springs Airport). Mean minimum temperatures in the region range from 3.3°C in August to 24.2°C in January in the north (Rabbit Flat) and 6.8°C in July to 25.5°C in January in the south (Alice Springs Airport). Rainfall and temperature data are presented in **Figure 2-1**.

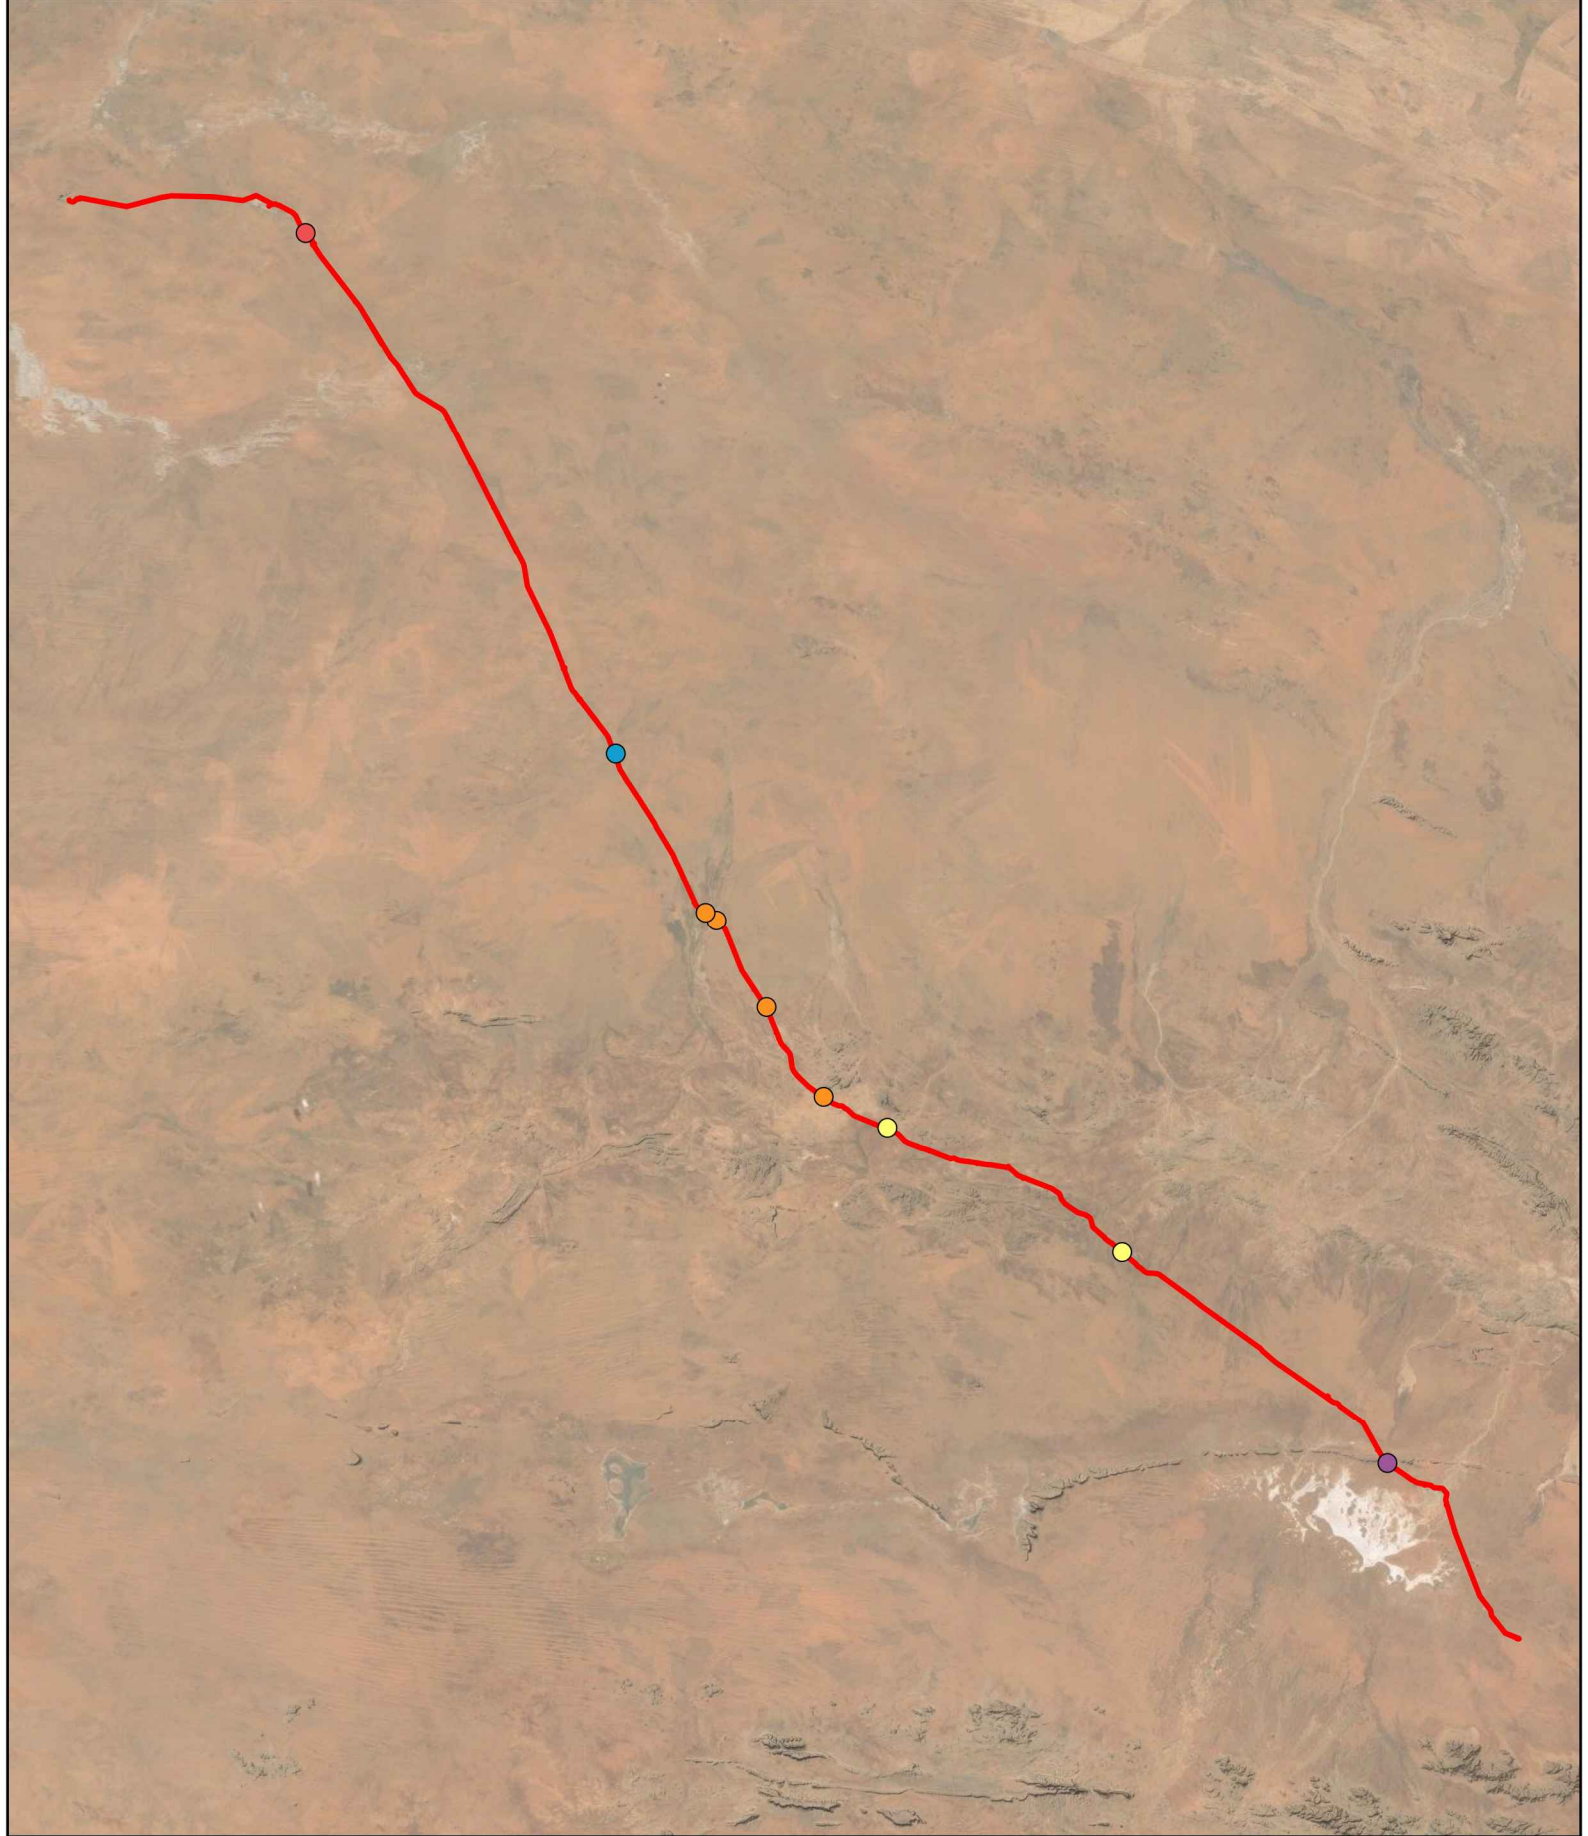
Figure 4-1: Flora of significance recorded at monitoring sites across the TNP

- Flora of Significance**
- *Heliotropium parviantrum* (DD)
 - *Heliotropium subreniforme* (DD)
 - *Sida* sp. *excedentifolia* (J.L. Egan 1925) (DD)
 - *Tephrosia brachyodon* (INFRA)
 - *Tribulus minutus* (DD)

No Threatened flora listed under the Commonwealth *Environment Protection and Biodiversity Conservation Act 1999* were recorded during the field survey. A total of four flora species listed as Data Deficient (DD) under the Northern Territory *Parks and Wildlife Conservation Act 2006* (TPWCA 2006) and one species listed as Intraspecific (INFRA) were recorded, namely *Heliotropium parviantrum* (DD), *Heliotropium subreniforme* (DD), *Sida* sp. *excedentifolia* (J.L. Egan 1925) (DD), *Tribulus minutus* (DD) and *Tribulus brachyodon* (INFRA). All of these species, with the exception of *Tribulus minutus* (DD), occurred within rehabilitation quadrats. Species in these genera tend to respond well to disturbance and so would be expected to colonise previously disturbed areas. Future surveys will determine whether these are viable populations of these species.

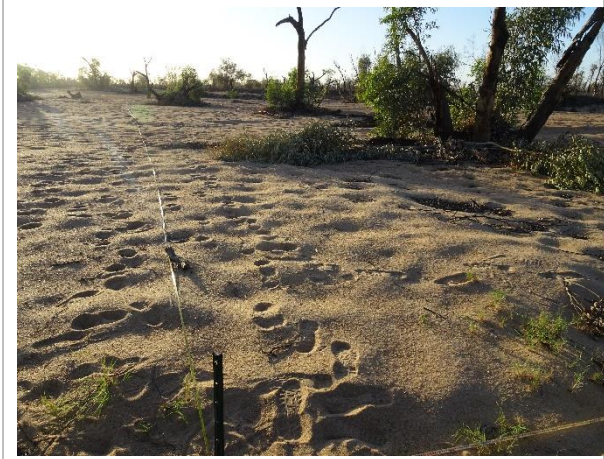
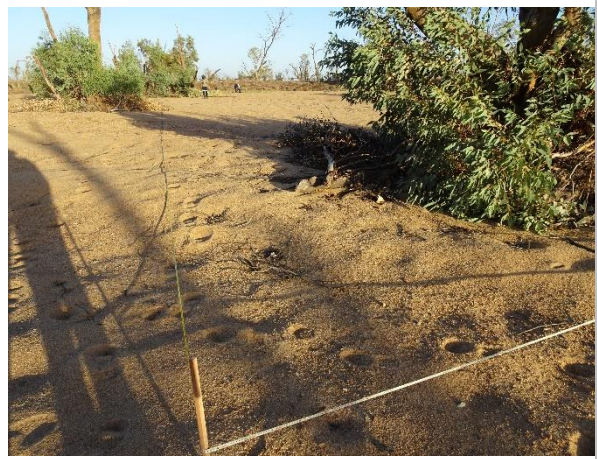
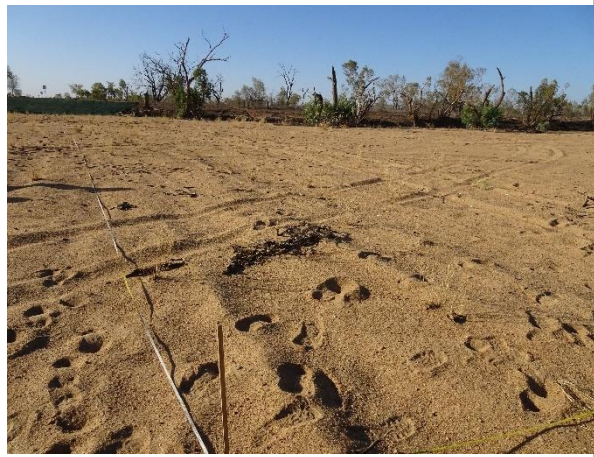
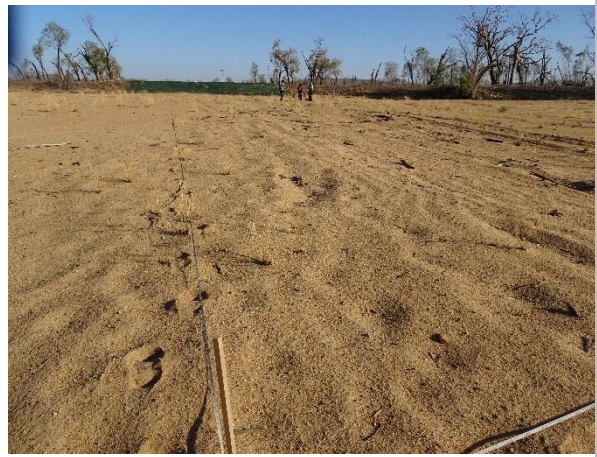
Monitoring site 1 (16/03/2020)

Control – photo from the northwest

Control – photo from the southeast

Rehabilitation – photo from the northwest

Rehabilitation – photo from the southeast
