Pluto North West Shelf Interconnector Pipeline

Australian Gas Infrastructure Group

2023 Compliance Assessment Report – Ministerial Statement 1117

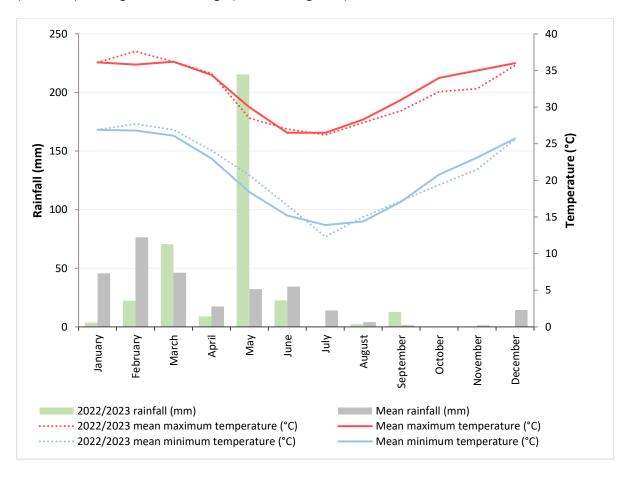
Figure 2: Climate data (BoM 2023)

In the 12 months preceding the field survey, Karratha Aero weather station received a total of 358.4 mm of rainfall which is more than the long-term average for the area (287.9 mm). A total of 96.6 mm was recorded in the three months prior to the field survey, which is significantly lower than the long-term average for the same period (168.4 mm) though rainfall in the month directly preceding the field survey (70.6 mm) was higher than average (46.3 mm; **Figure 2**).

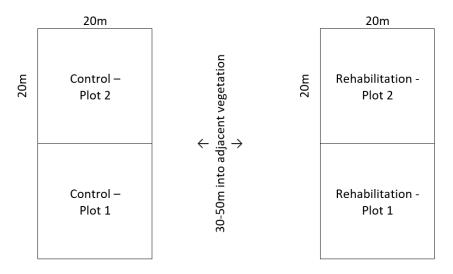
Figure 3: Design of individual vegetation monitoring sites

Each vegetation monitoring site consisted of two adjoining 20 x 20 metre (m) plots, established within representative rehabilitated areas within the right-of-way (ROW) and within adjacent, undisturbed vegetation (control areas; **Figure 3**, **Figure 4**). The northwest corner of each control site was permanently demarcated with a metal fence dropper. Rehabilitation plots were not permanently demarcated with metal fence droppers, but rather demarcated with GPS coordinates and reference

photos only, due to safety reasons associated with the nature and depth of the high-pressure gas pipeline.

For each vegetation monitoring site, photographs (photo monitoring points) were taken within the northwest and southeast corner (e.g., northwest of Control Plot 2, southeast of Control Plot 1).

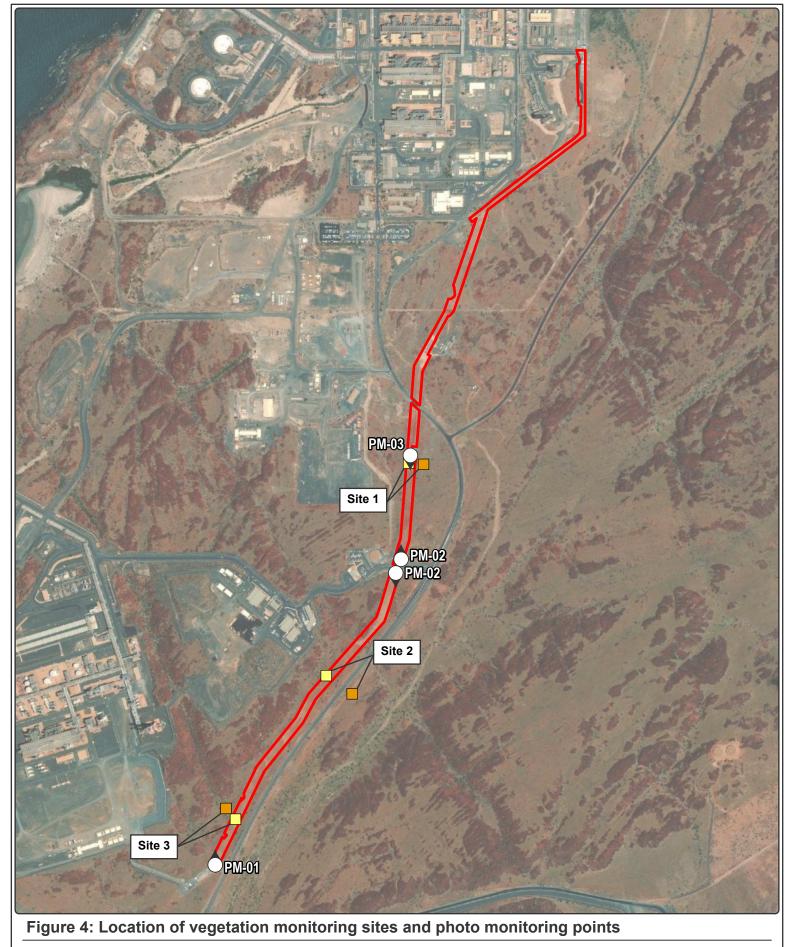
Photo location

Four photo monitoring sites were established along the corridor, where accessible along the pipeline in view of the PNI Construction Environmental Management Plan (AGIG 2019; Figure 4). Photo monitoring sites consisted of photographs taken facing along survey corridor. All photos were date stamped and the photo number recorded with appropriate details (monitoring site number and direction of photo). It is noted that PNI Construction Environmental Management Plan (AGIG 2019) states that 'photographs shall be established every 5 km', however the survey corridor is only 3.6 km in length. Noting issues with access (refer to **Table 5**), photographs were therefore taken at the start (facing north), middle (facing north and south) and end (facing south) of the survey corridor.

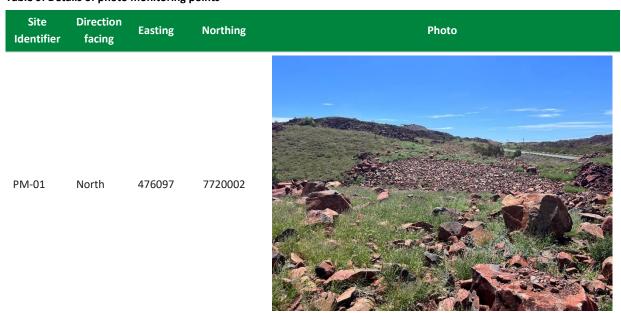
Table 9: Details of photo monitoring points

Four photo monitoring points were established along Burrup PNI rehabilitation areas (**Table 9**). Noting issues with access (refer to **Table 5**), photo monitoring points were located at the start (PM-01, facing north), middle (PM-02 facing south and PM—2 facing north) and end (PM-03, facing south).

Site Identifier	Direction facing	Easting	Northing	Photo
PM-02	South	476702	7720980	
PM-02	North	476720	7721026	
PM-03	South	476751	7721374
