WEST ERREGULLA PROCESSING PLANT AND PIPELINE

CONSTRUCTION ENVIRONMENTAL MANAGEMENT PLAN

E-PLN-034

**Revision 1
December 2021**

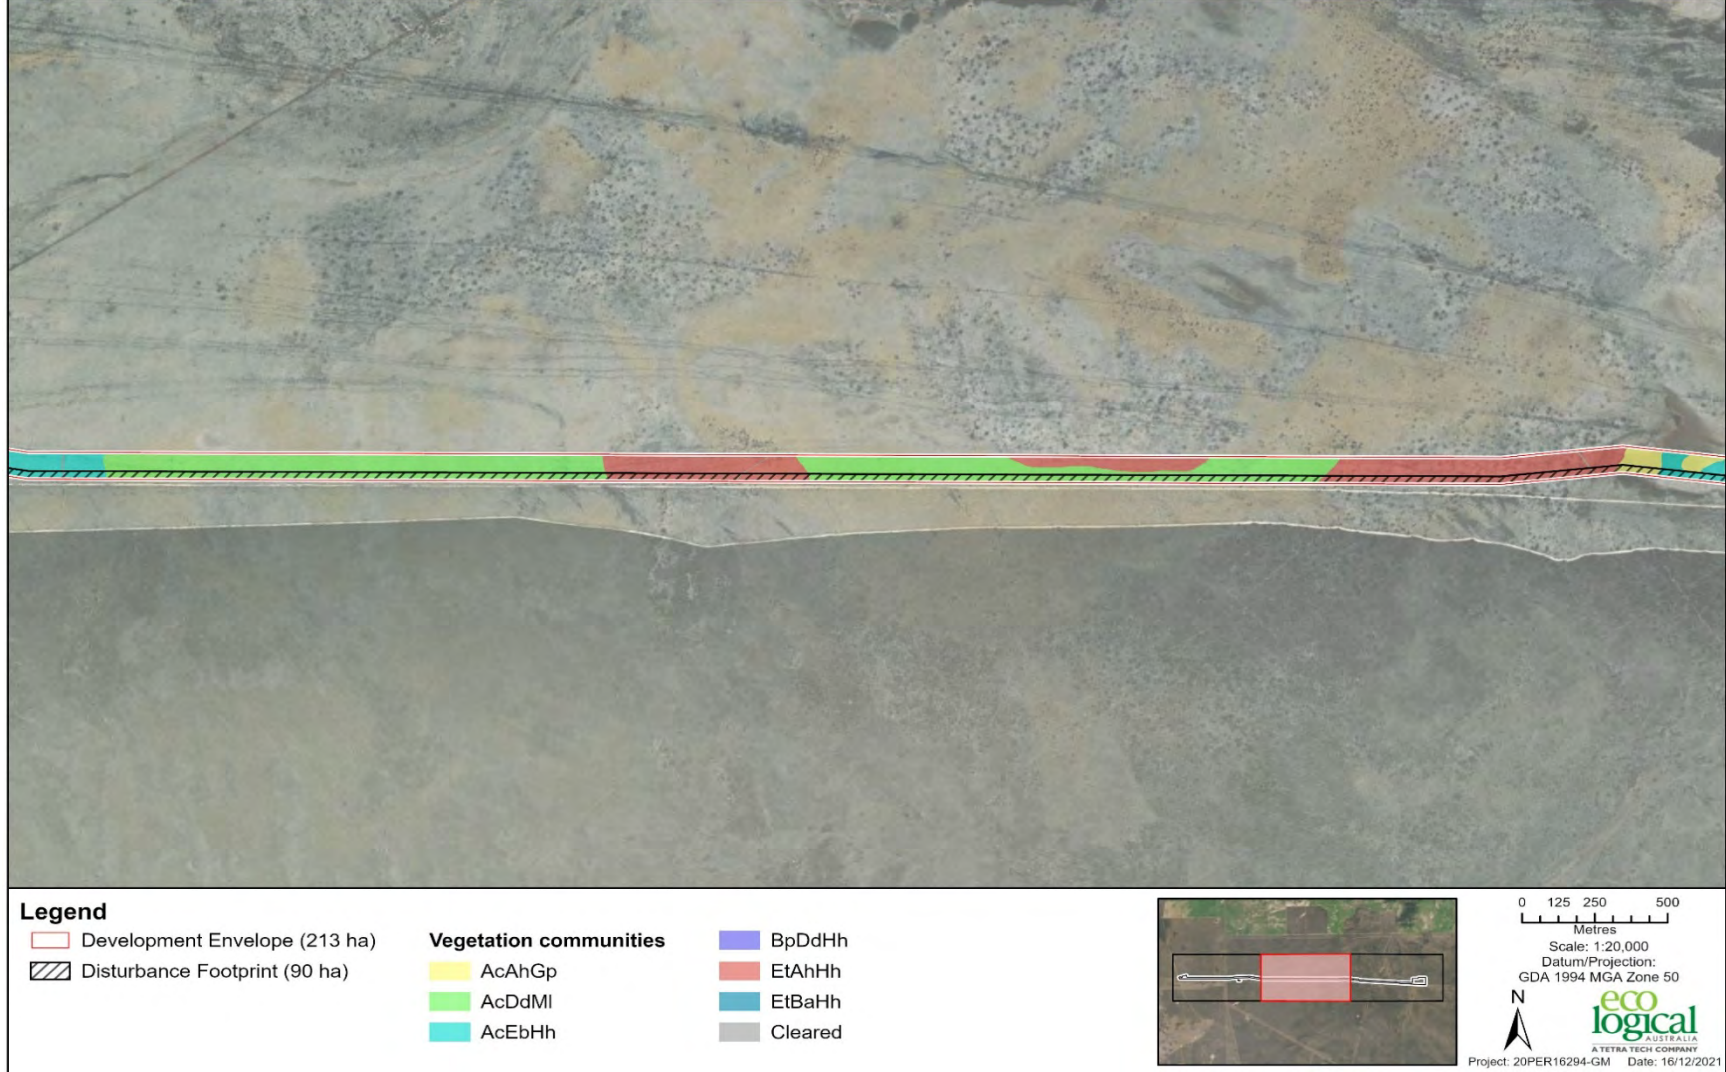
Figure 3-1 Vegetation communities within the Development Envelope

Figure 6-2: Vegetation communities mapped within the Development Envelope (Page 1 of 3)

Figure 6-2: Vegetation communities mapped within the Development Envelope (Page 2 of 3)

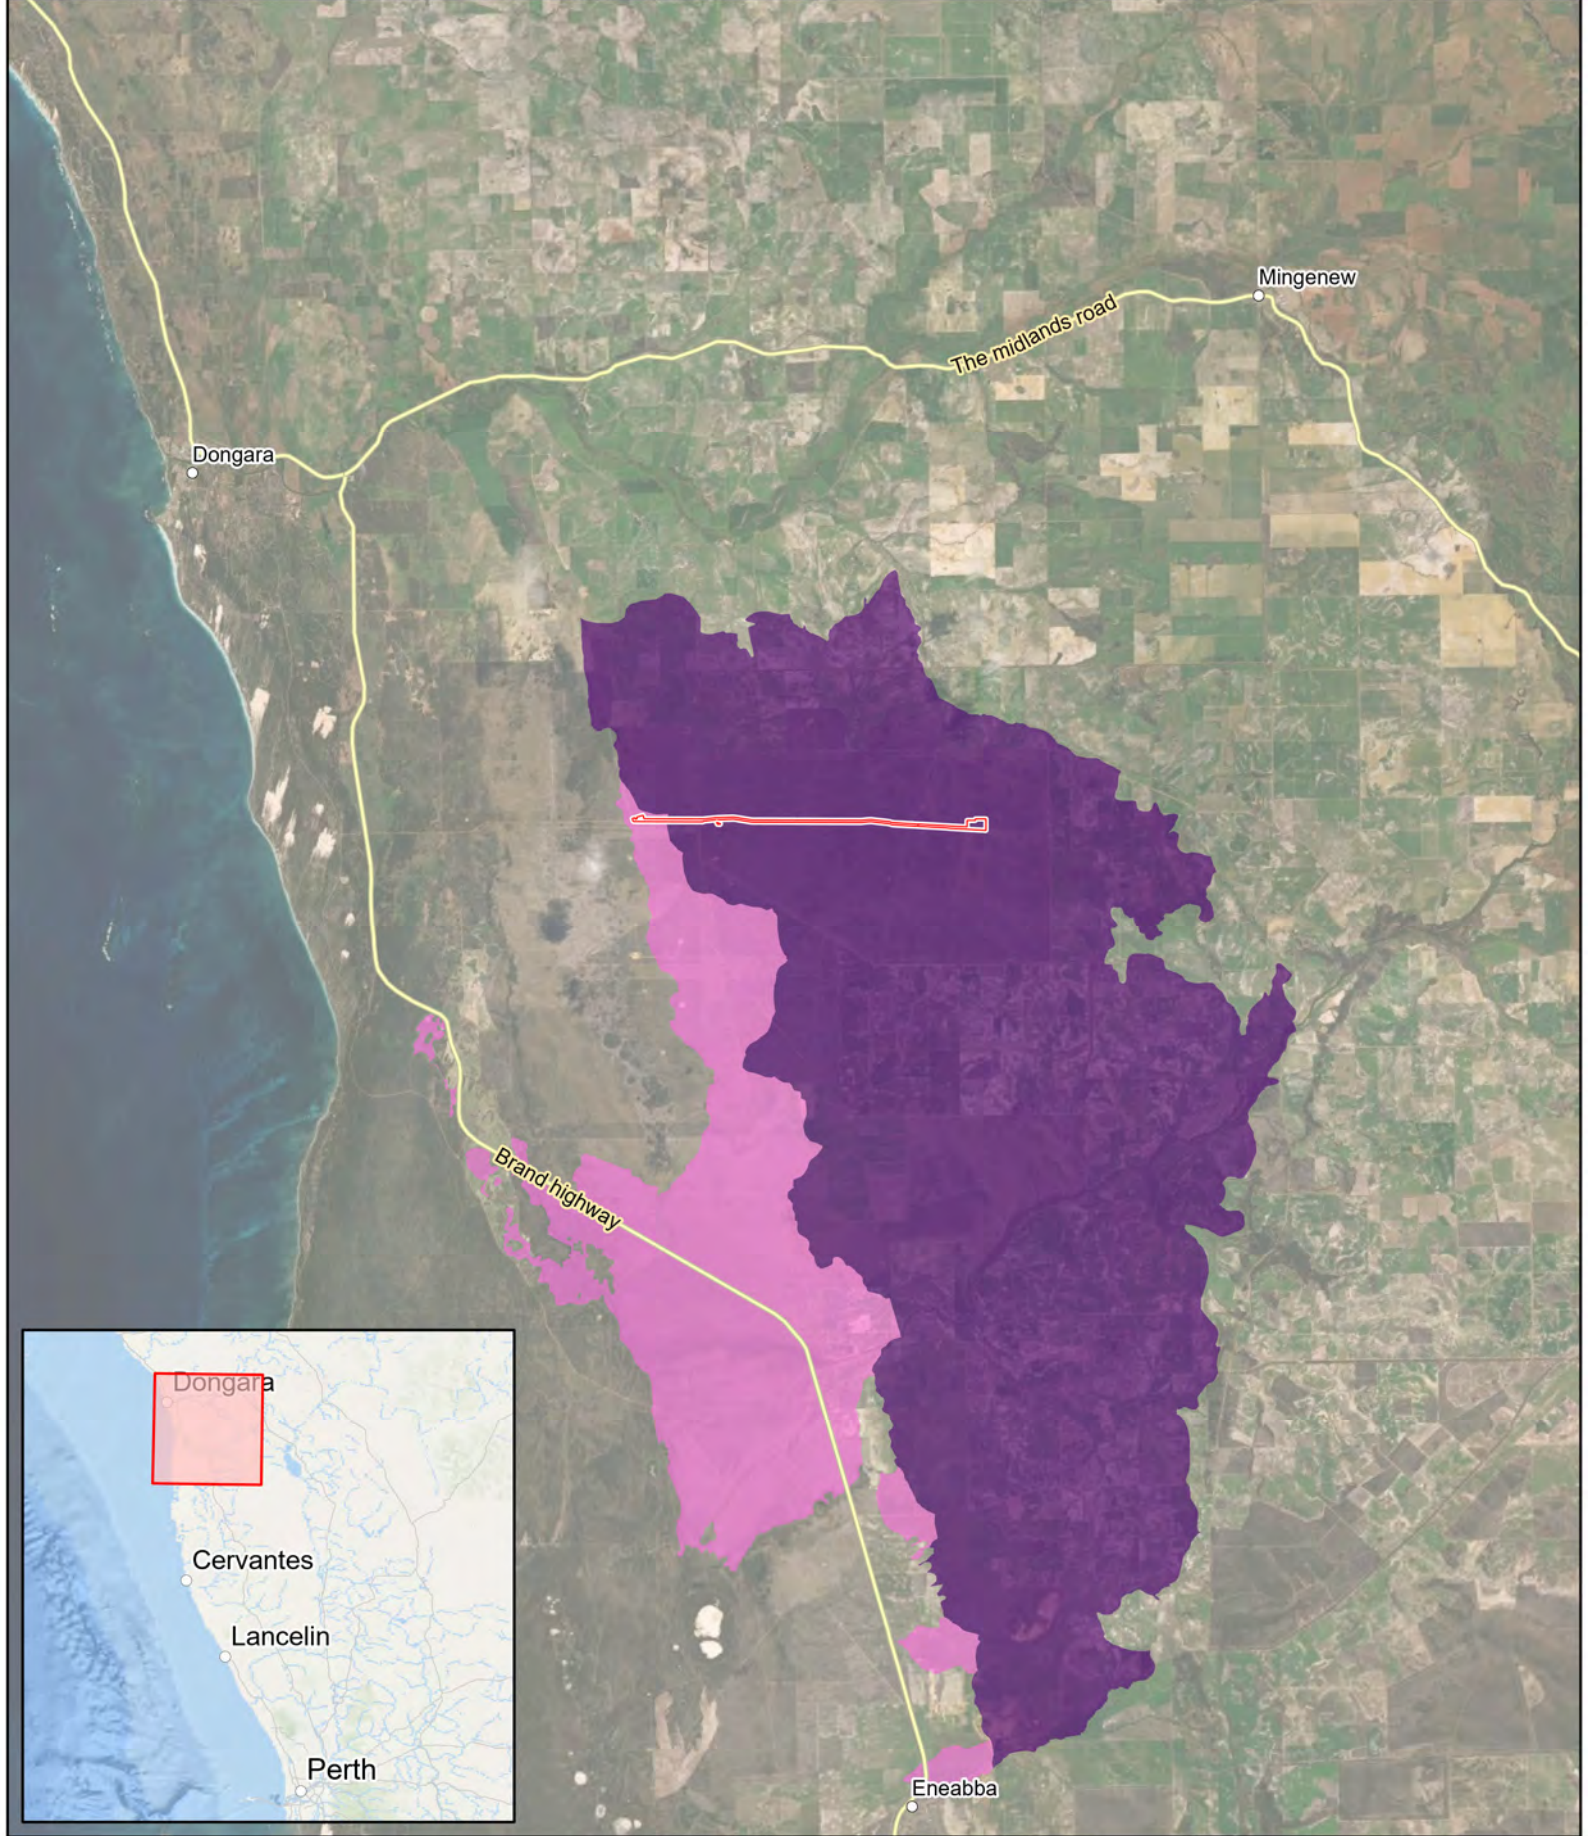
Figure 3: Land system mapping of the survey area

- Legend**
- Land system**
- Correy System (221Cy)
 - Mount Adams System (224Ma)

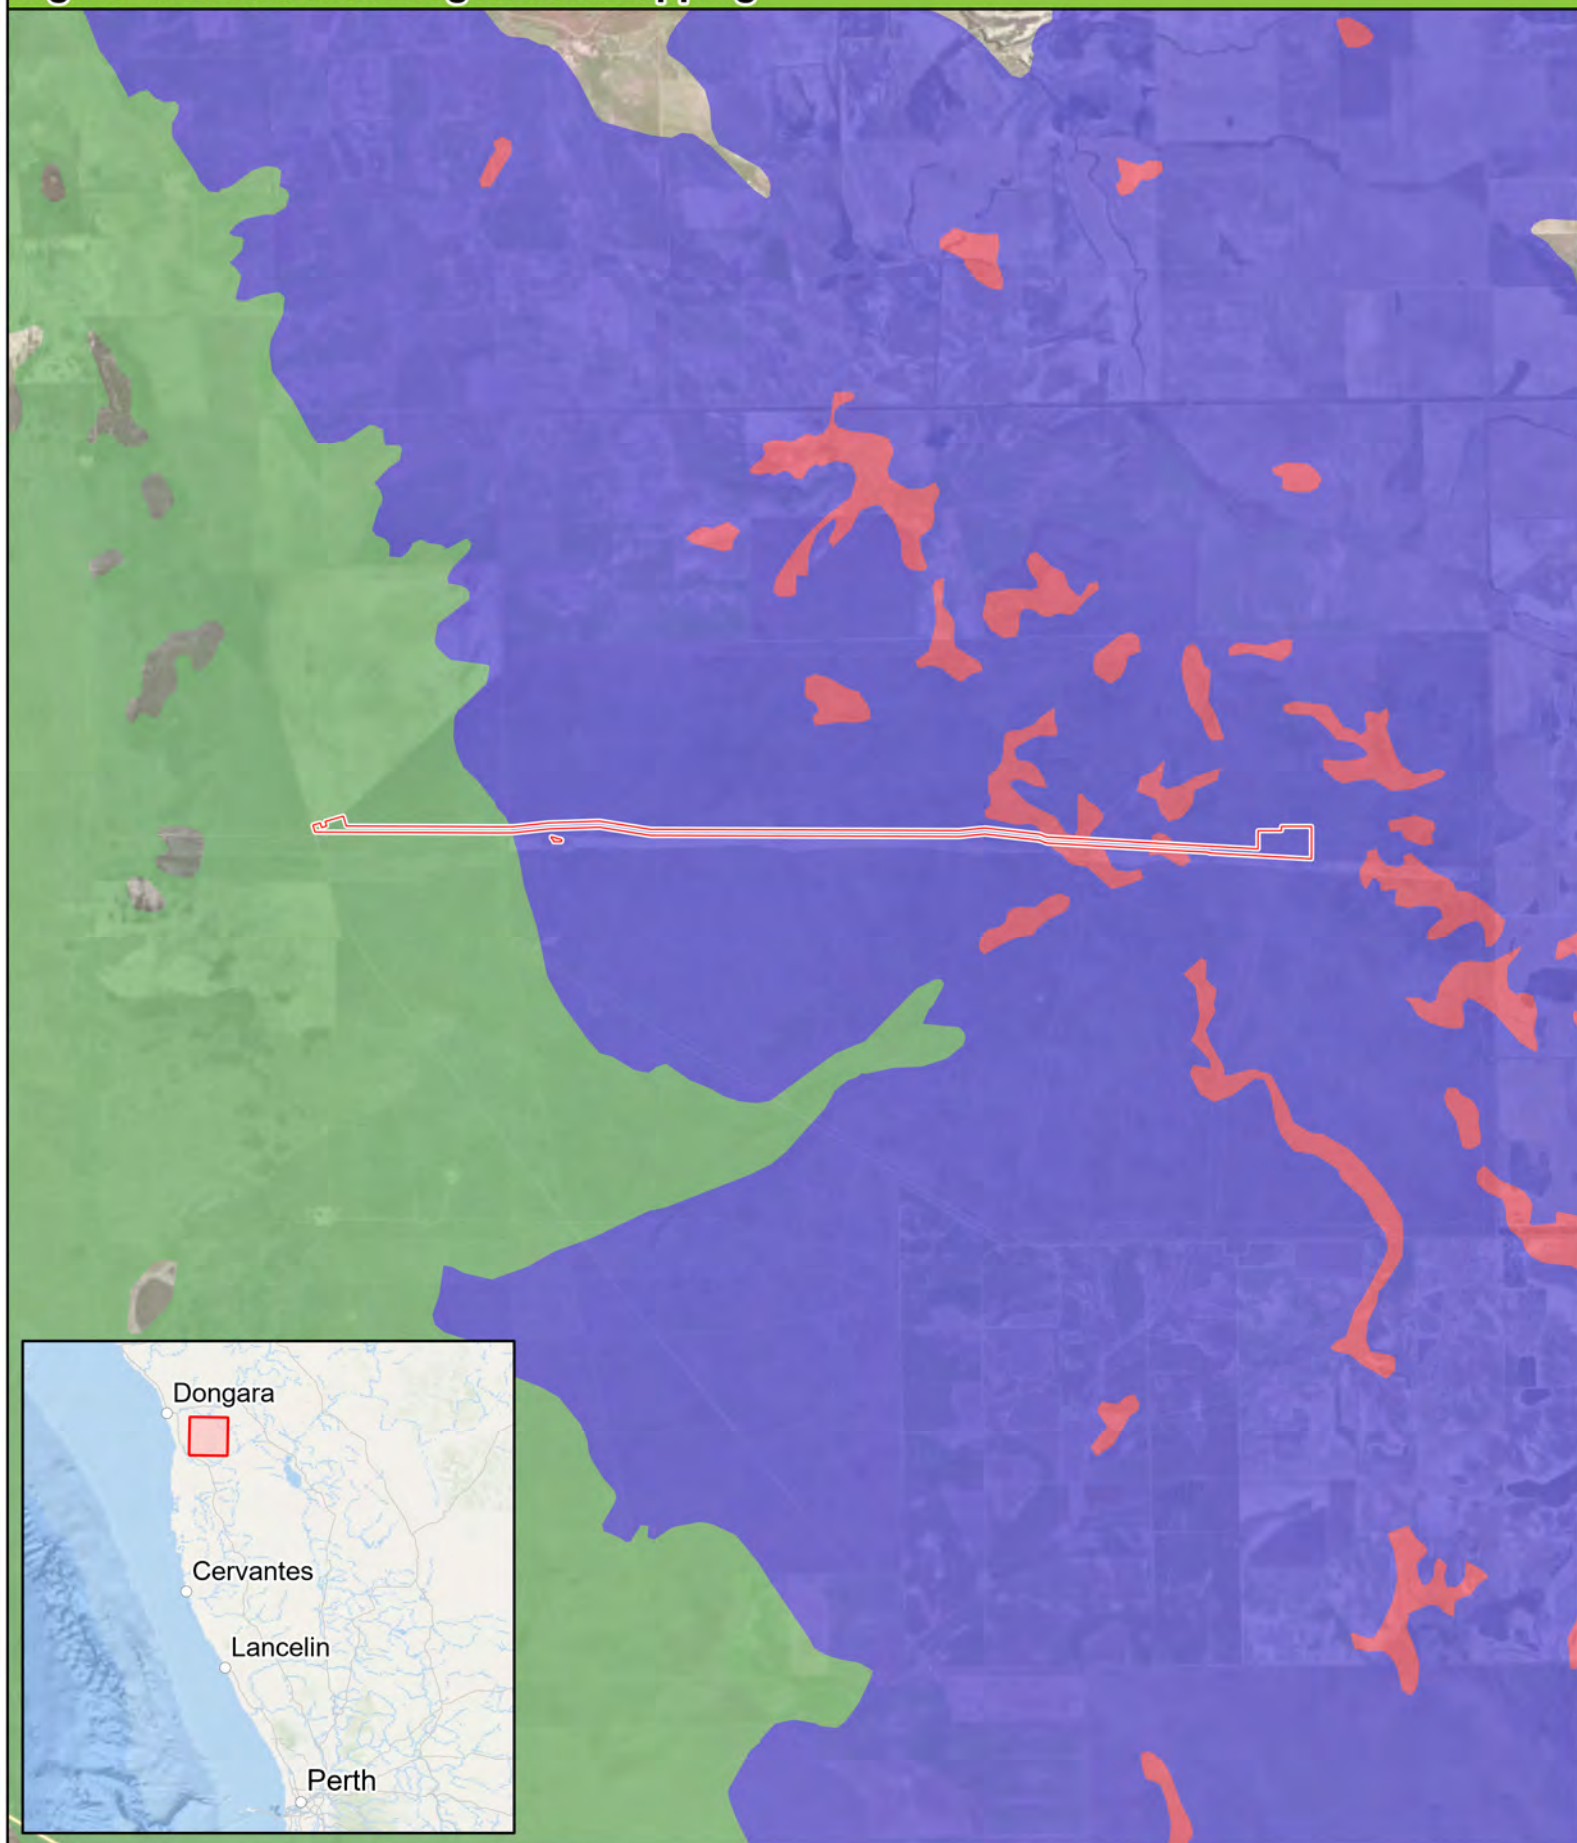
Figure 4: Broad scale vegetation mapping

- Beard's (1975) vegetation associations**
- ERIDOON_378
 - TATHRA_379
 - TATHRA_49

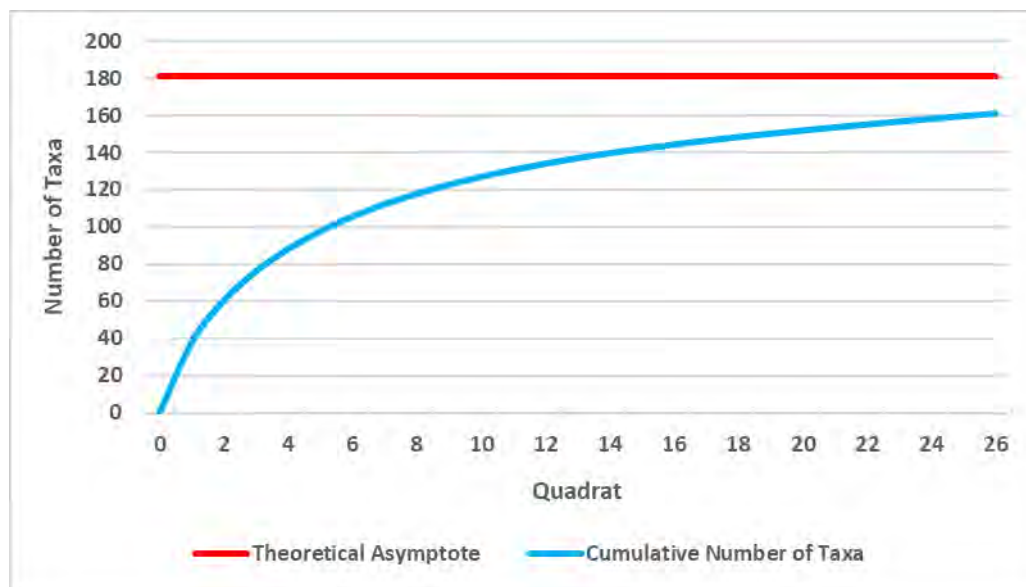
Figure 8: Average randomised species accumulation curve

Note: Only species recorded from quadrats were used to calculate the species accumulation curve and theoretical maximum number of species (asymptotic value).

A species accumulation curve (**Figure 8**) was used to evaluate the adequacy of sampling (Clarke and Gorley 2006). Only species data recorded from defined quadrats were used, no opportunistic flora collections were included. The asymptotic value was determined using Michaelis Menten modelling. Using this analysis, the incidence-based coverage estimator of species richness was calculated to be 181.05. Based on this value, and the total of 161 species recorded within quadrats, approximately 88.9% of the flora species potentially present within the survey area were recorded. This result, in addition to opportunistic collections, indicates that the majority of flora potentially present within the survey area were recorded.
