WEST ERREGULLA PROCESSING PLANT AND PIPELINE

Rehabilitation and Offset Management Plan

E-PLN-044

Revision 8

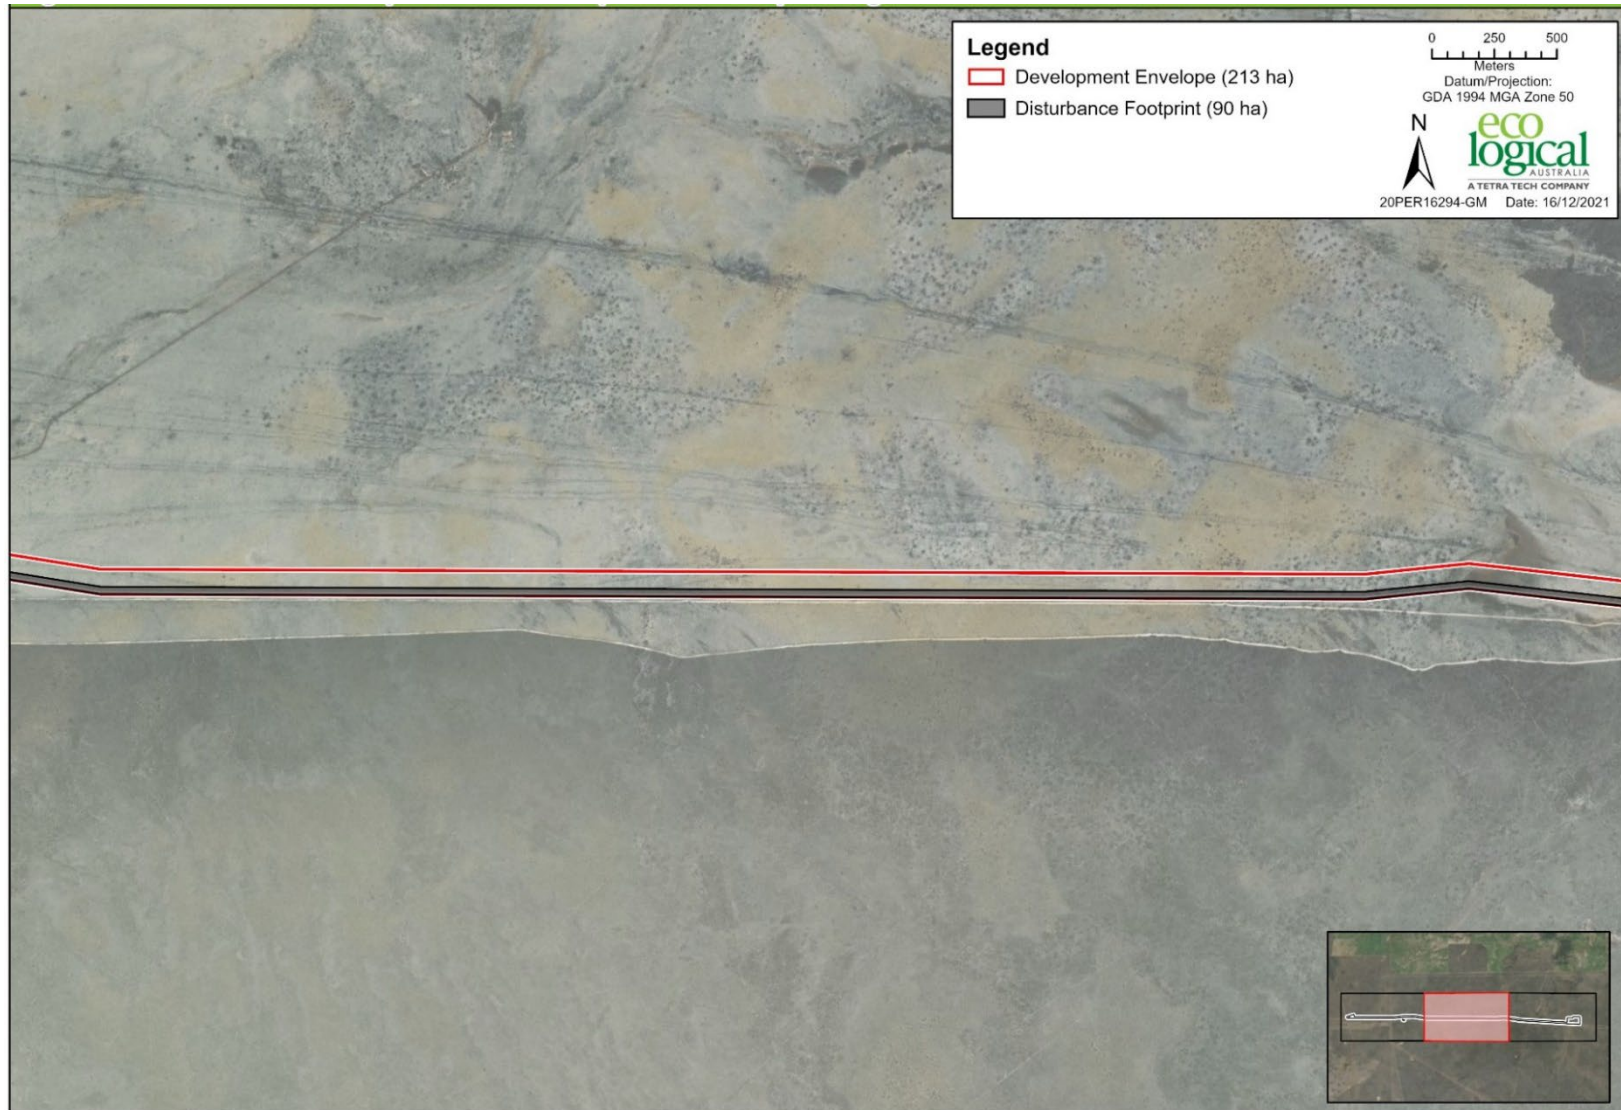
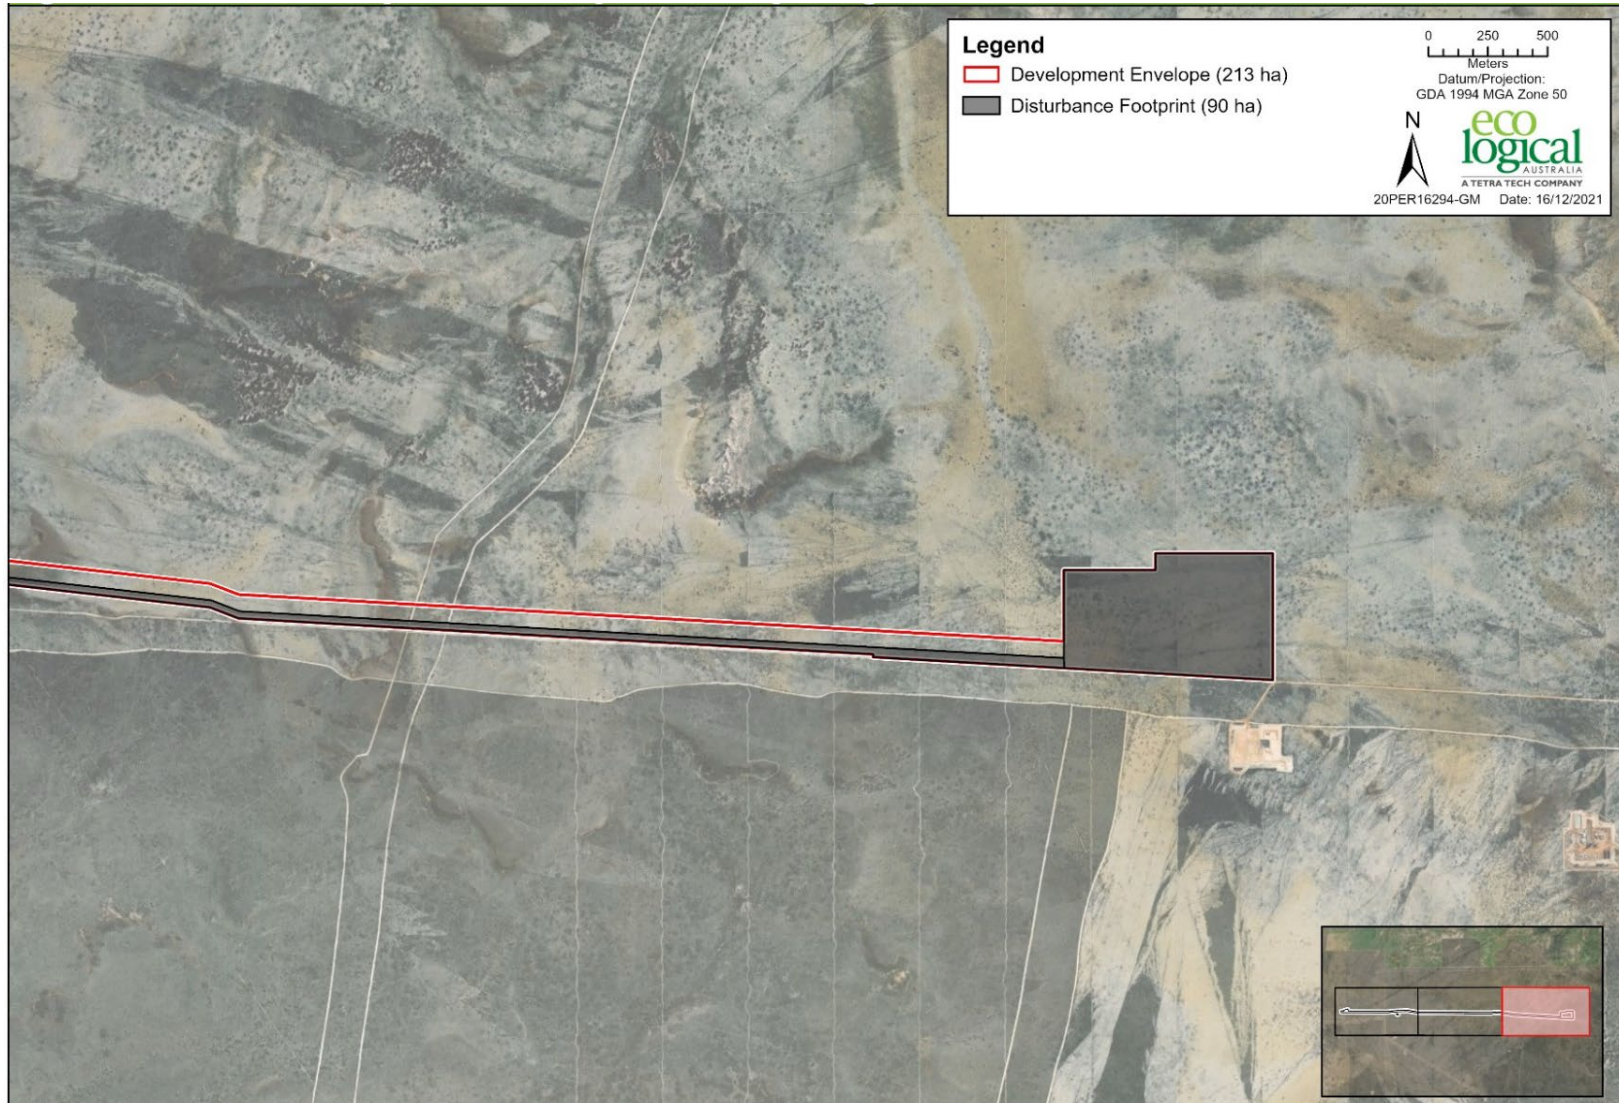
Figure 1-2 Disturbance Footprint and Development Envelope (1/3)

Figure 1-2 Disturbance Footprint and Development Envelope (2/3)

Figure 1-2 Disturbance Footprint and Development Envelope (3/3)

A Development Envelope of 213 ha was surveyed to ensure siting to minimise environmental impacts. Total proposed disturbance is 90 hectares (ha), referred to as the 'Disturbance Footprint' (Figure 1-2). Approximately 41.5 ha (46%) of the Disturbance Footprint is intended to be rehabilitation upon completion of construction.

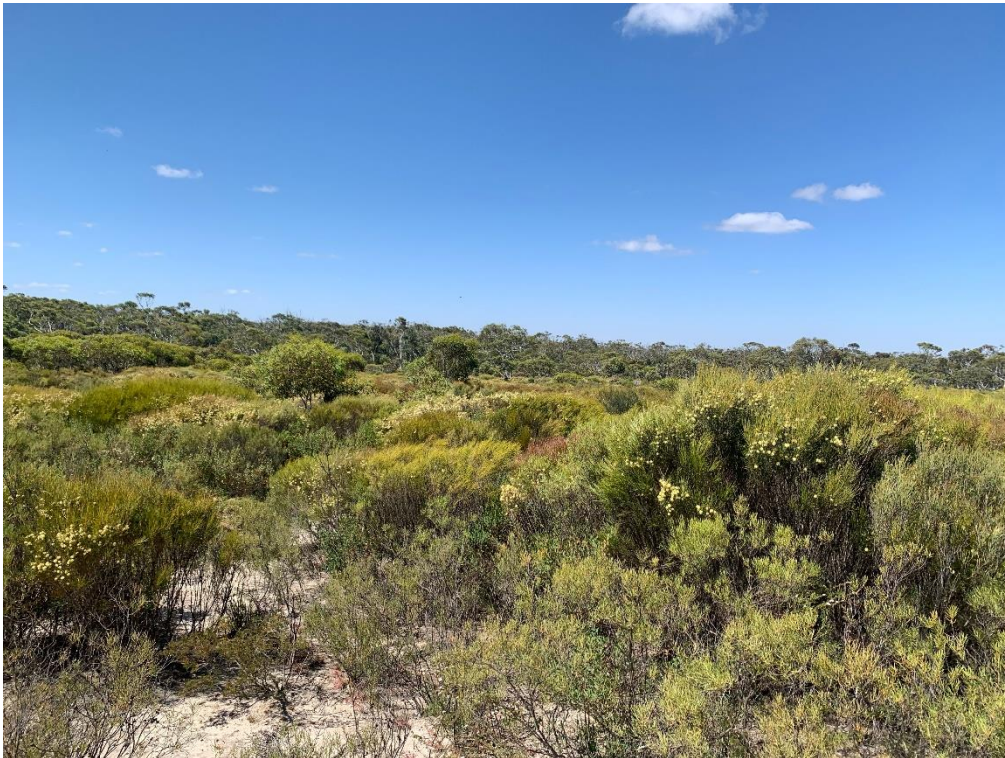
Photograph 1: Vegetation Community H1, Heathland on clay slopes

Within the 7 relevé quadrats 103 species were found. Each of the seven sites were completed in different communities with five different heath communities, one open forest and one woodland recorded. Two of the sites were burnt (B) within 5 years (Photographs 1-5).

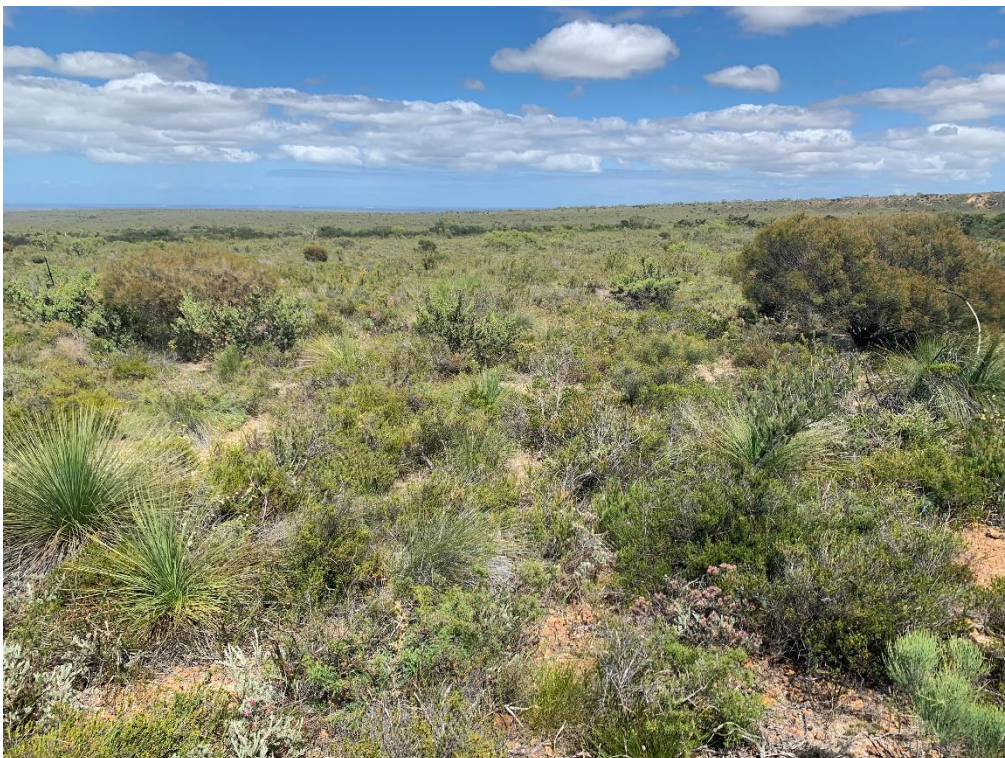
Photograph 2: Vegetation Community H4, Heathland on low breakaways

- H4** Heathland of *Calothamnus longissimus*, *Melaleuca carrii* and *Banksia fraseri* over *Ecdeiocolea monostachya* and *Conostylis androstemma* on low laterite breakaway.

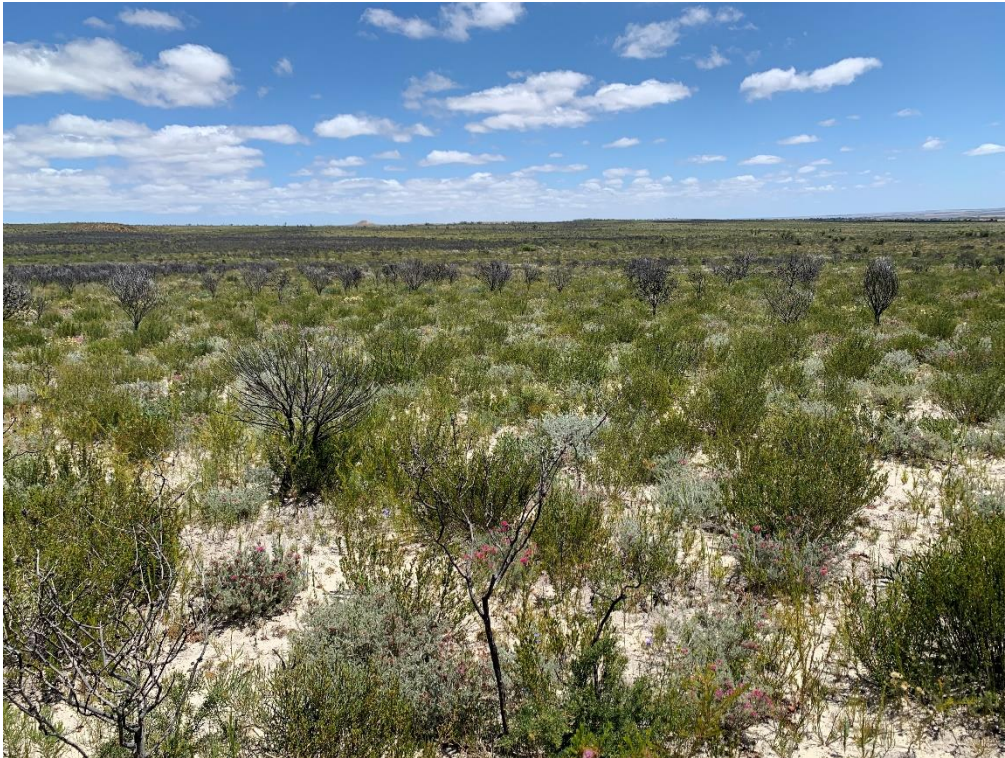
Photograph 3: Vegetation Community H5, Heathland on low sand dunes

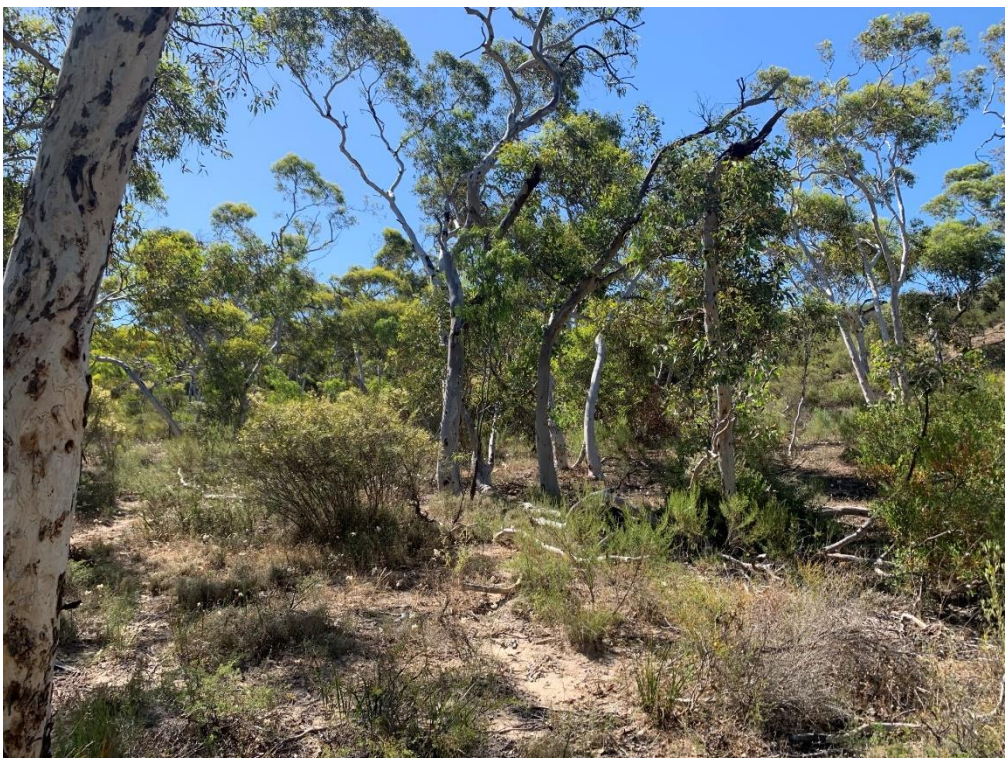
Photograph 4: Vegetation Community F1, Open Forest on brown sandy clay loam slopes

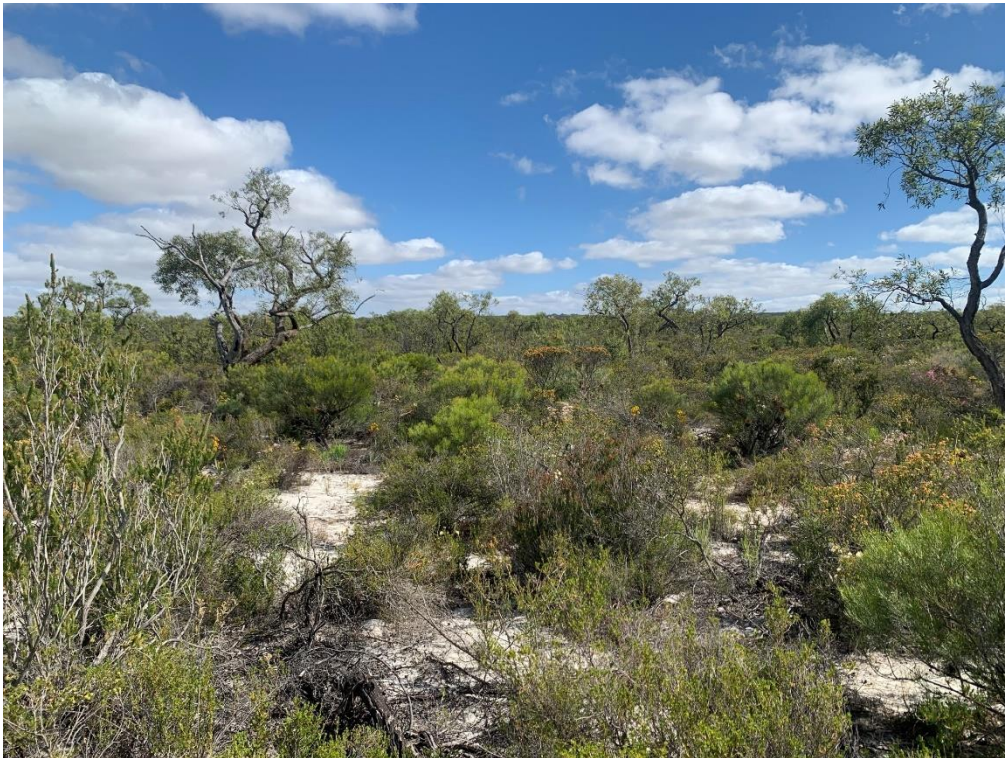
Photograph 5: Vegetation Community W1, Woodland on low sand dunes
