Tanami Gas Pipeline
Annual Compliance Assessment Report
EBPC 2017 / 7997 – 2023/24

E-REP-089

Revision: 1
Date: 6 August 2024

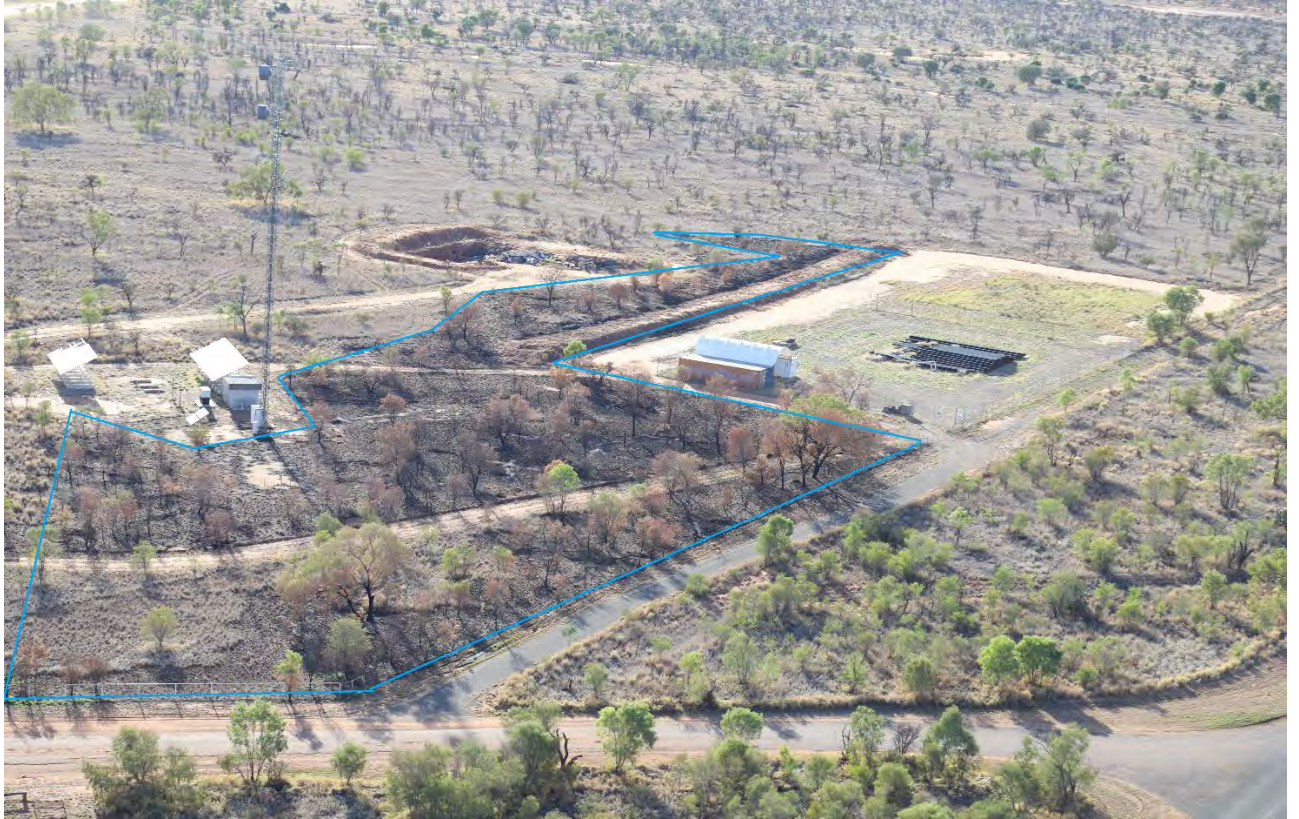
Tilmouth
Road House
Compound

- A recent small scrub fire has occurred in close proximity to the Tilmouth compound.

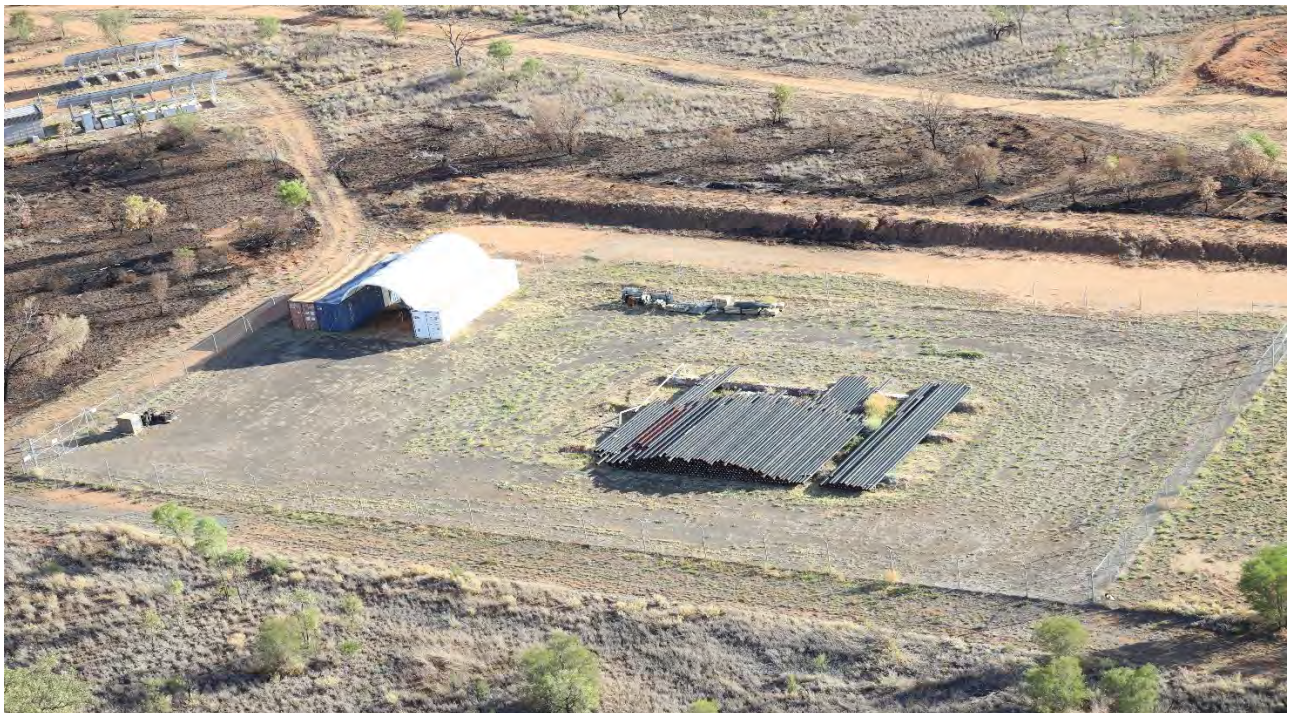
- Tilmouth compound remains without issue and secure.

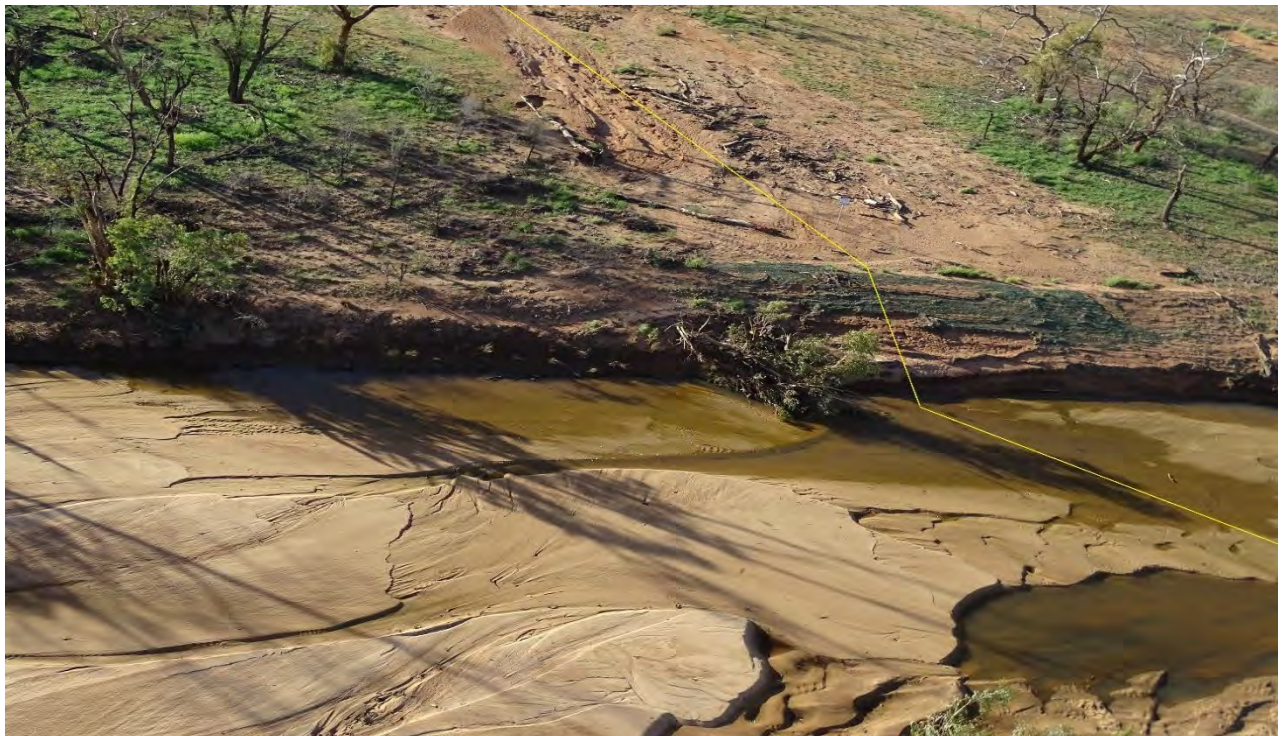
January 2021:

- Below image shows the current condition of the creek.
- Upstream bank had significant damage but no major changes since Feb 2021.

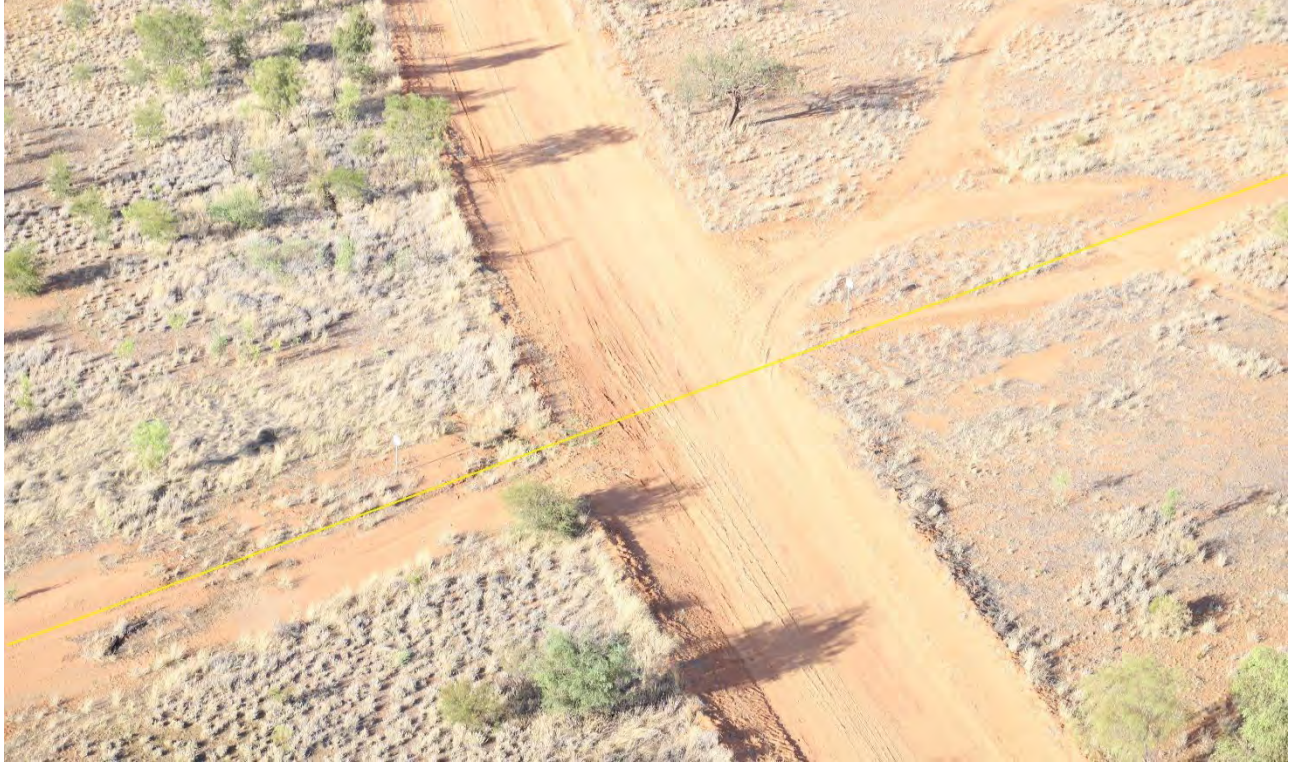
Napperby
Station
Access Road

- Below image shows the current condition of the access road.

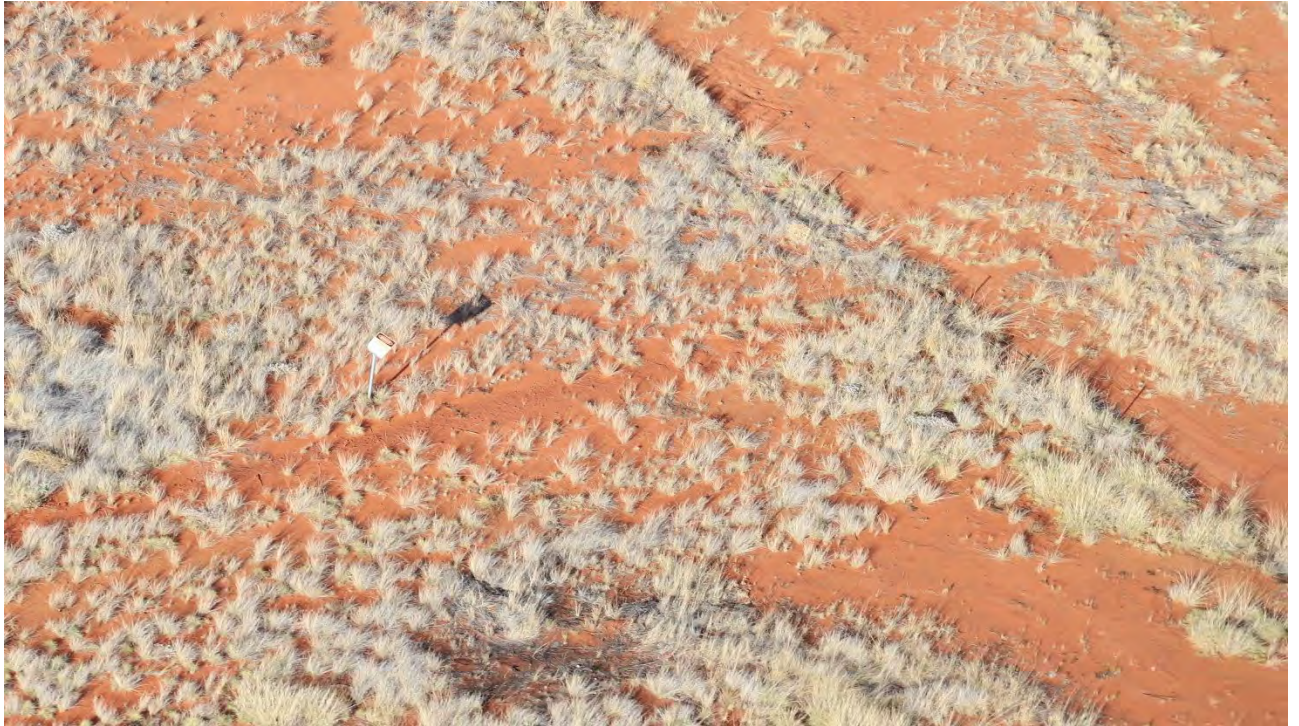
TGP-03
KP 42.620

- Below image details a Danger sign has been bent over at KP42.620.
- GPS 53 S 246954E 7478399S refers.

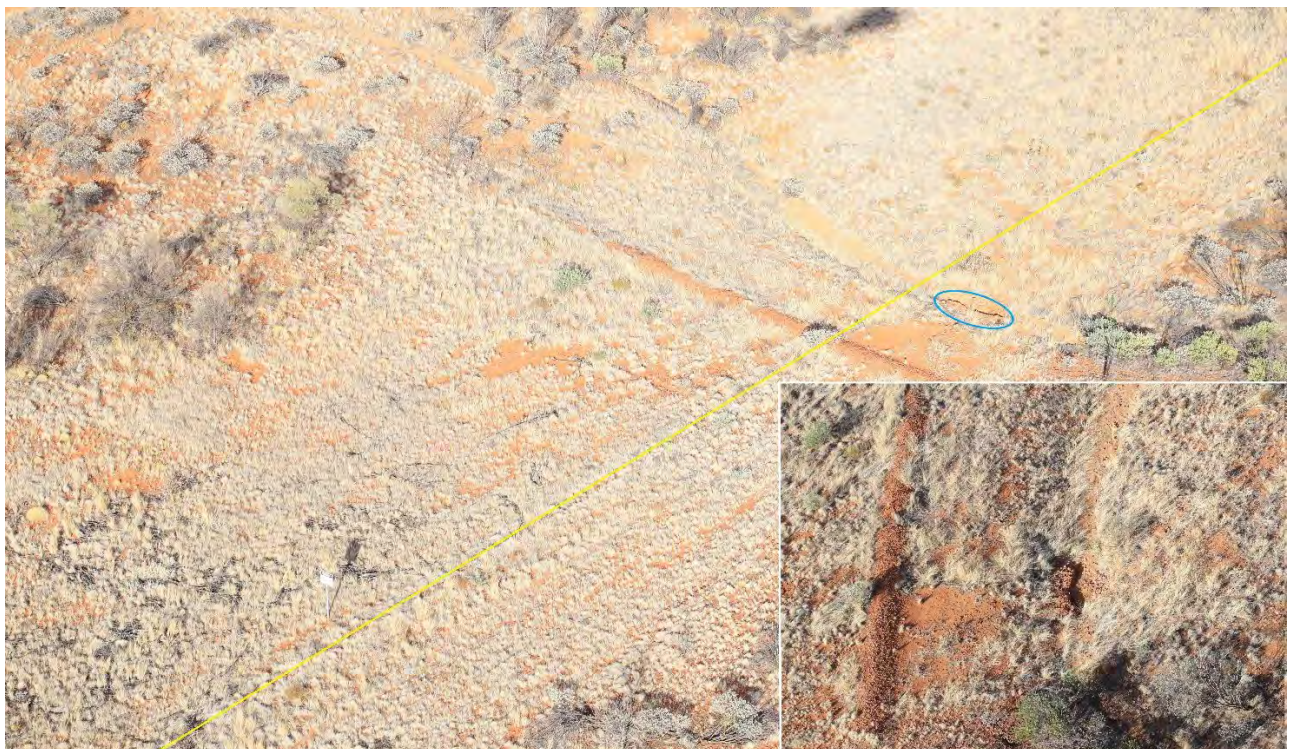
- Below image depicts erosion remains as previously reported at a water course crossing the easement.
- KP 47.500 and GPS 53 S 242831E 7480991S refers.

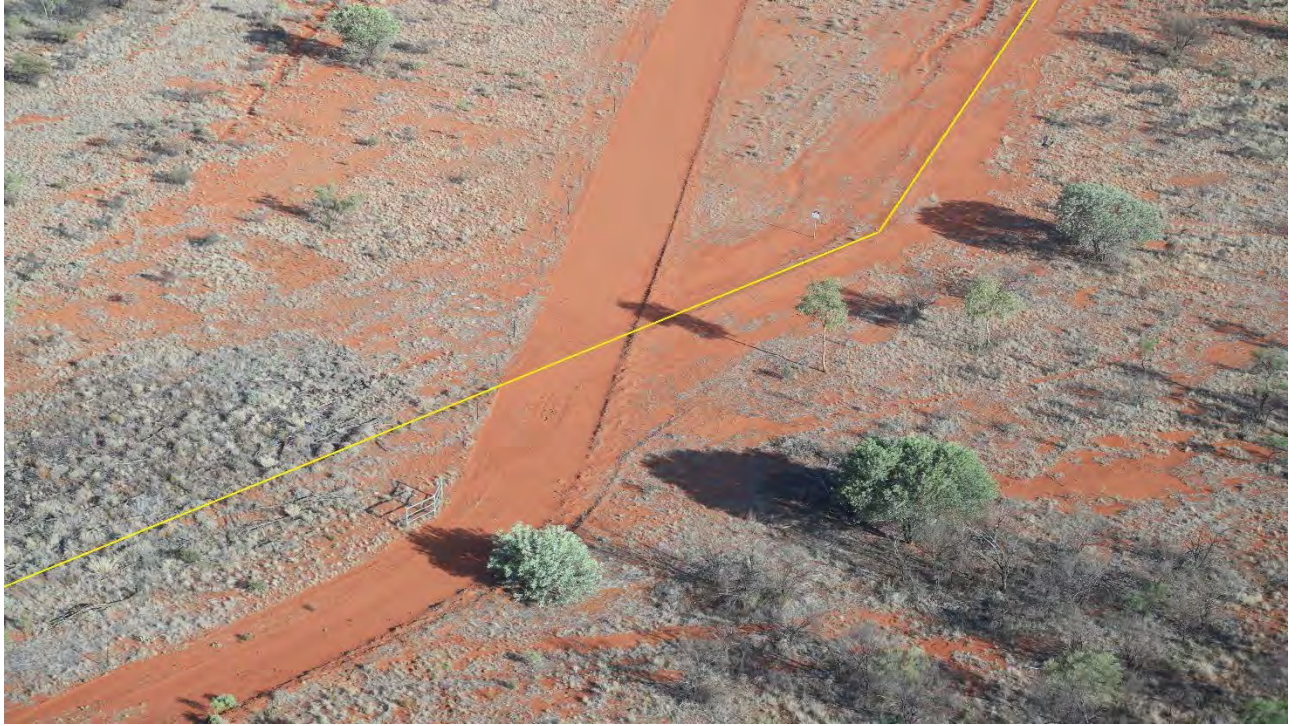
TGP-03
KP 48.590

- Below image details the current condition of the easement and a track crossing at TGP-03, KP 48.590.

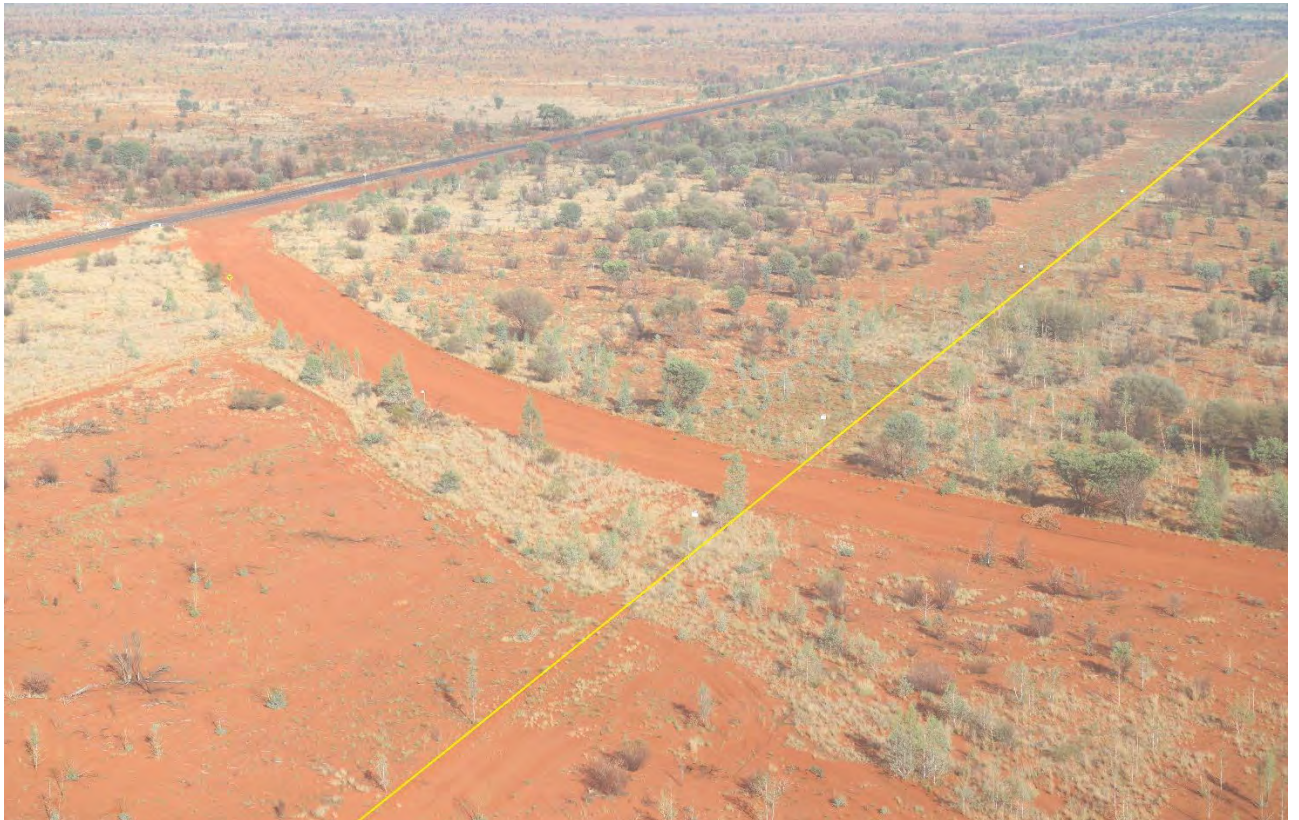
Gravel Track
to Pulardi
KP 72.90

- Below image shows the current condition of the track to Pulardi.

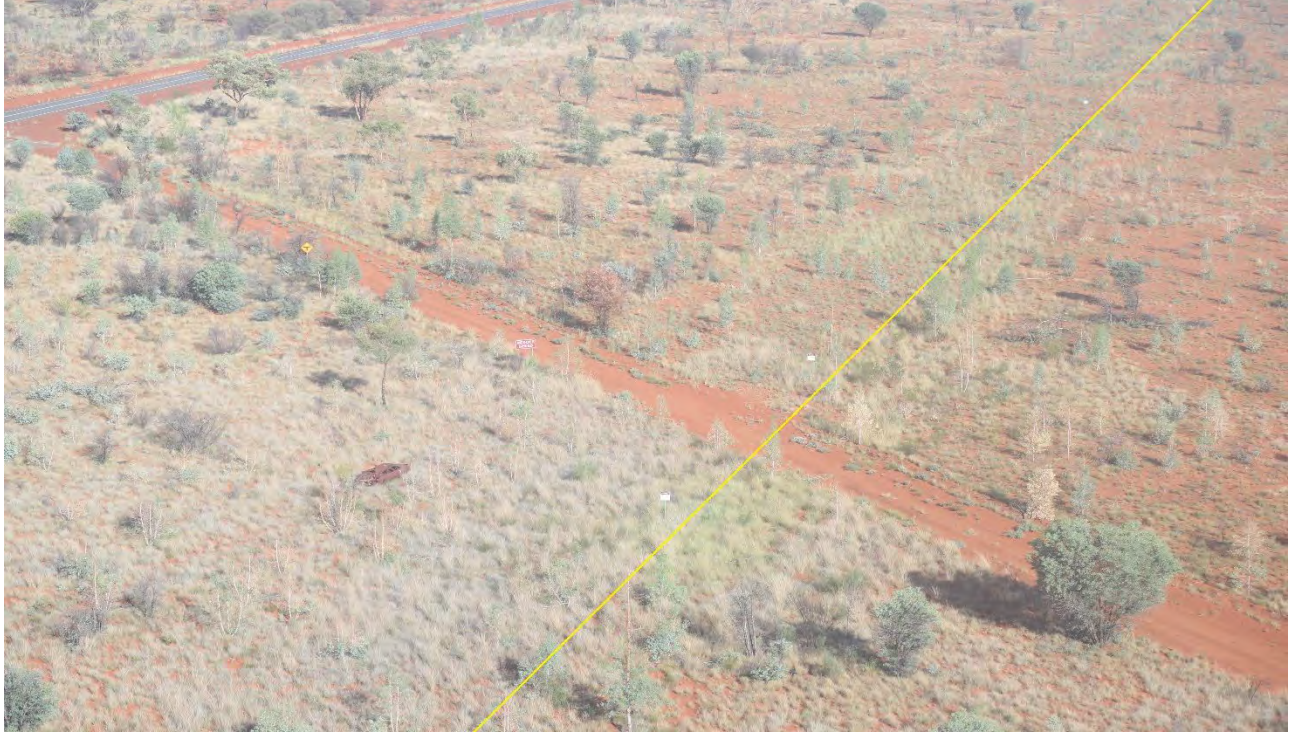
Pulardi Rd
Gravel to
Laramba
KP 78.51

- Below image shows the current condition of the track.

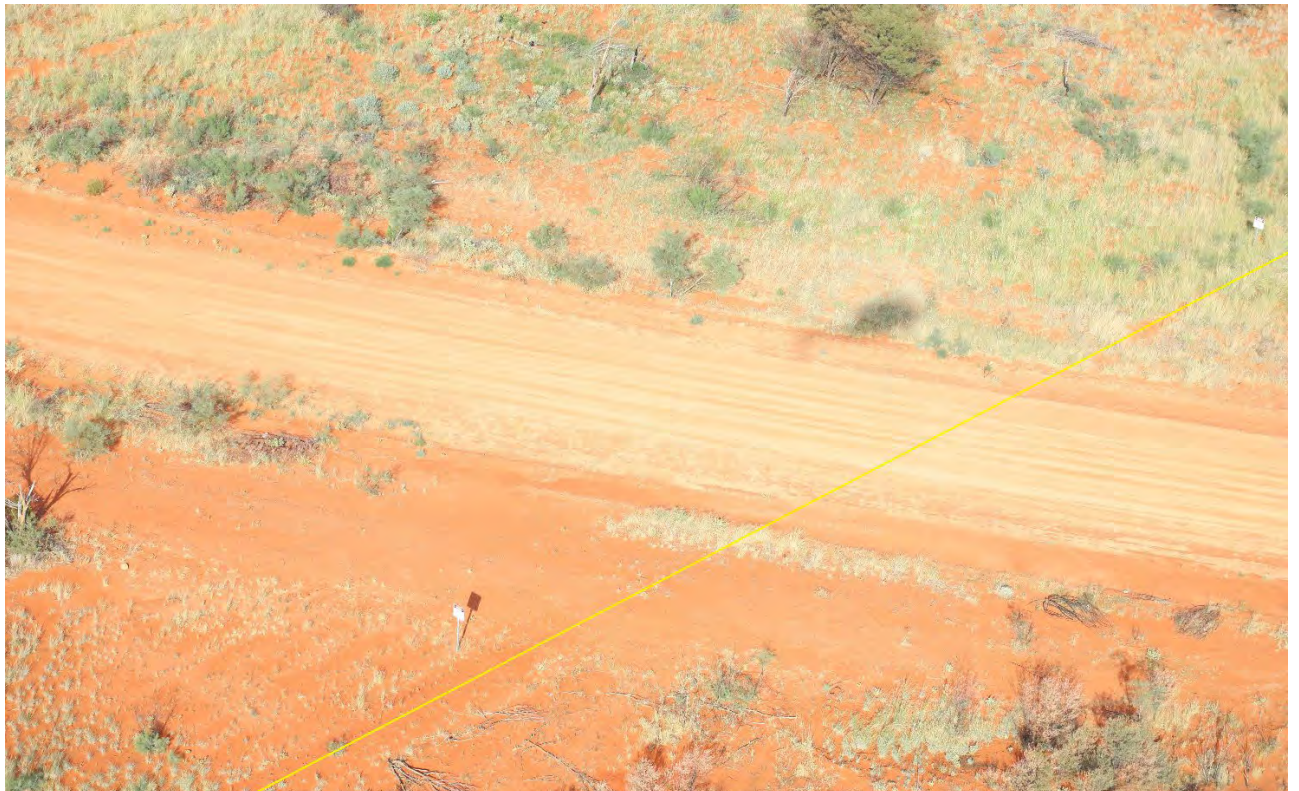
Yeulamu Rd
Gravel
KP 100.15

- Below image shows the current condition of the track.

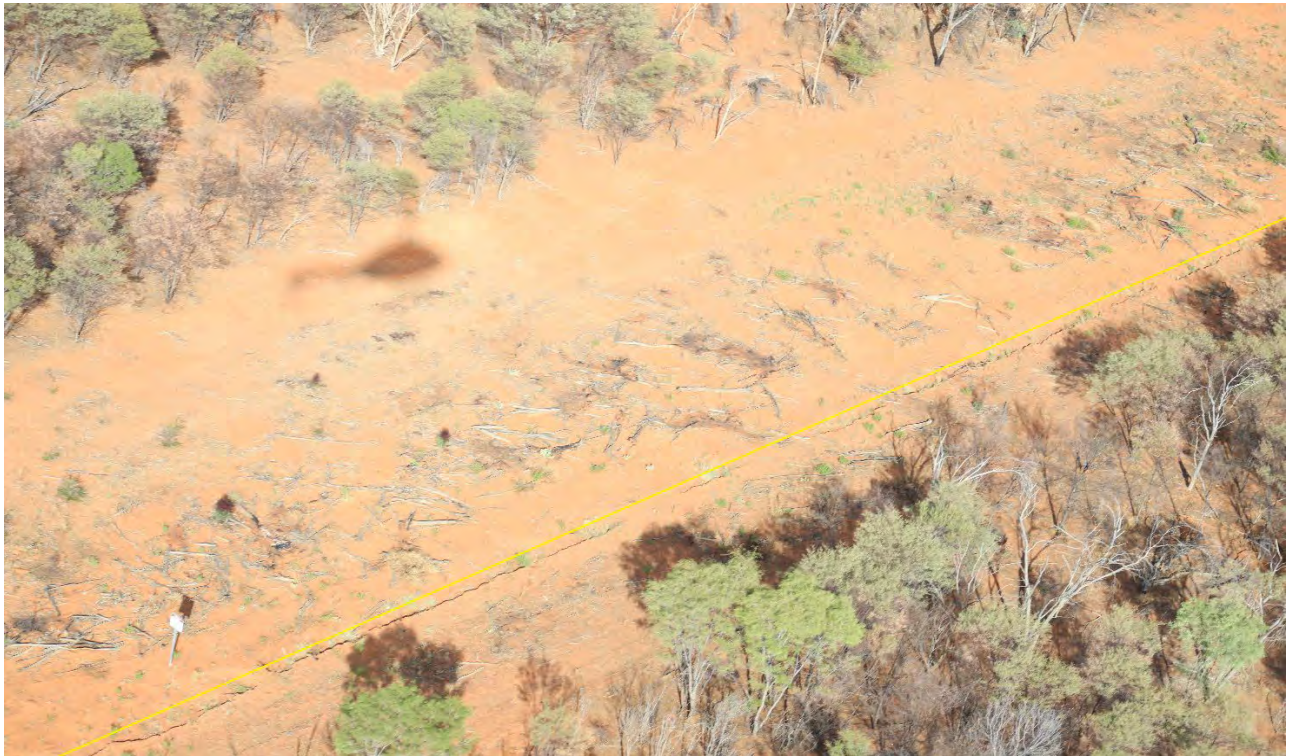
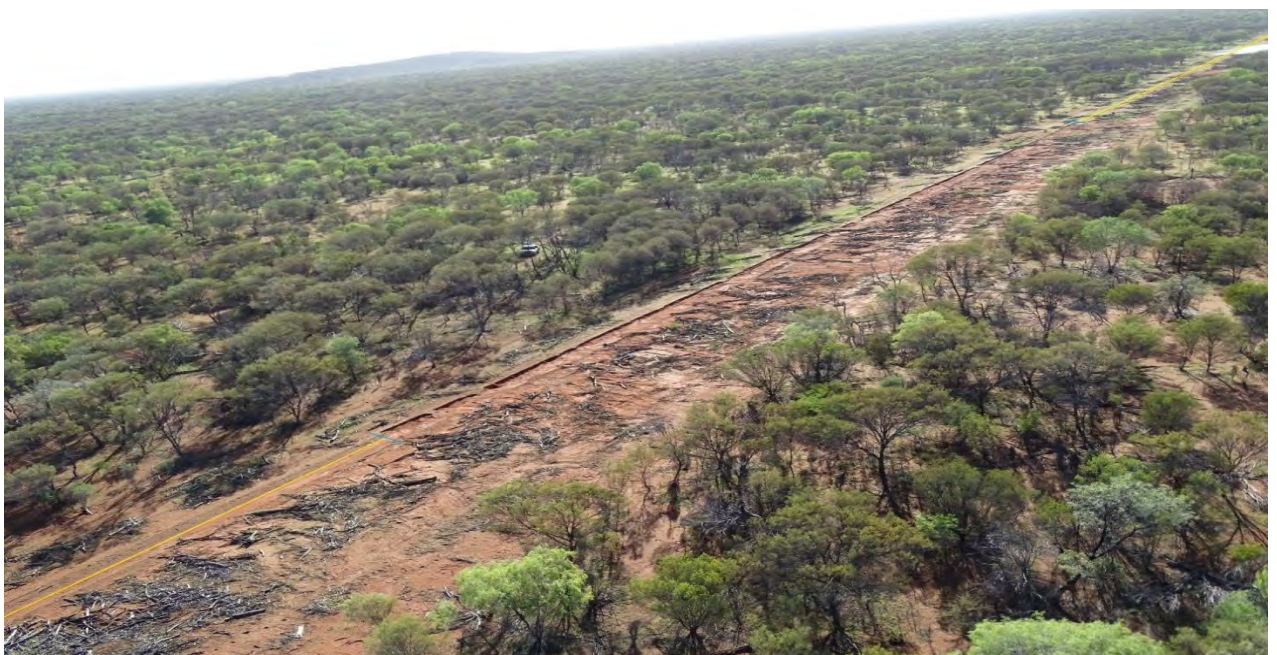
- Below image updates sporadic subsidence over the pipeline from KP 114.540 to approximately KP 115.000. This subsidence doesn't pose a threat to the asset.
- ASO's to continue monitoring.

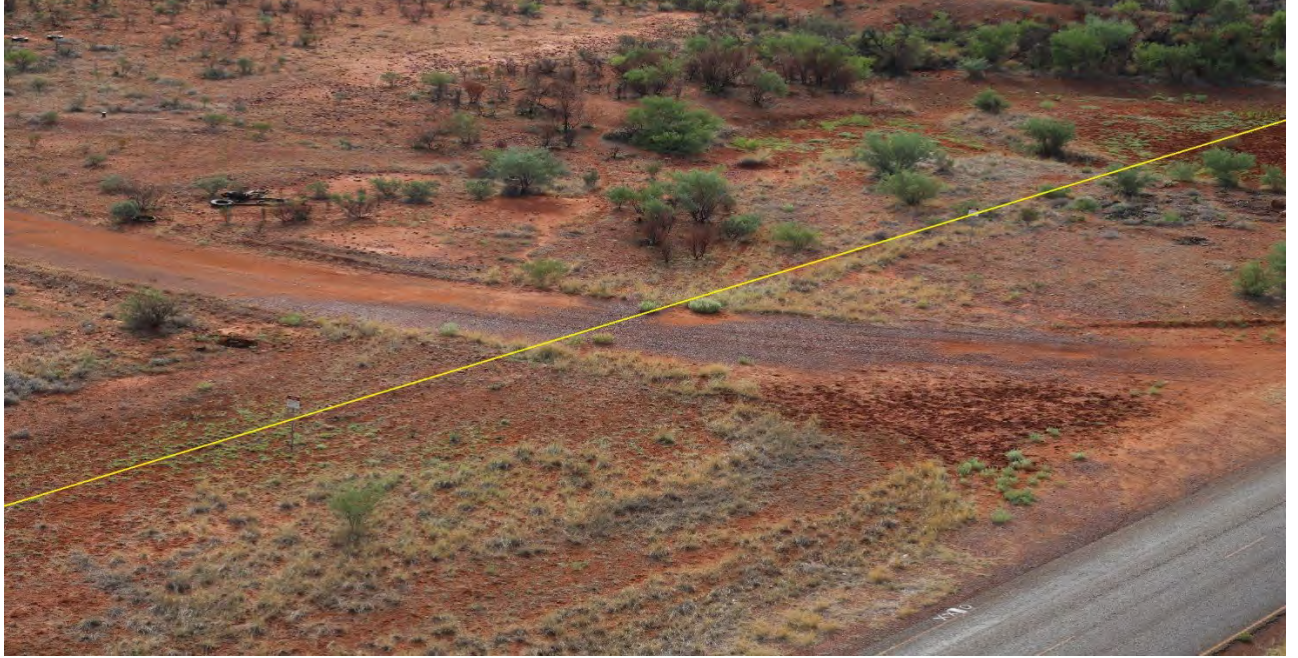
Road to Bore
& Gravel Pit
KP 119.99

- Below image shows condition of the road to the Gravel Pit.

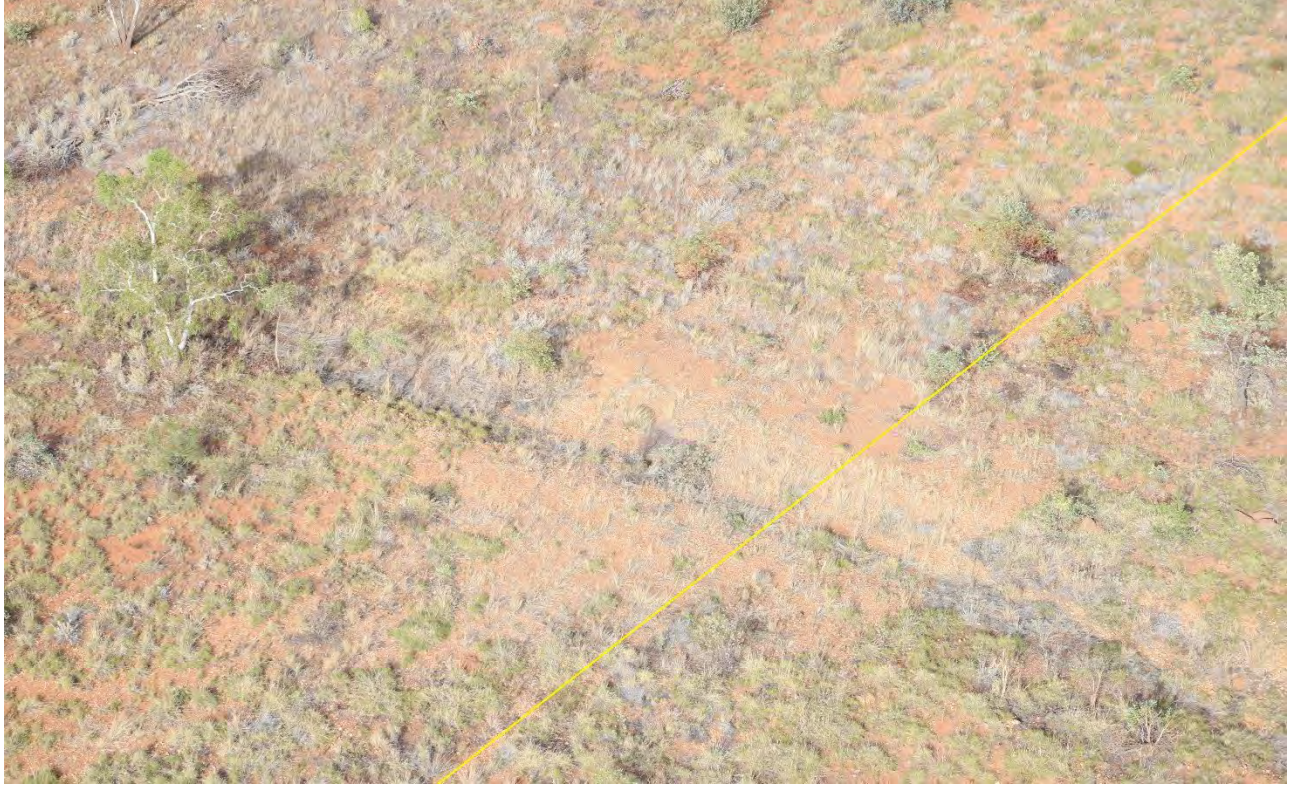
KP 137.66

- T3 water course crossing the pipeline remains in good condition.

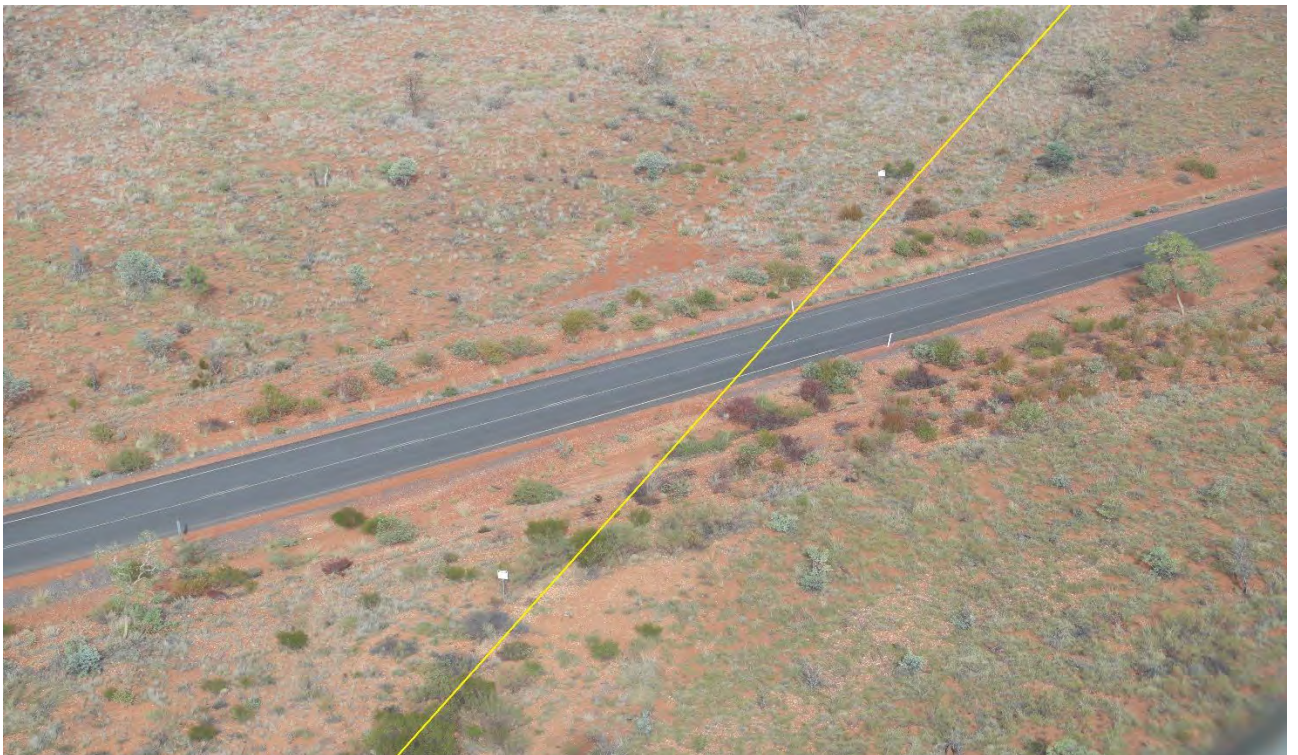
Yuendumu Rd
KP 137.92

- Road crossing appeared in good condition.

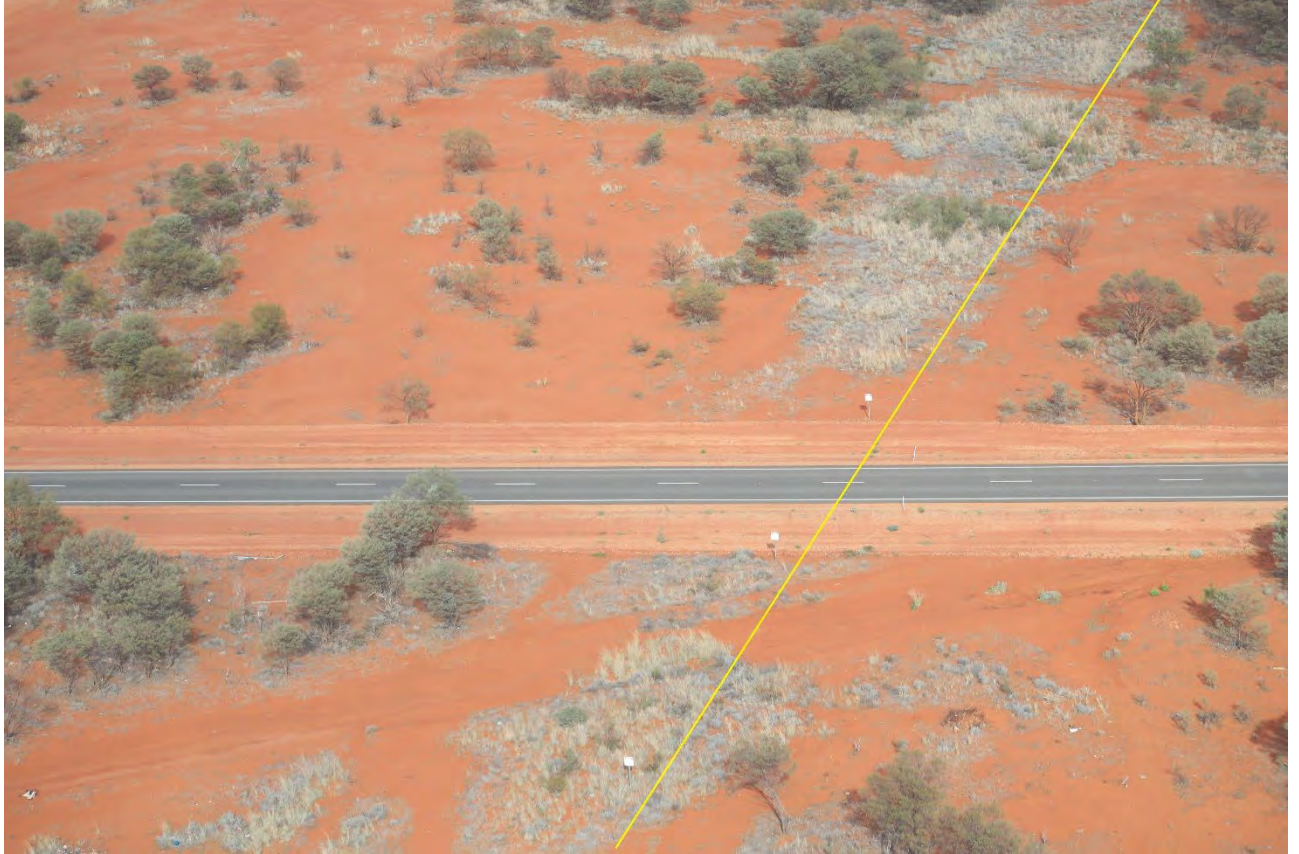
Bookmark
Ave
KP 140.04

- Road crossing remains in good condition, post upgrade works.

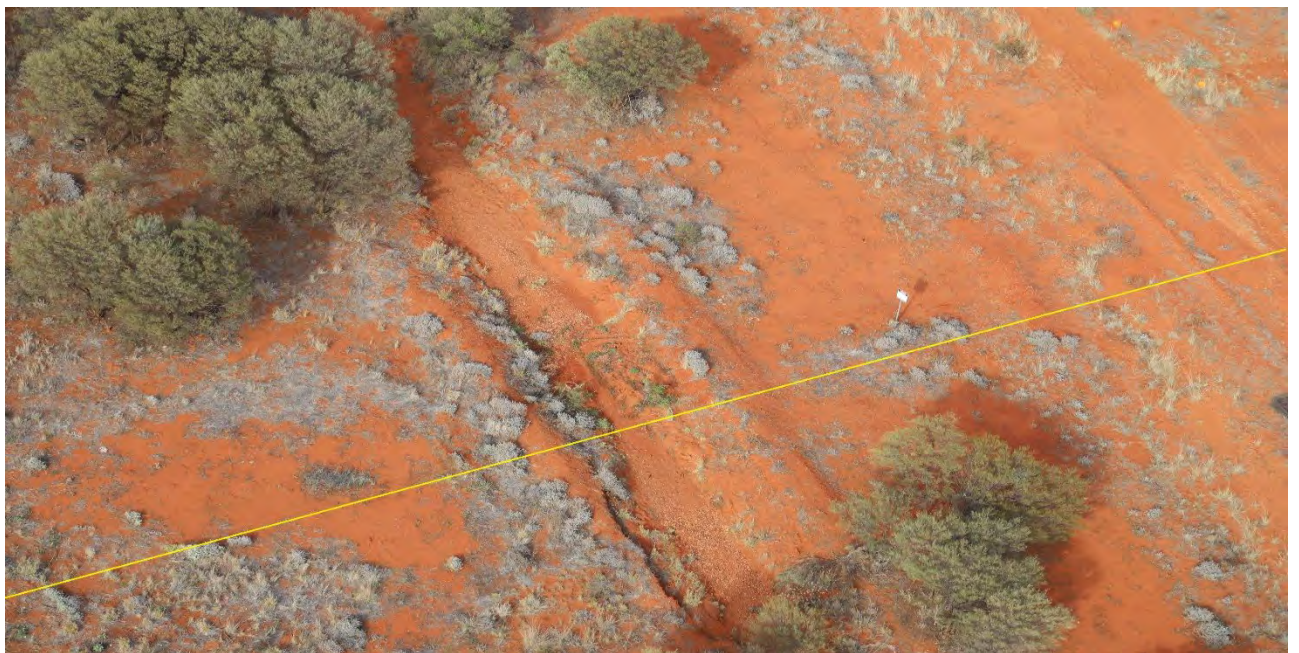
KP 140.22

- Image below shows no significant changes to the natural water course forming across the pipeline at this location.

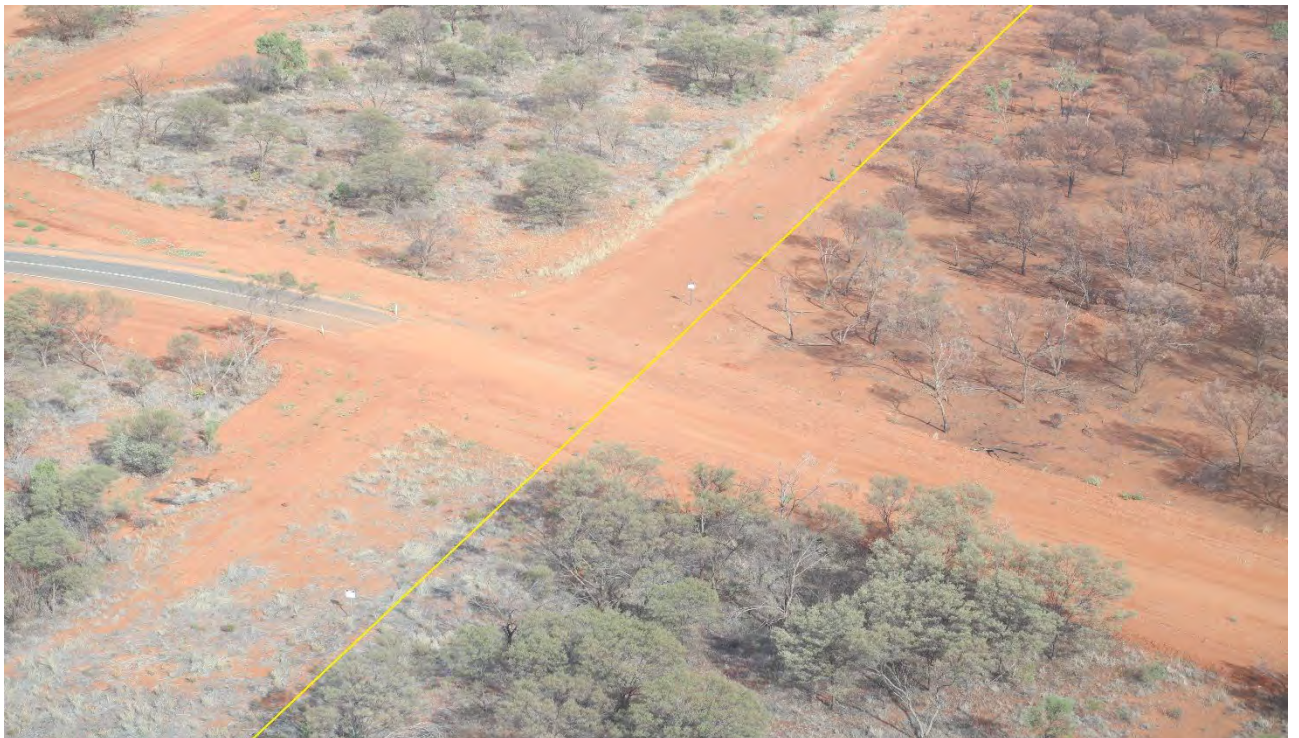
Rd to
Yuendumu
Airport
Intersection
KP 143.85

- Road crossing appeared in reasonable condition.

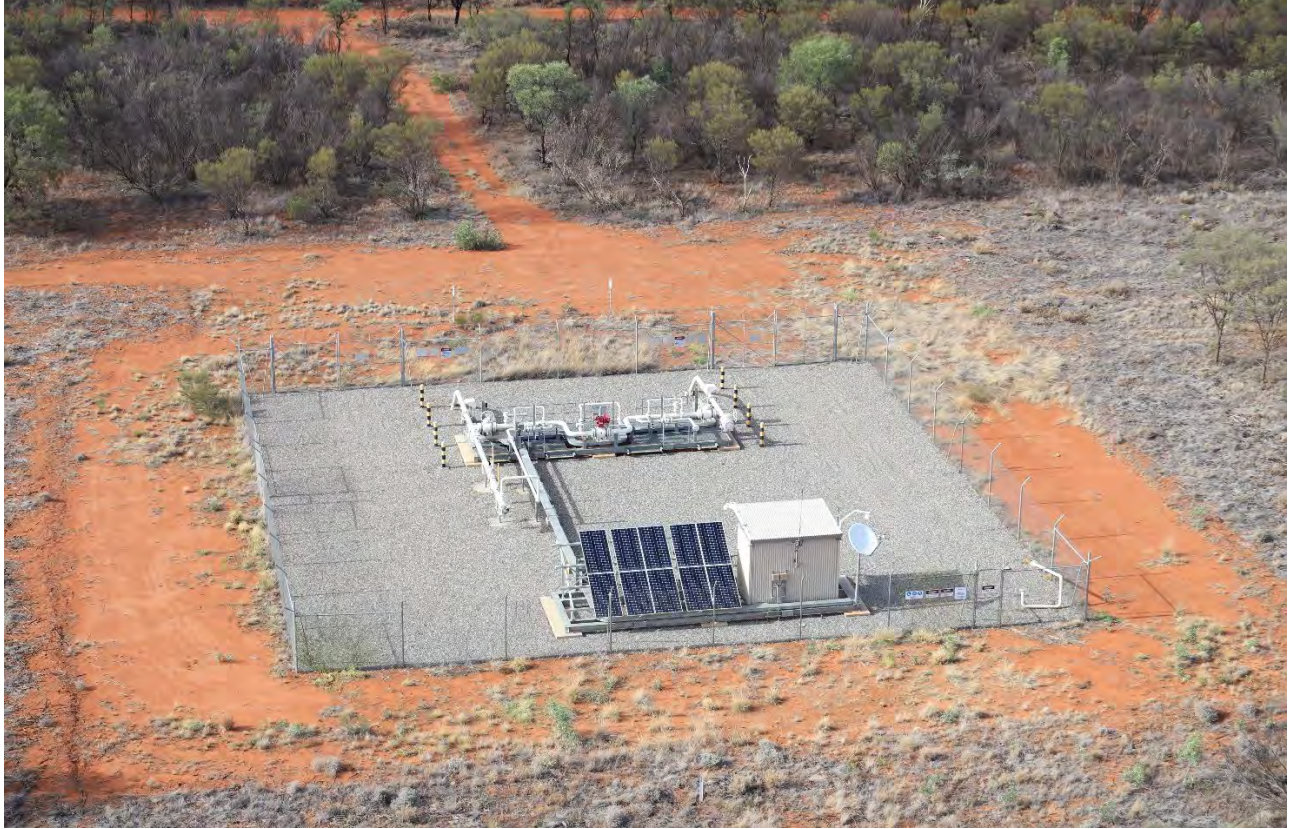
SS1
Yuendumu
KP 144.91

- All appeared correct and secure.

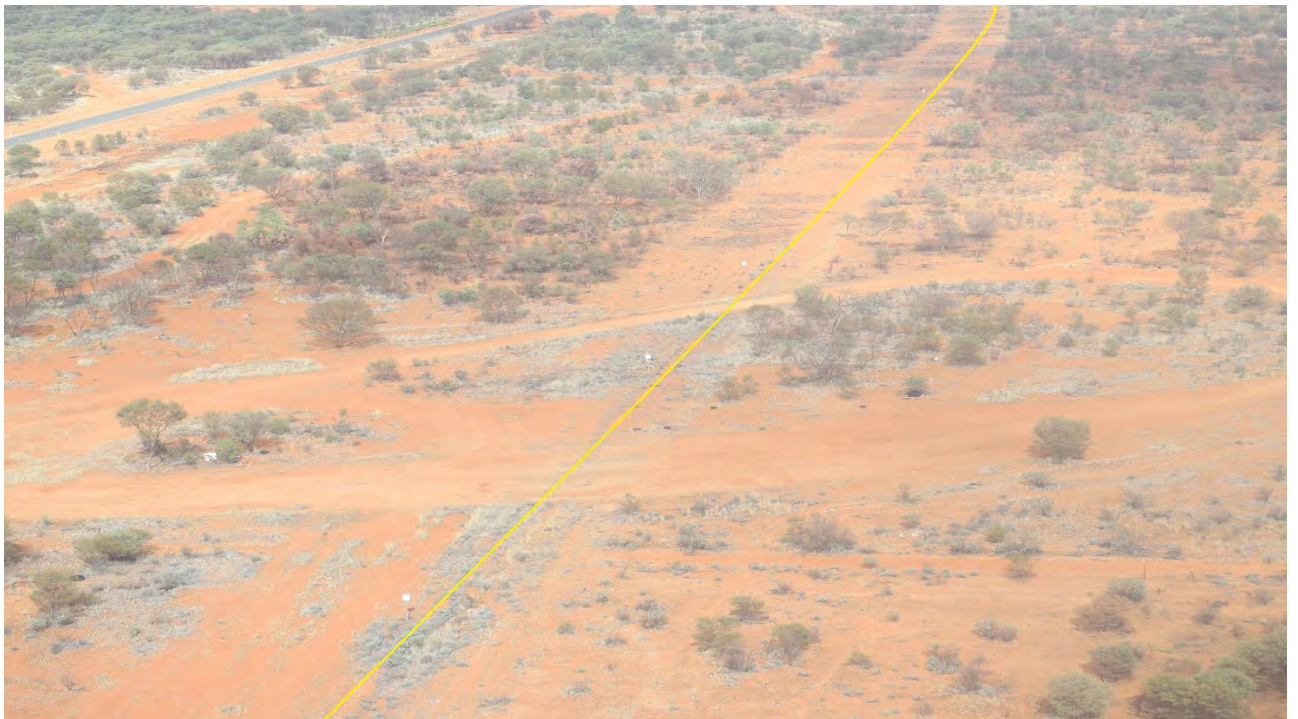
Truck Turning
& Parking Bay
KP 147.39

- No significant changes observed to these crossings.

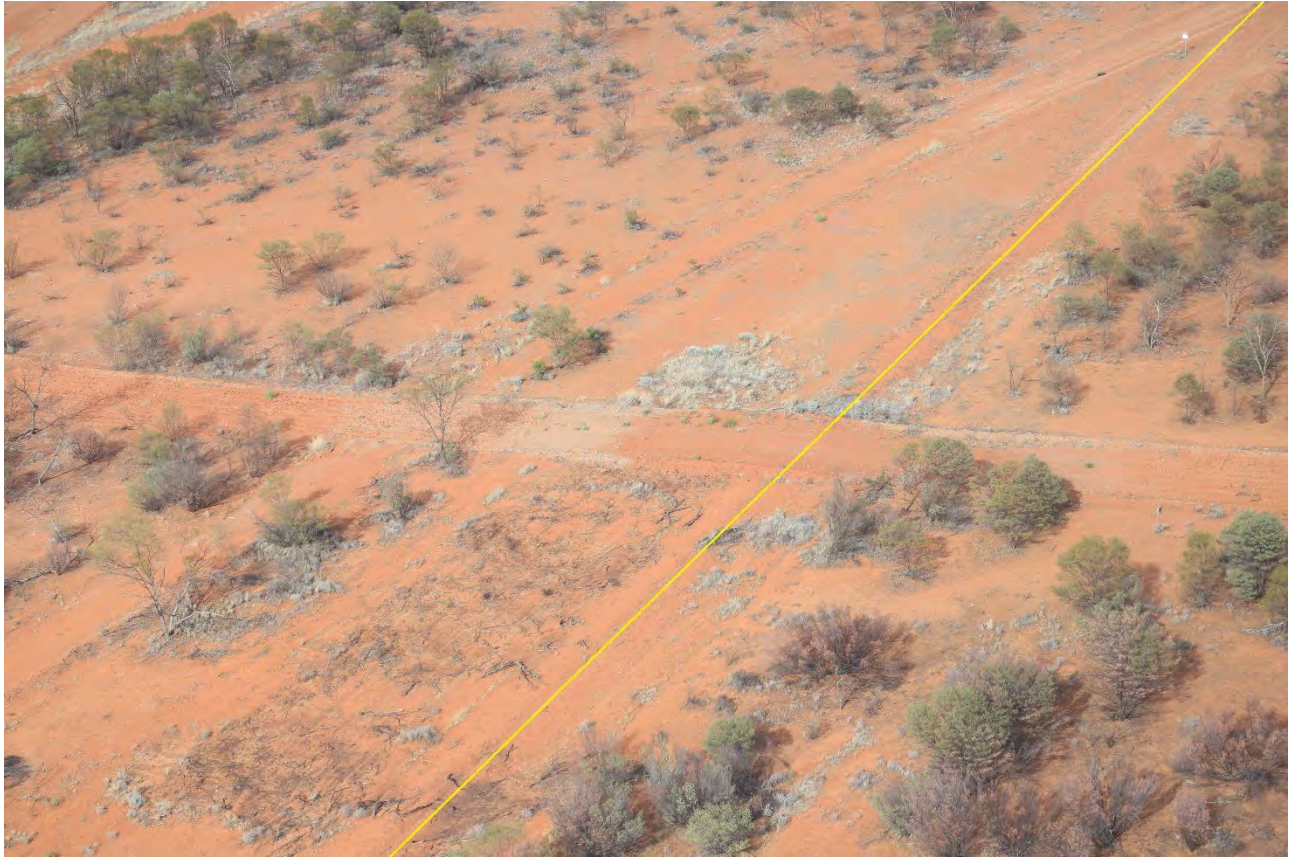
KP 148.48

- Image below details the current condition of 1 of 3 approved H.V crossing points as part of the Tanami Road upgrade project, completed by Exact Contracting.
- Most upstream crossing pictured below remains in good condition.

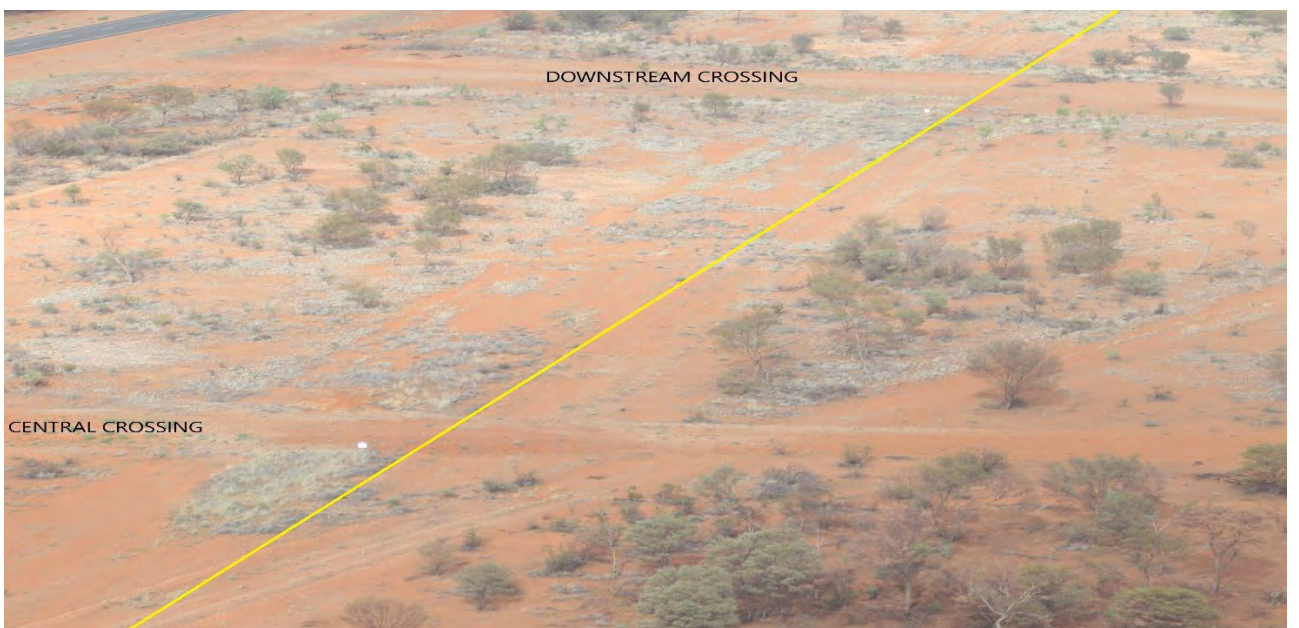
KP 148.48

- Central and downstream crossing pictured below; both remain in good condition.

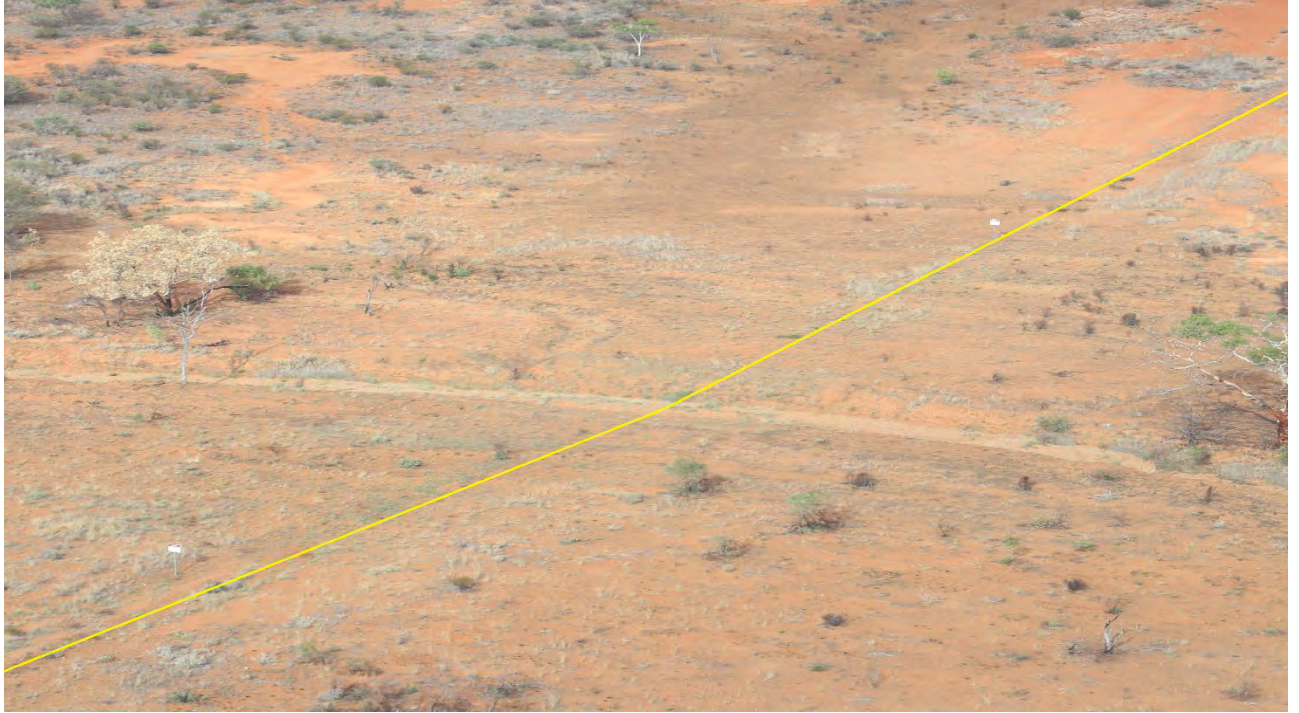
Mission Creek
T2
KP 153.04

- Appeared to remain in good condition.
