Tanami Gas Pipeline
Annual Compliance Assessment Report
EBPC 2017 / 7997 – 2023/24

E-REP-089

Revision: 1
Date: 6 August 2024

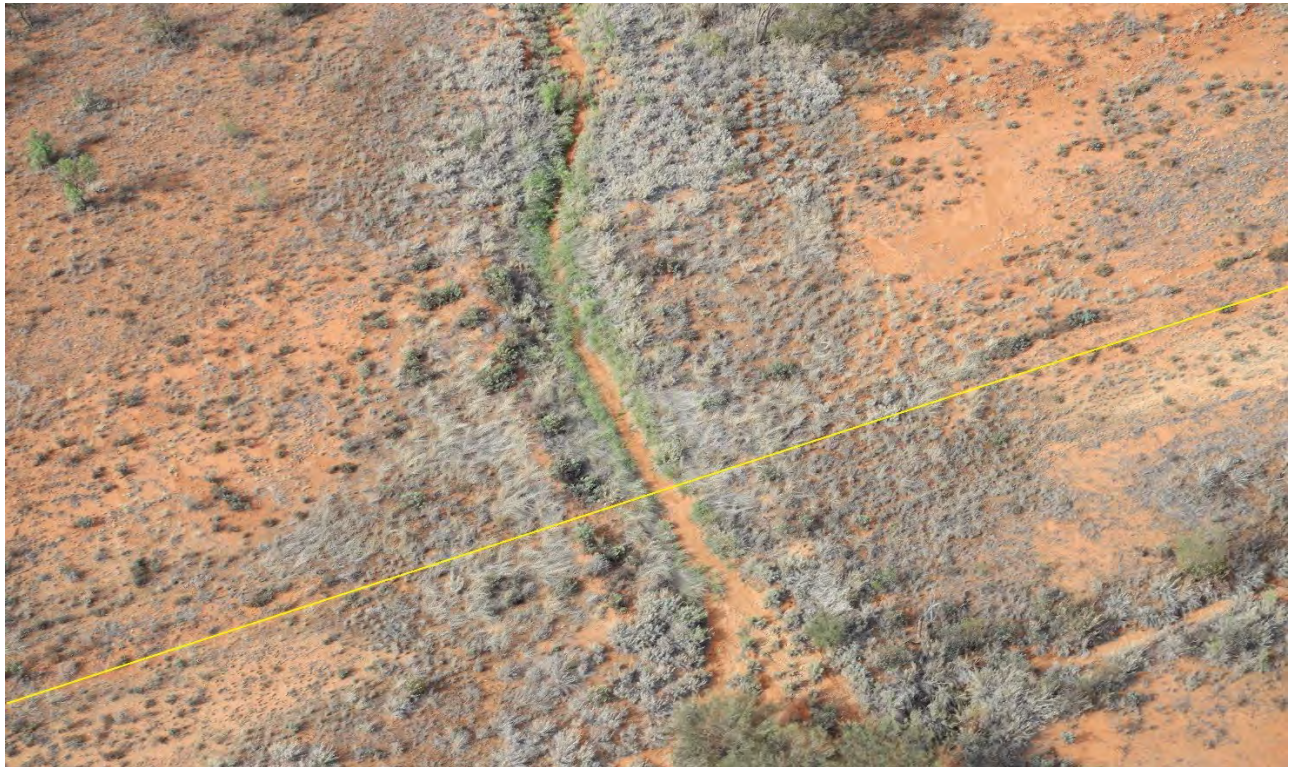
Mission Creek
T3
KP 153.39

- Appeared to remain in good condition.

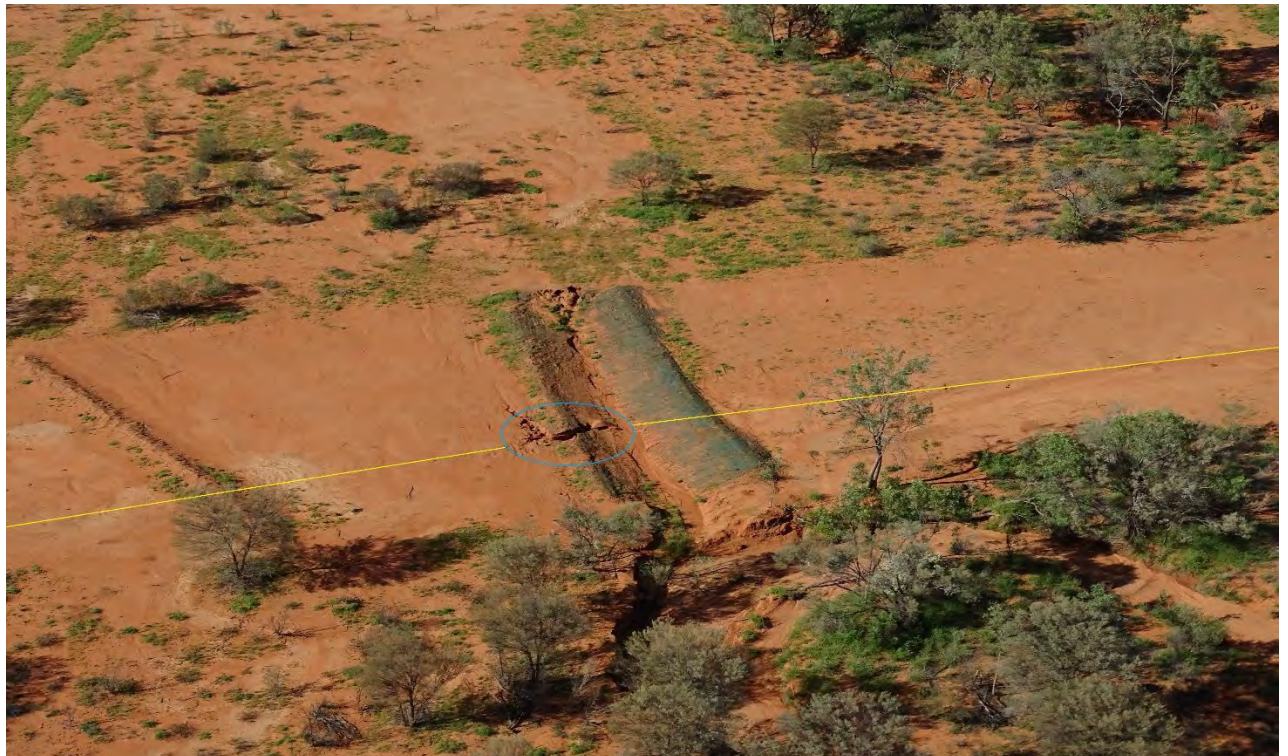
January 2021:

- Creek appears to be in reasonable condition and no significant change to erosion observed since the time of last flight.
- The erosion appears to be at least 1m in depth on the D/S bank.

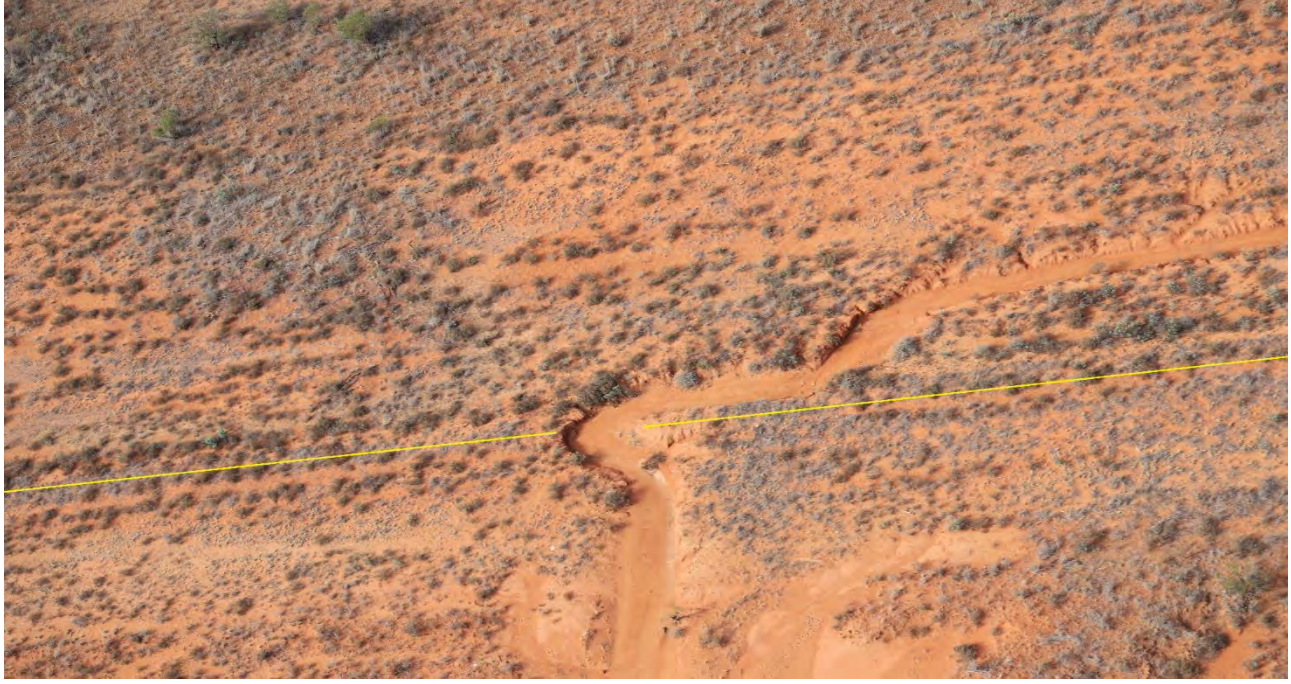
<p>ROW KP 155.67</p>	<ul style="list-style-type: none"> • A natural water course forming across the pipeline in this location. • Helicopter landed October 2023; erosion appears to be approximately 400mm in depth, with 1000mm of cover remaining over the pipe.

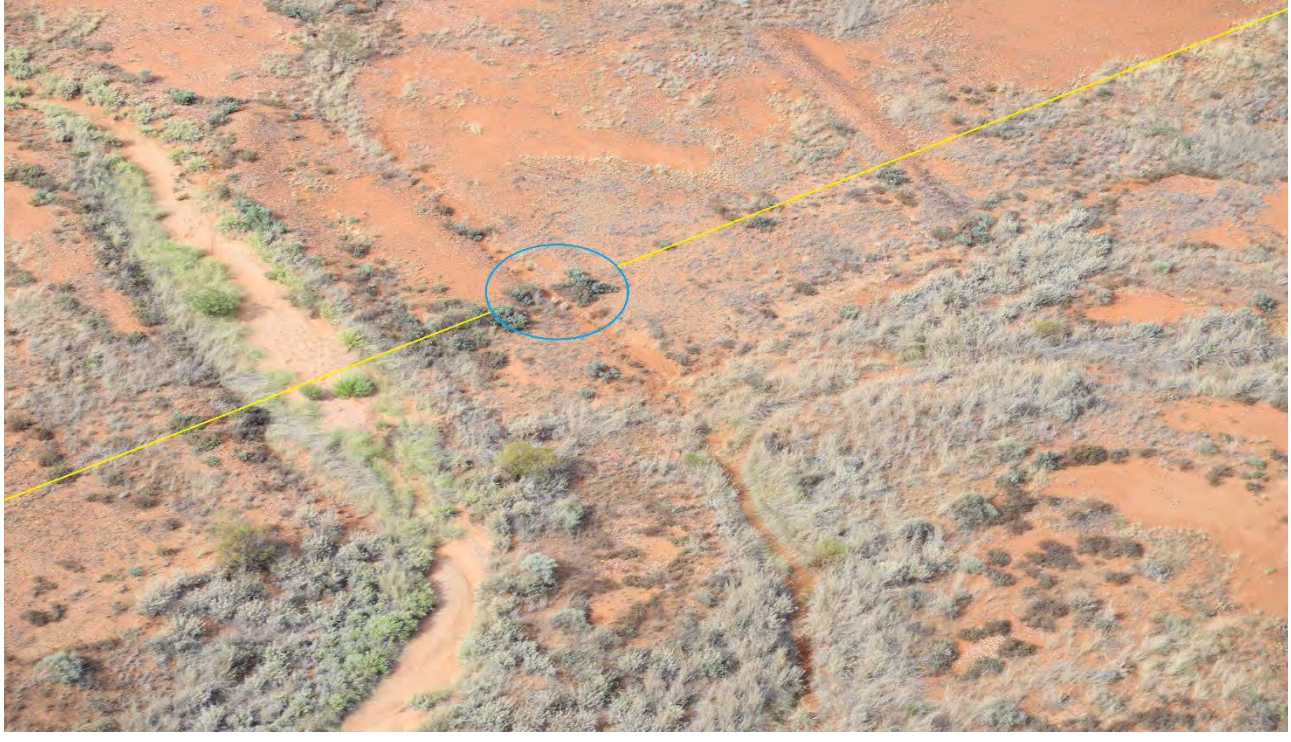
<p>Keridi Creek Tributary T2 KP 156.29</p>	<ul style="list-style-type: none"> • Below image details moderate water erosion developing across the pipeline downstream of the Keridi Creek tributary, no change since the previous flight; erosion appears to be approximately 300-400mm in depth.

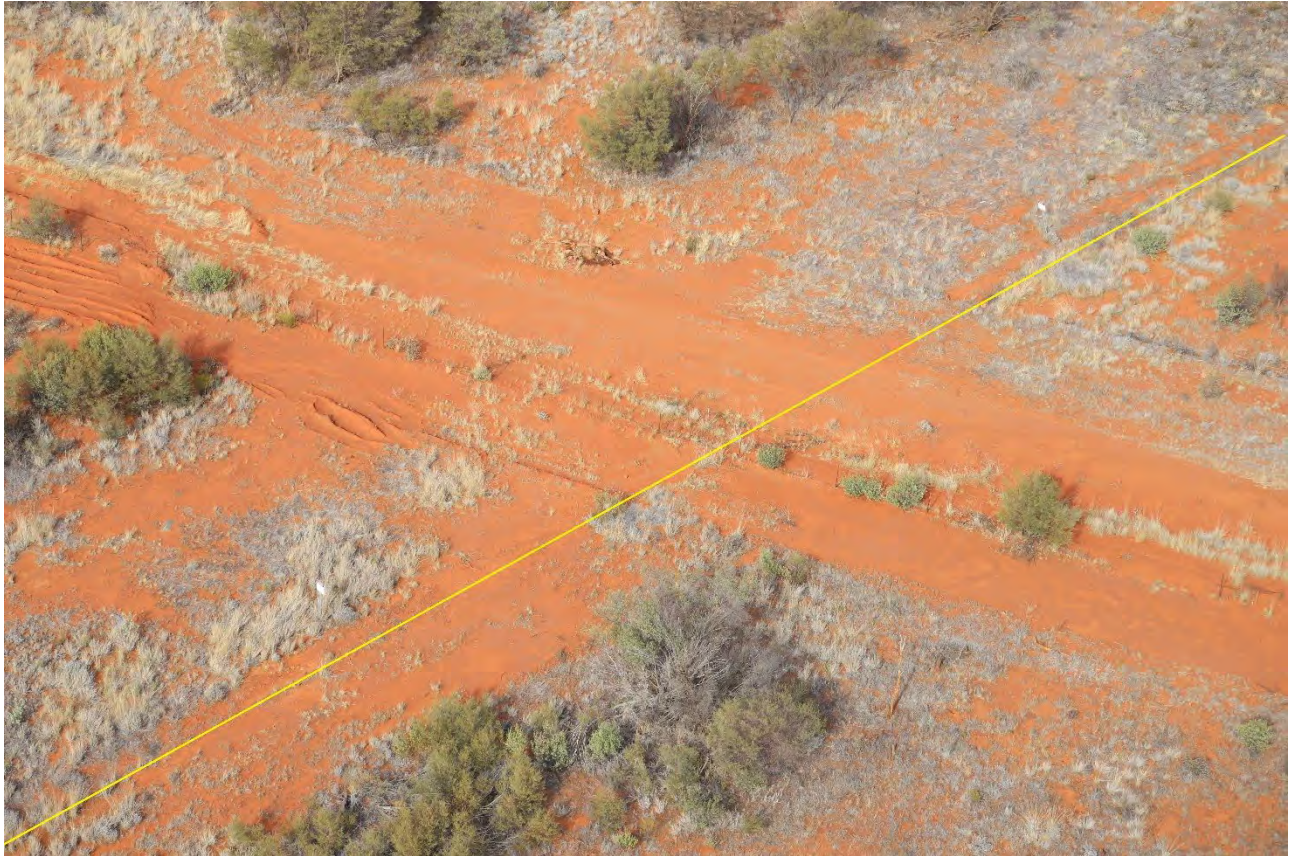
Mount Doreen
Station Rd
KP 159.93

- No issues observed at the crossing.
- Previously reported vehicle activity to the South of the easement remains without change.

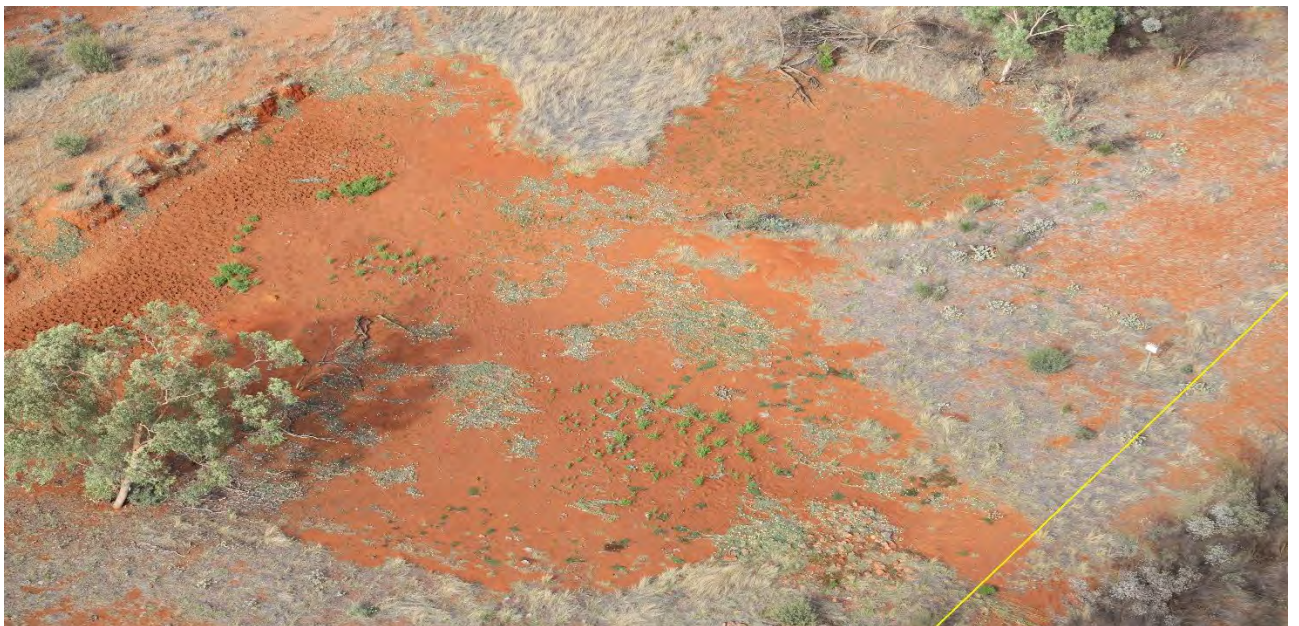
KP 160.89 –
KP 161.50

- Below image shows one of a few water catchment areas in the easement within this section.
- Surface water has reduced significantly since mid 2023.

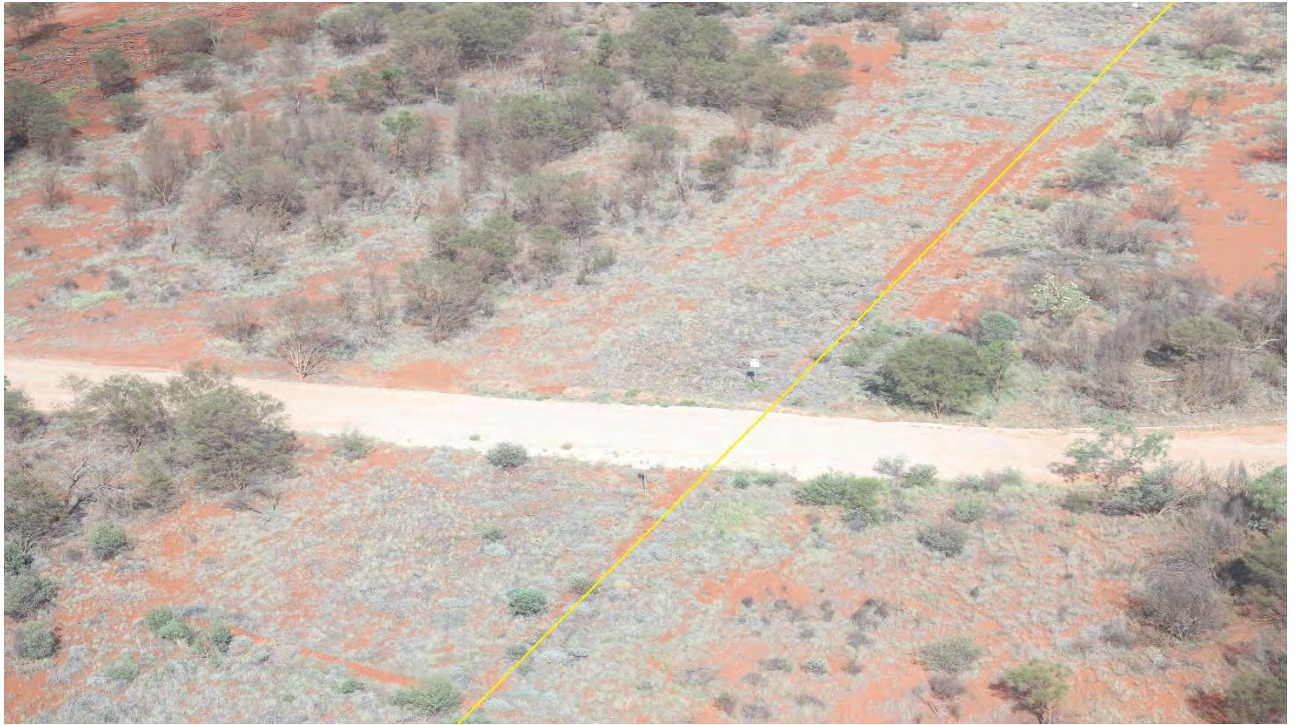
Tanami Rd
Camp 2 /
Laydown
vehicle
crossing
KP 170.62

- The Tanami Rd Camp 2/ Laydown area crossing remains in good order. The camp is no longer in use and has been rehabilitated.

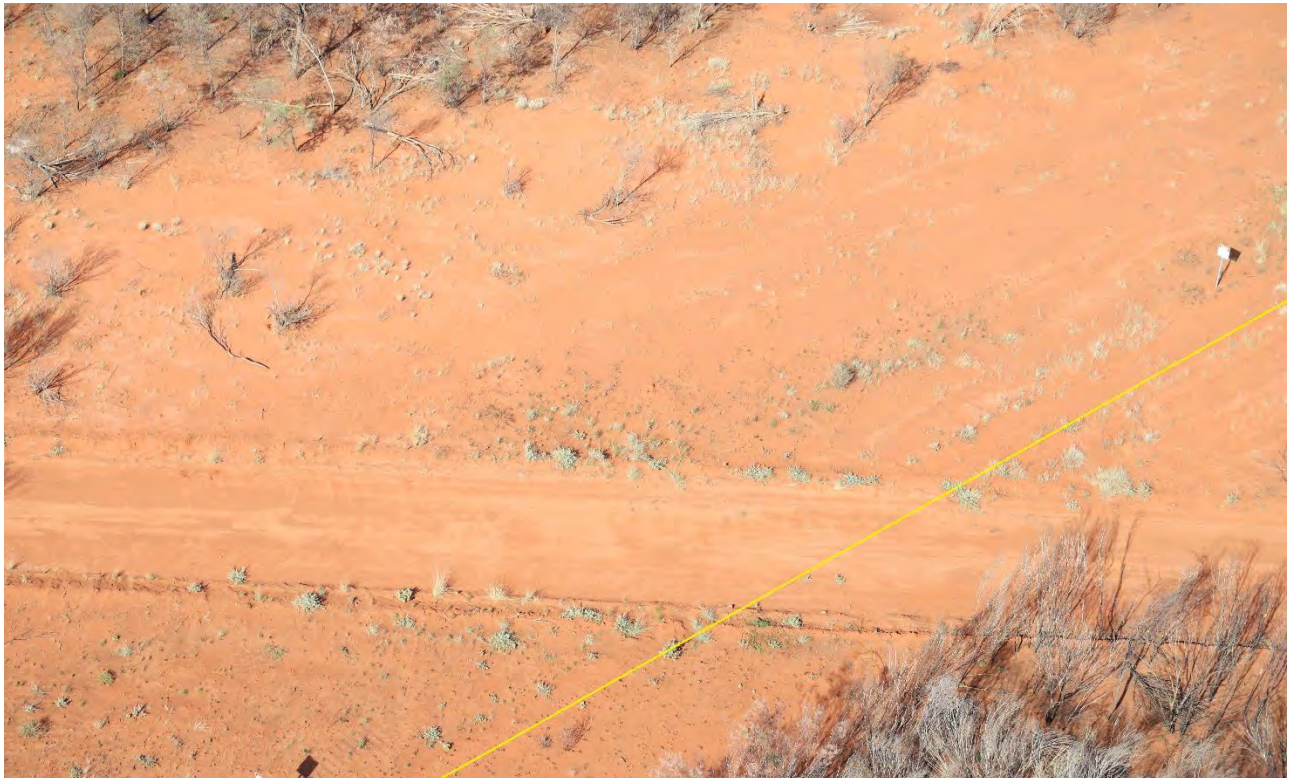
Gintys Bore
Access Road
KP 173.10

- No change to the current condition of the road crossing.

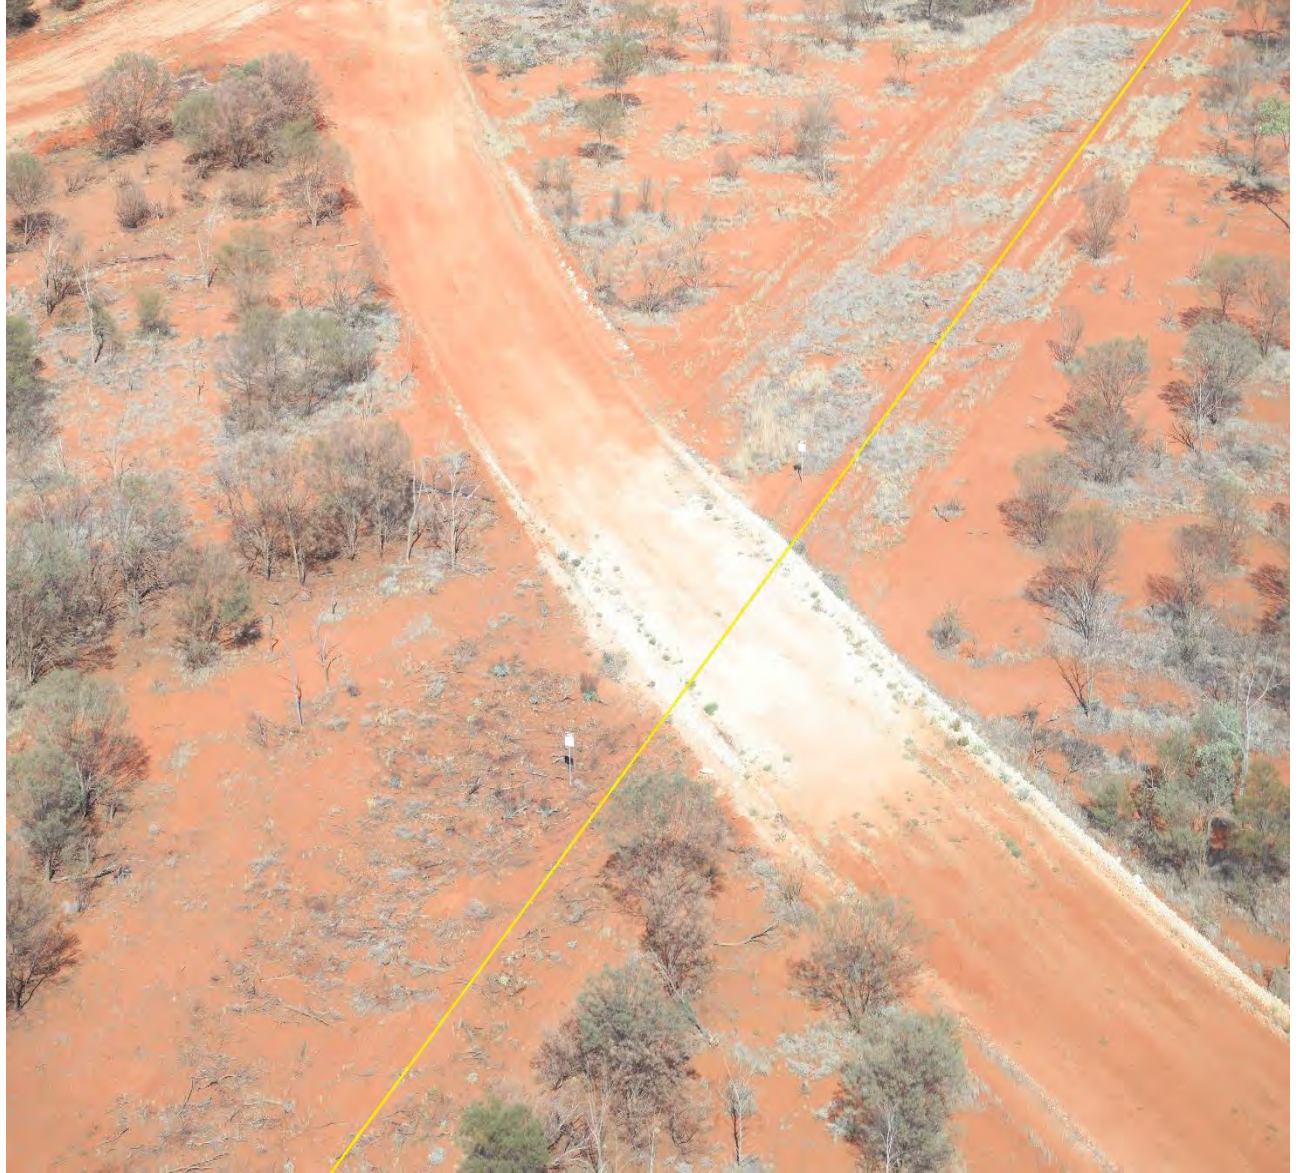
KP 177.31

- Below image shows an approved H.V crossing constructed by Exact Contracting at this location.

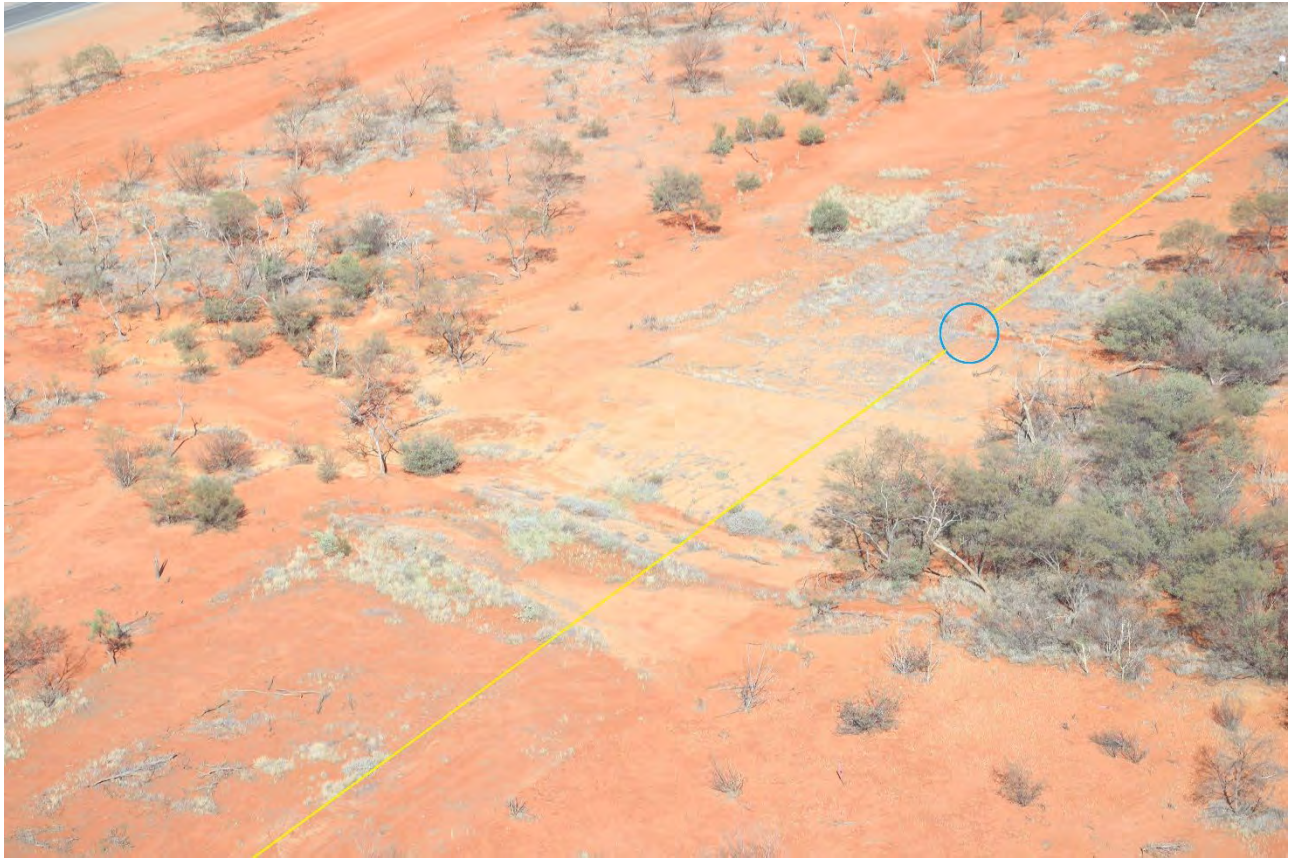
Watercourse
T3
KP 177.70

- The watercourse across the easement remains in good condition. Previously reported erosion downstream of the watercourse remains without change.

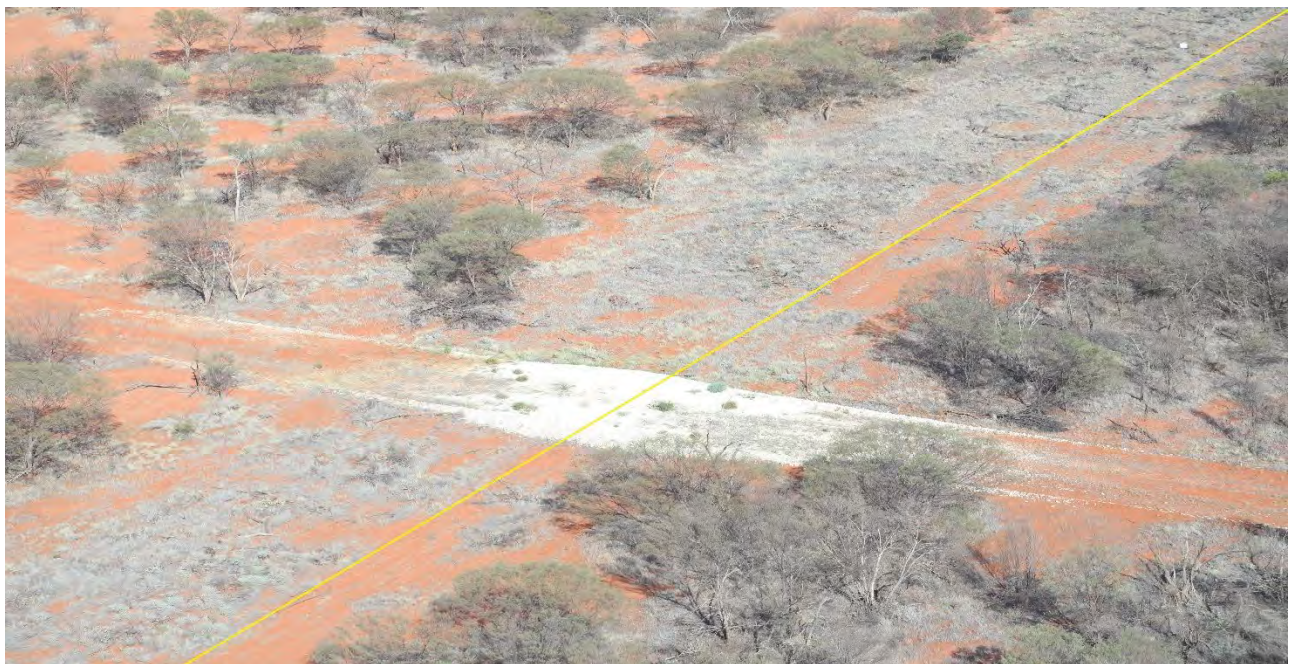
KP 177.94

- Below image shows an approved H.V crossing constructed by Exact Contracting at this location.

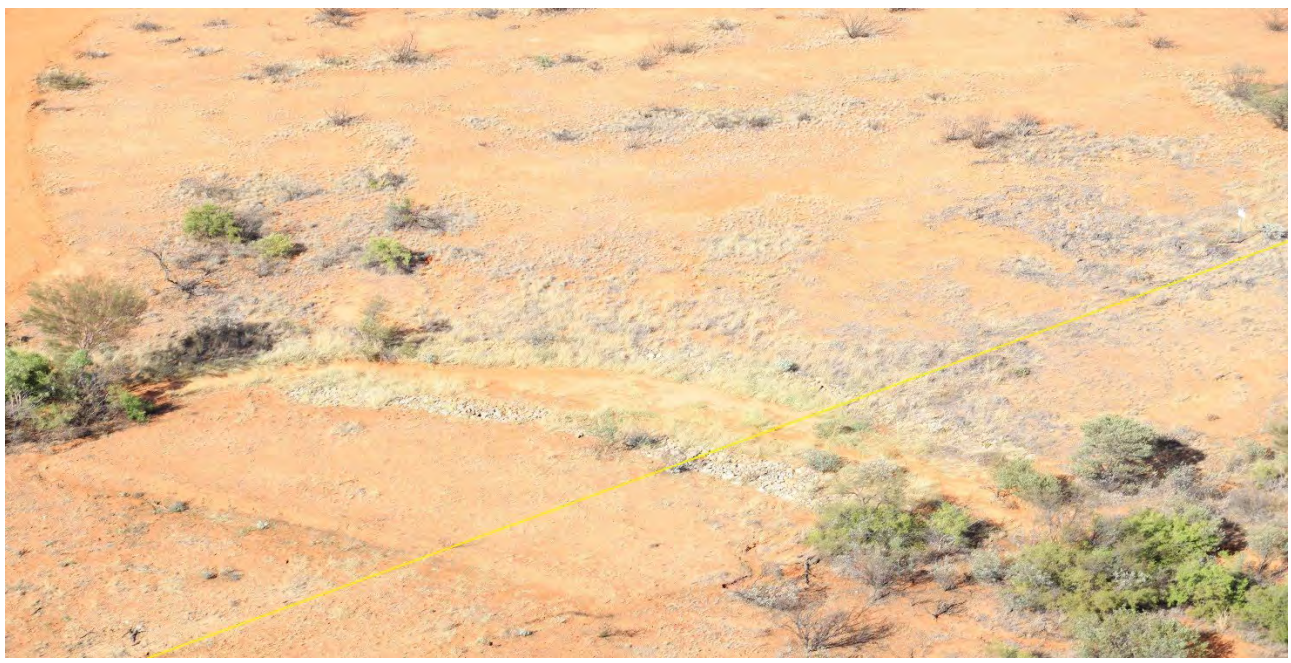
<p>Yaloojarrie Creek T1 & Tributaries KP 179.96 – KP 181.36</p>	<ul style="list-style-type: none"> Image below shows works associated with the Tanami Road Upgrade in proximity to the corridor.

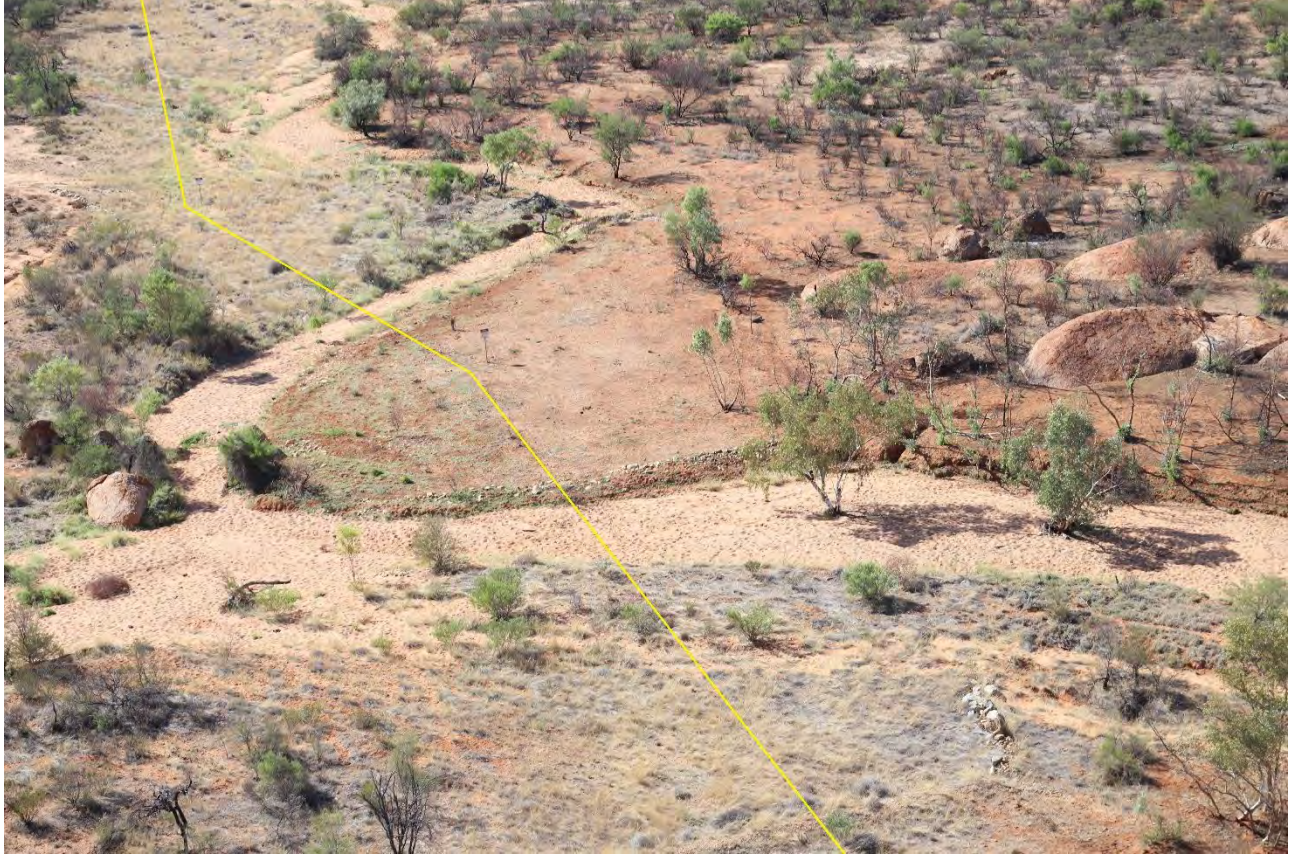
Yaloojarrie
Creek T1
& Tributaries
KP 179.96 –
KP 181.36

- No significant changes observed to the creek and its tributaries.

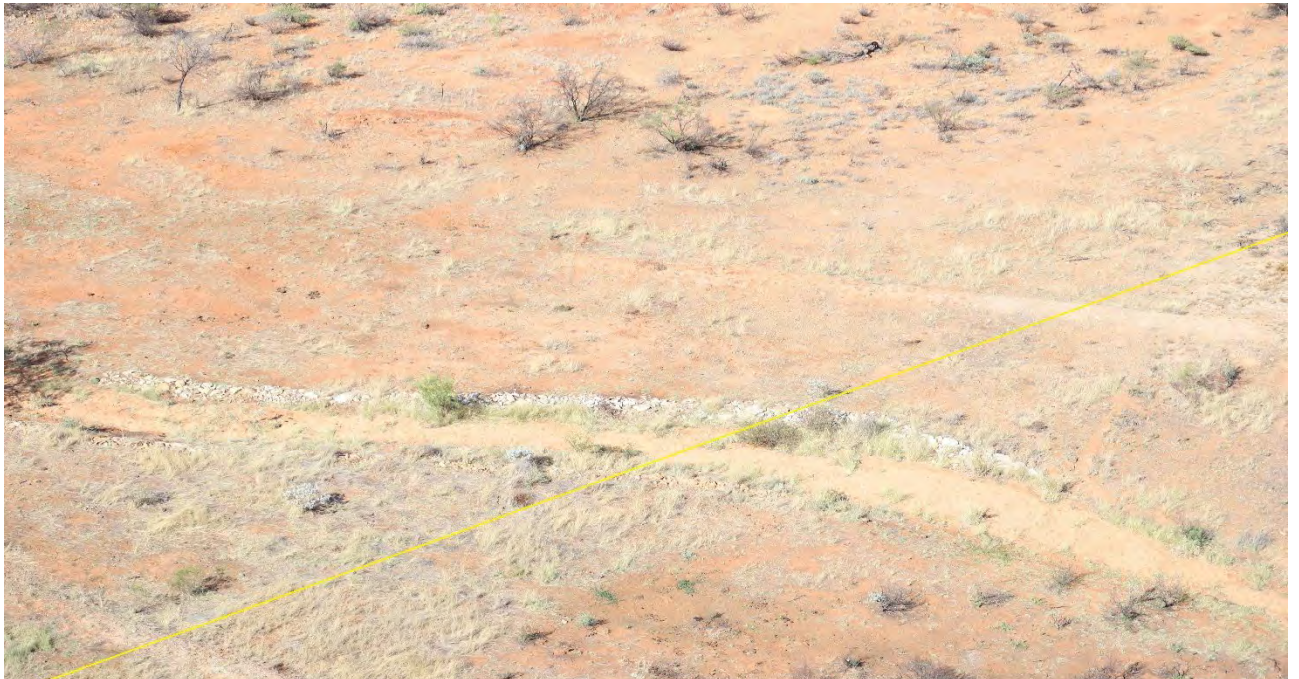
Yaloojarrie
Creek T1
& Tributaries
KP 179.96 –
KP 181.36

- No significant changes observed to the creek and its tributaries.

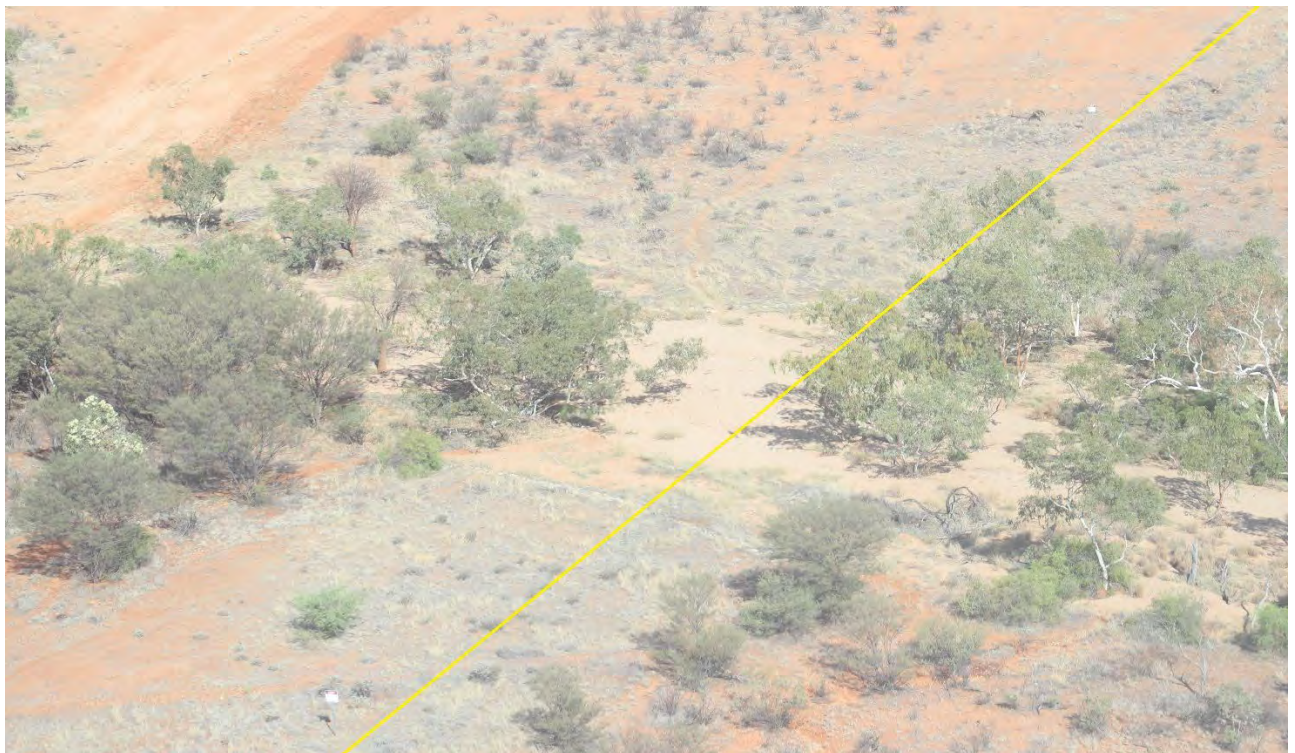
Yallogarrie
Creek
Tributarie
KP 184.36

- No change observed to the creek tributaries, rock pitching areas covered by vegetation overgrowth.

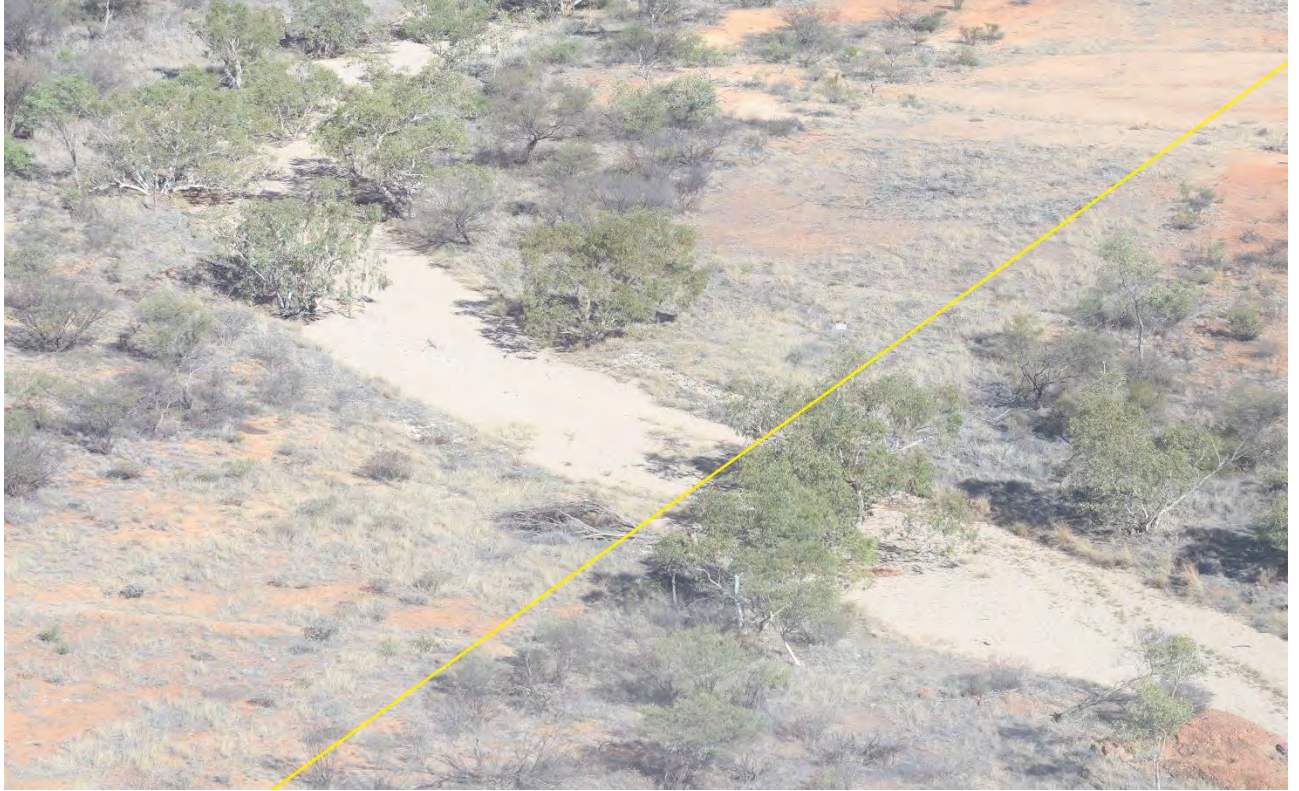
Yaloojarrie
Creek
Tributaries
KP 188.90 –
189.24

- The water crossing at this location appeared in good condition; rock pitching covered by overgrowth.

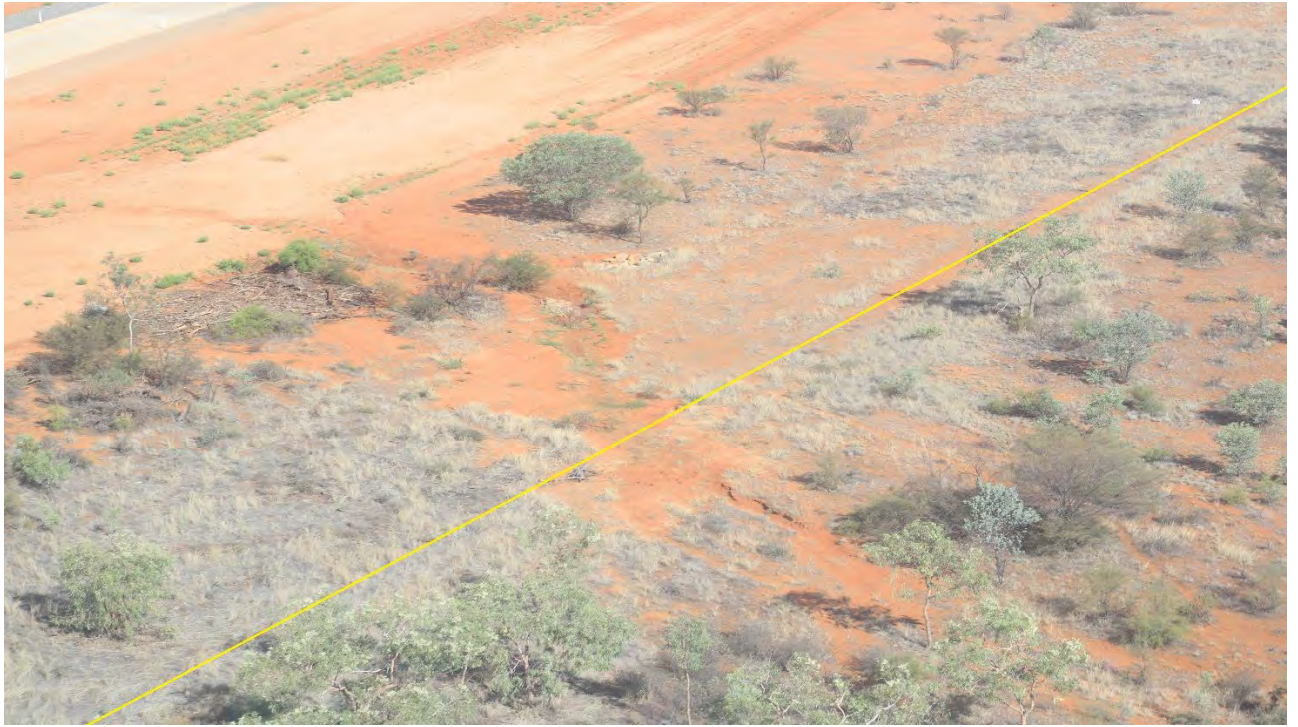
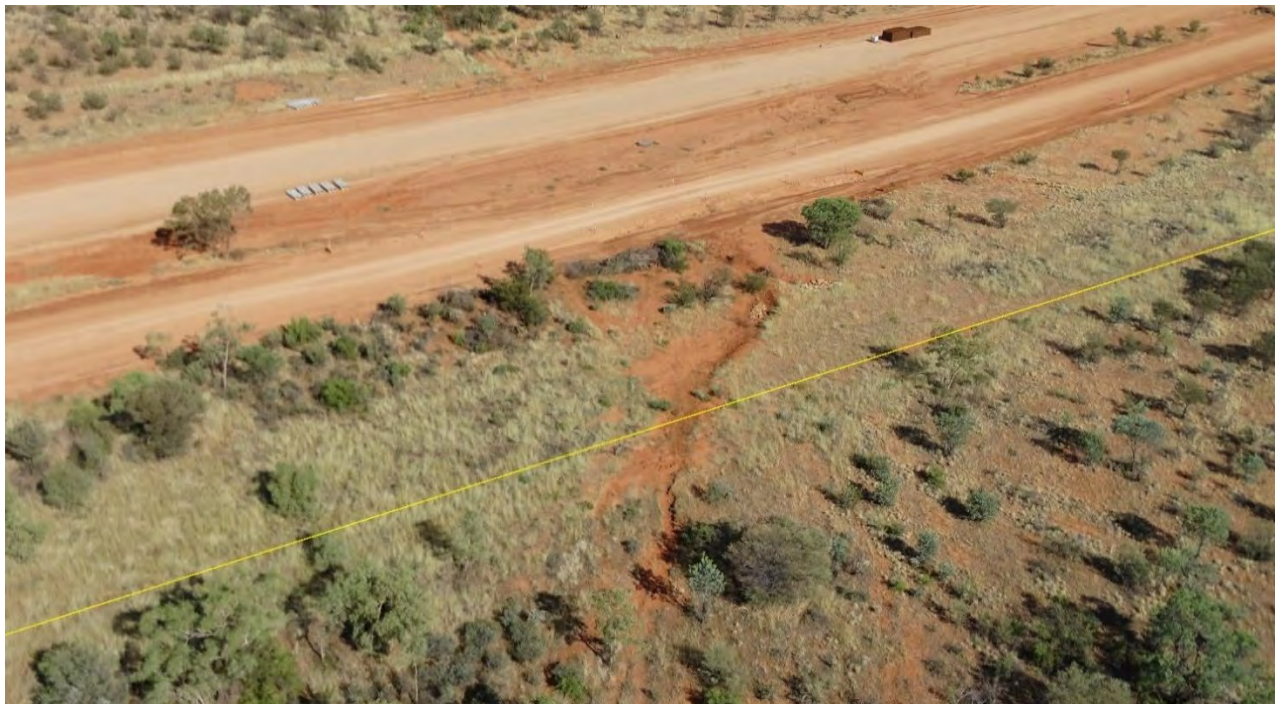
- Below image shows some moderate erosion developing close to a known T3 water crossing.
- The image depicts the surface seems to have stabilised with vegetation growing in this channel.

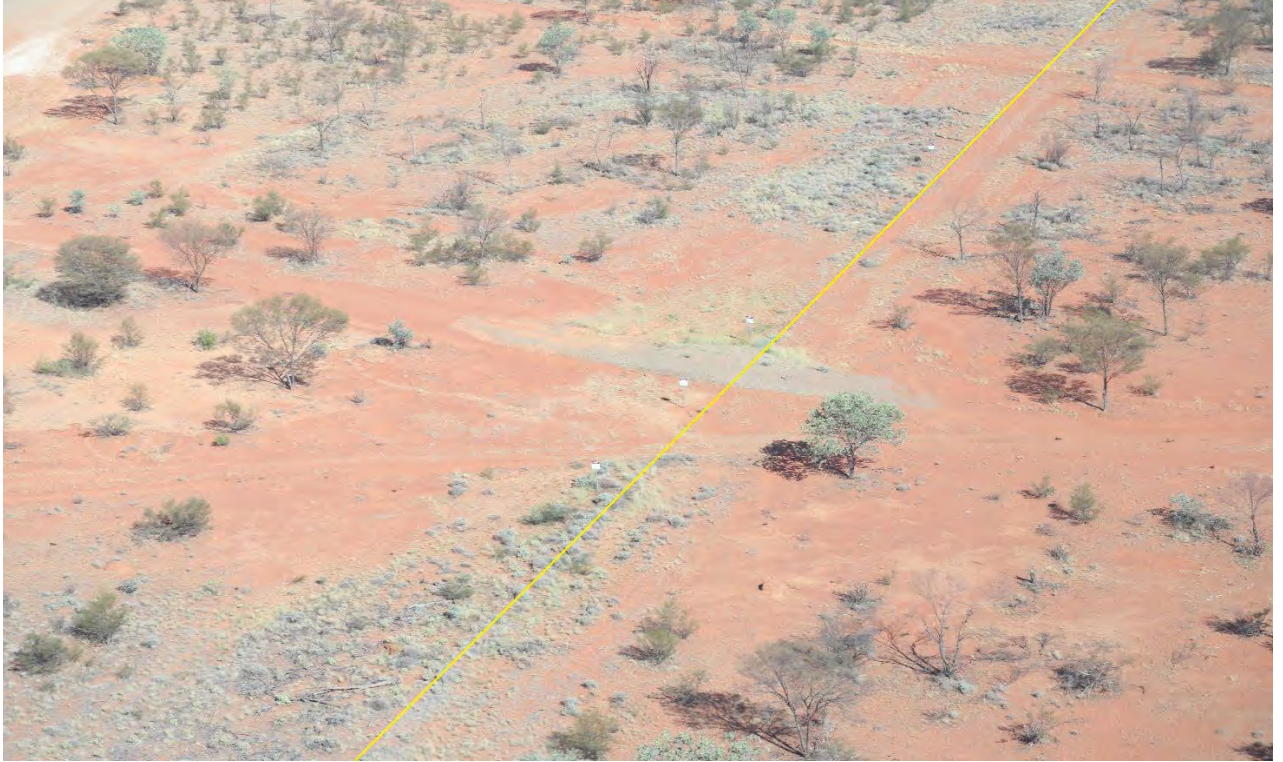
KP 196.74

- Below image shows an approved H.V crossing constructed by Exact Contracting at this location.

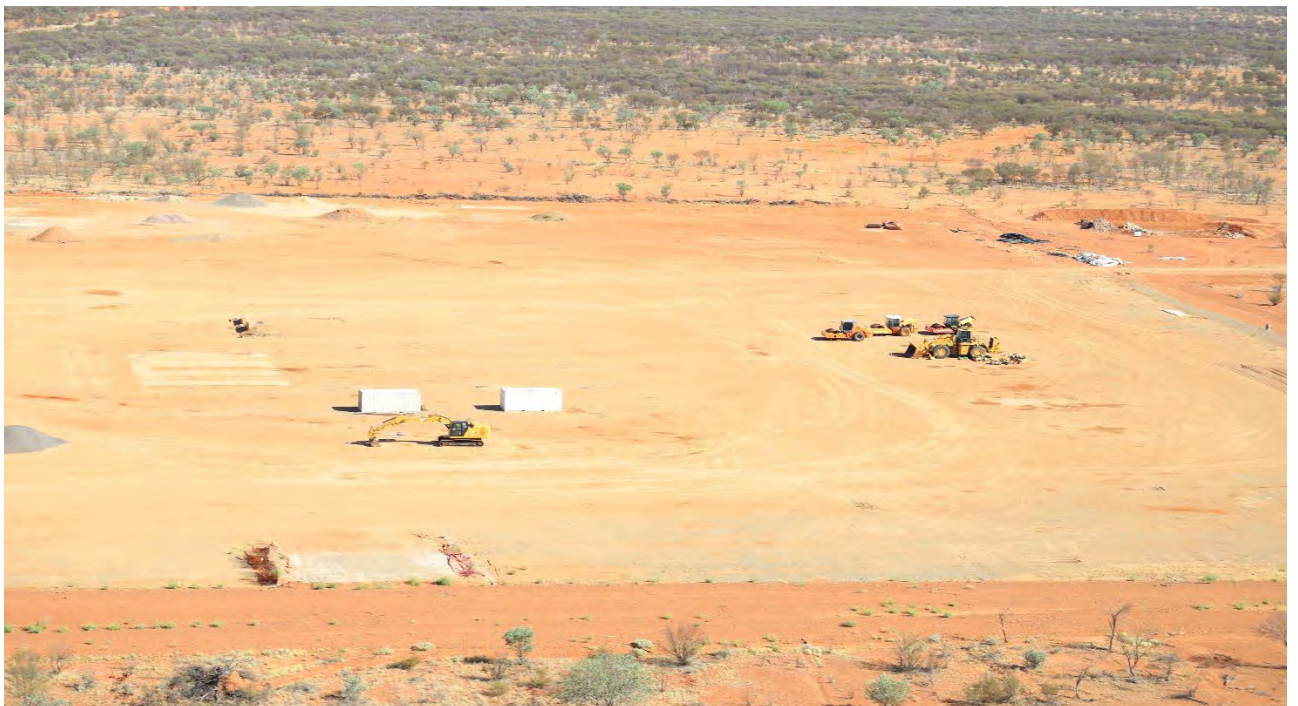
KP 199.07
Construction
Camp Exact
Contracting

- Below image shows main camp and laydown area, utilised by Exact Contracting for the next stage of the Tanami Road upgrade.
- Camp has been relocated, only some earth works equipment and materials remain.

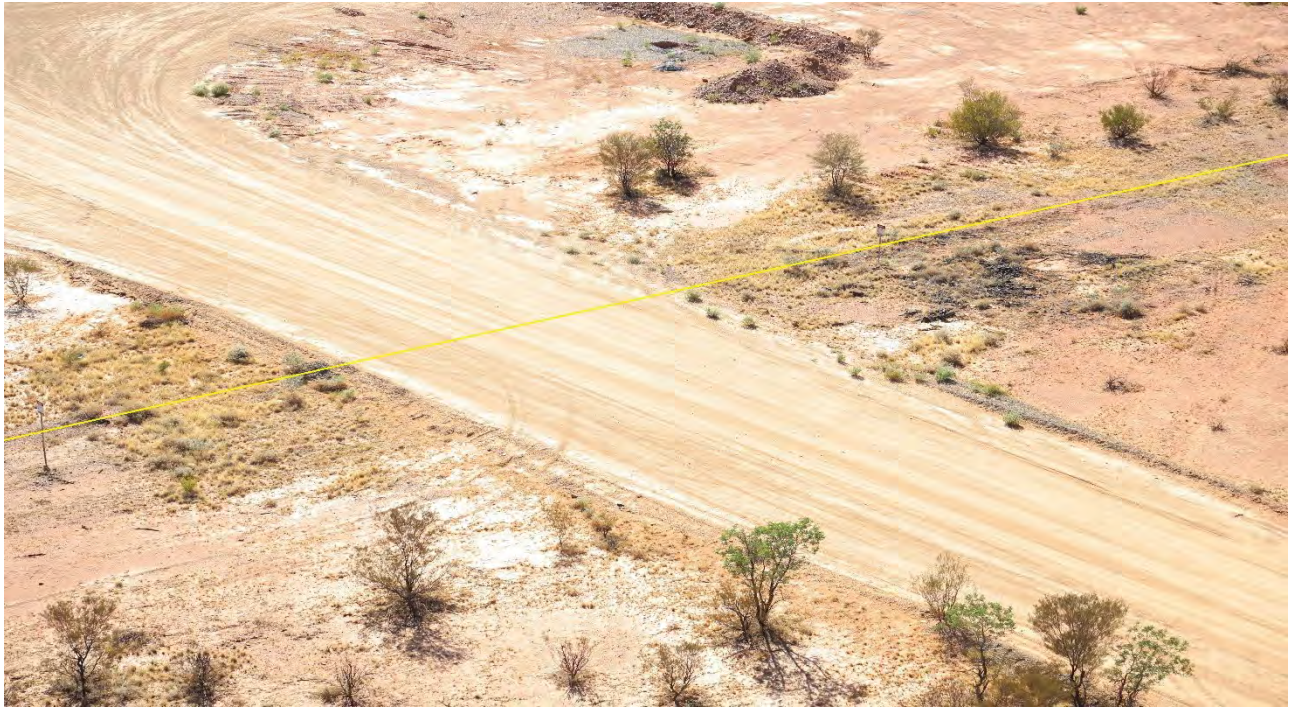
KP 199.07
Construction
Camp Exact
Contracting

- Heavy vehicle crossing (No. 11) leading into the decommissioned camp over the pipeline remains in good condition.

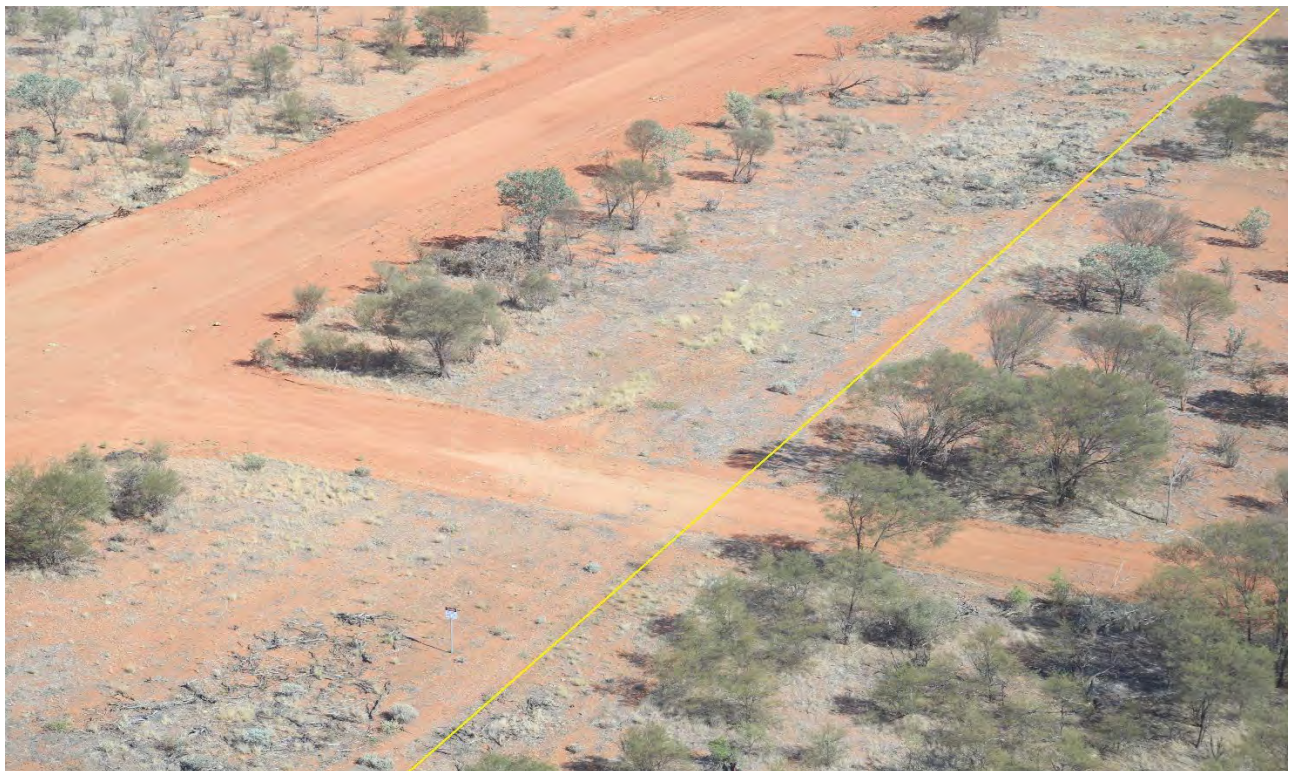
KP 201.52

- Below image shows Exact Contracting clearing the entrance to a slip road in very close proximity to the easement; no encroachments were observed.
