Tanami Gas Pipeline
Annual Compliance Assessment Report
EBPC 2017 / 7997 – 2023/24

E-REP-089

Revision: 1
Date: 6 August 2024

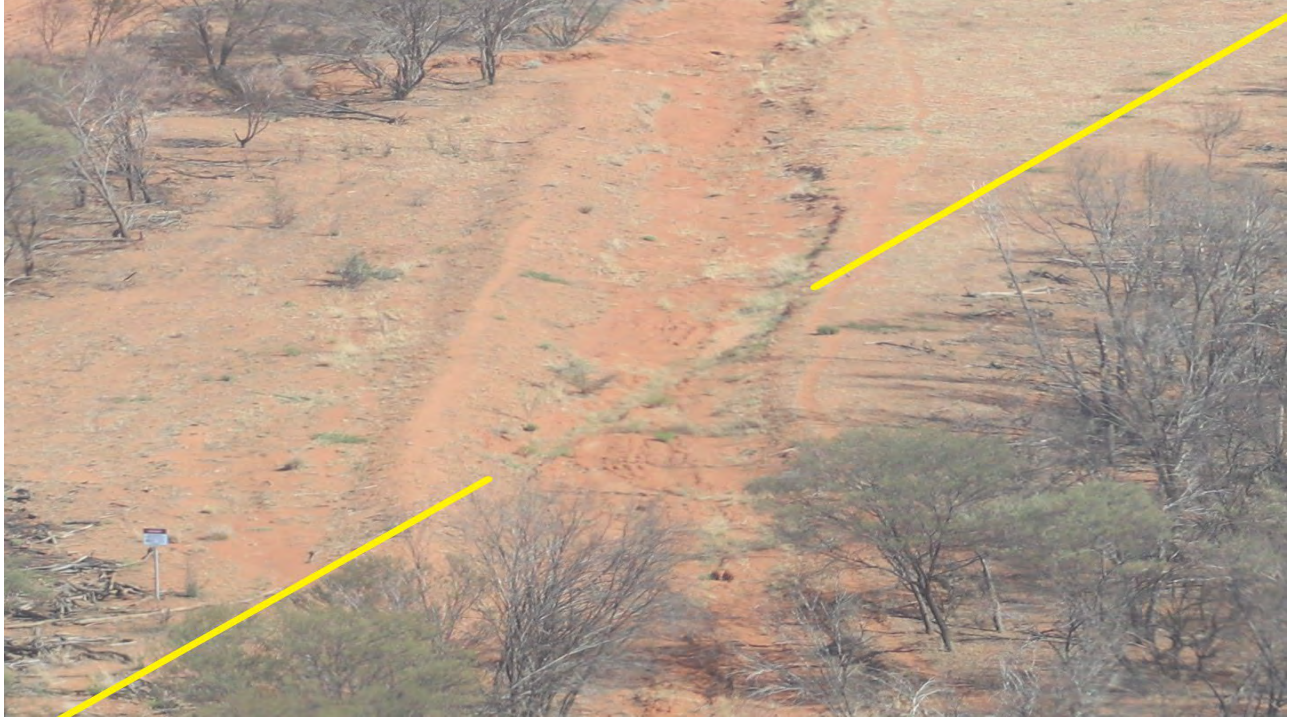
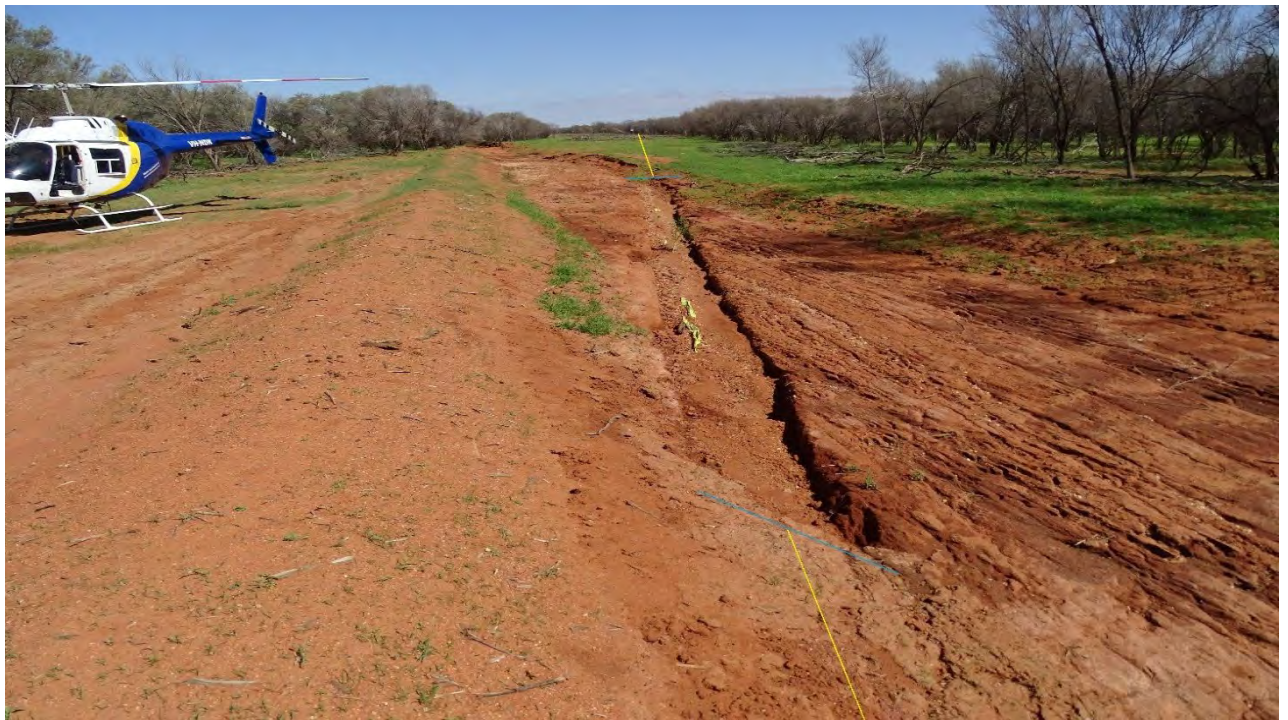
- Below image shows previously reported major erosion and washout over the easement.
- Marker tape is exposed but actual loss of cover over the pipeline is approximately 200 - 300mm.

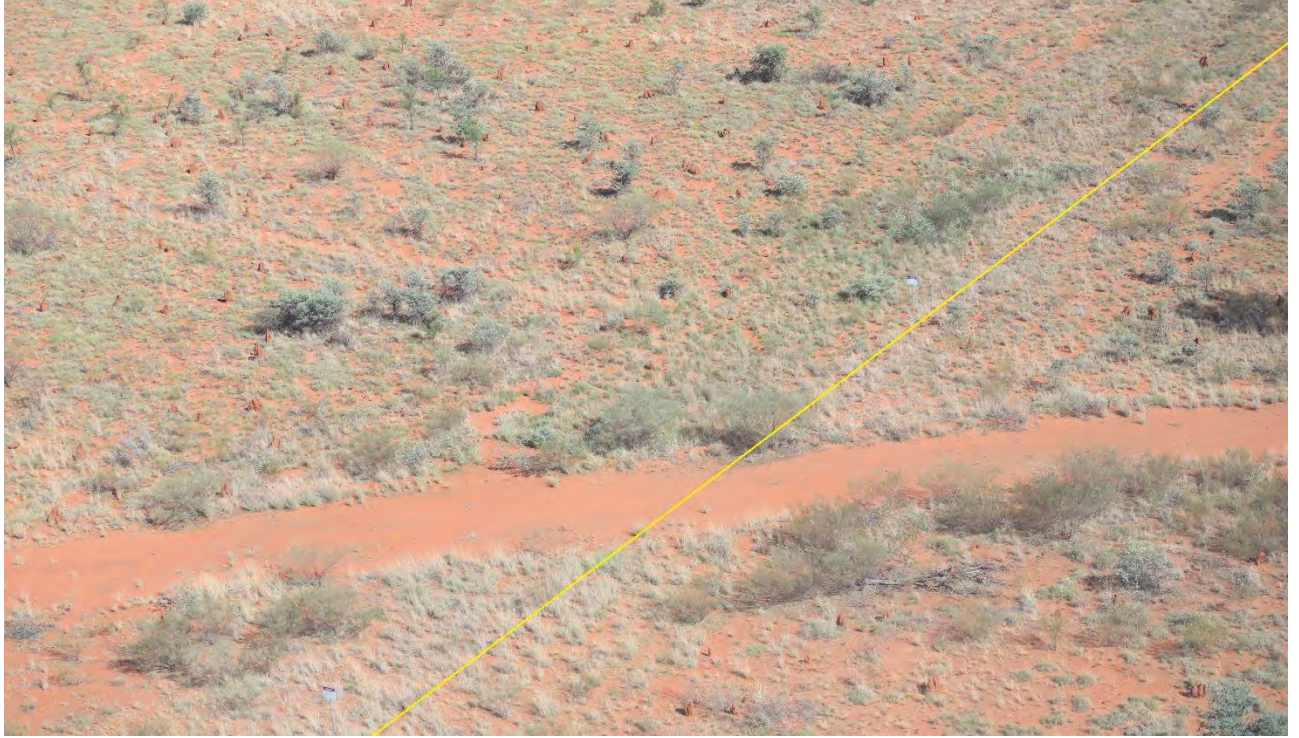
Gravel Road
KP 218.100

- No change observed to the current condition of the track crossing.

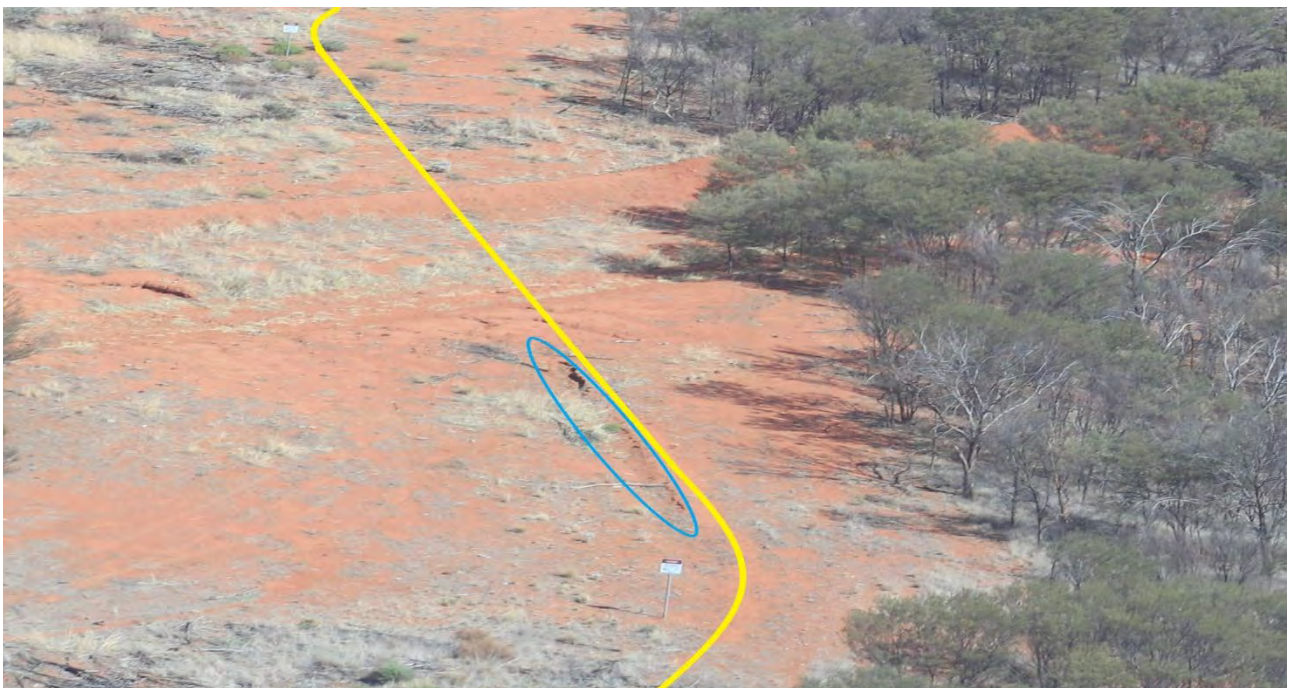
KP 234.41

- Below image updates previously reported erosion on the edge of the pipeline crown.
- ASO's to continue monitoring.

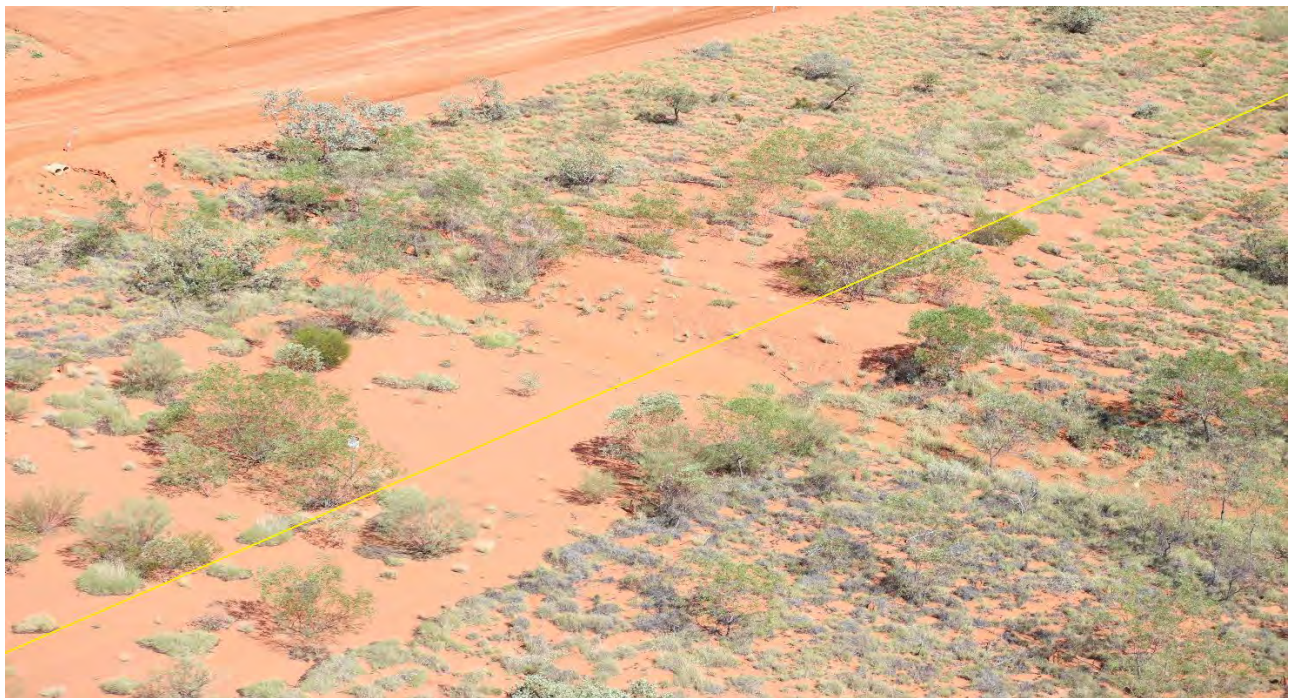
KP 254.63

- Temporary drainage culverts have been installed to direct surface water to this pre existing channel across the pipe corridor.
- Increased water flow may lead to further erosion across the pipe; ASO's continue to monitor.

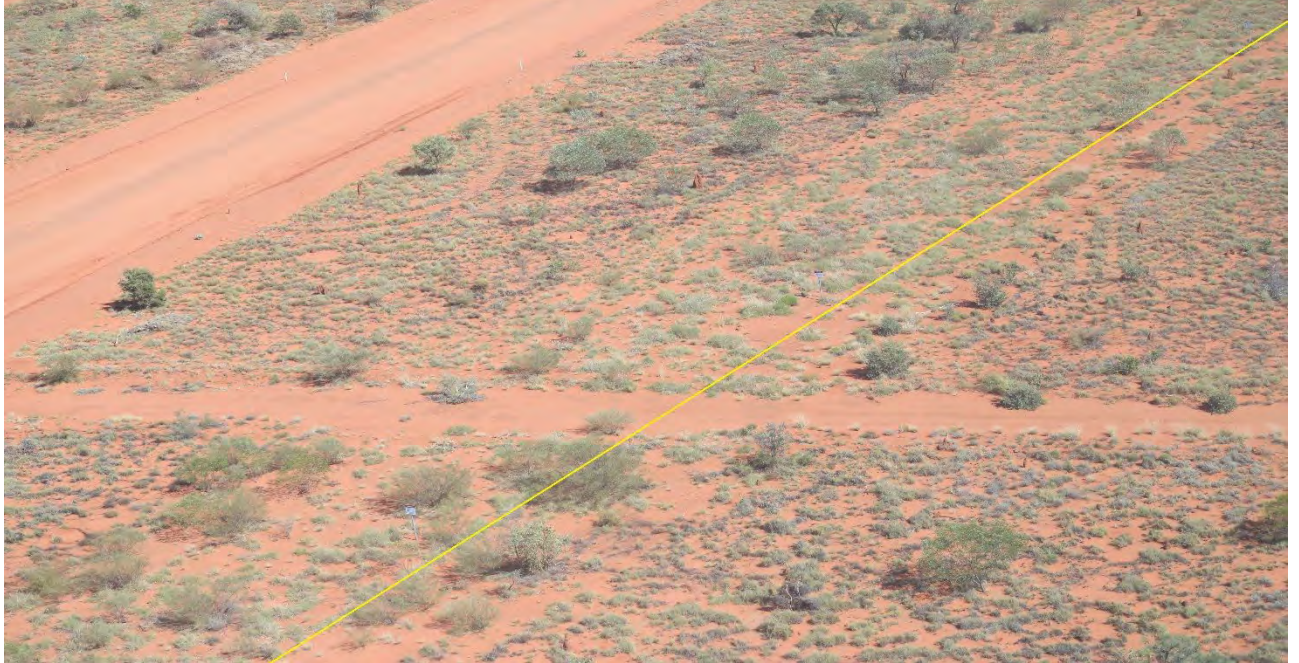
Mount Theo
Road
KP 263.24

- Mount Theo Road Crossing is in good condition.

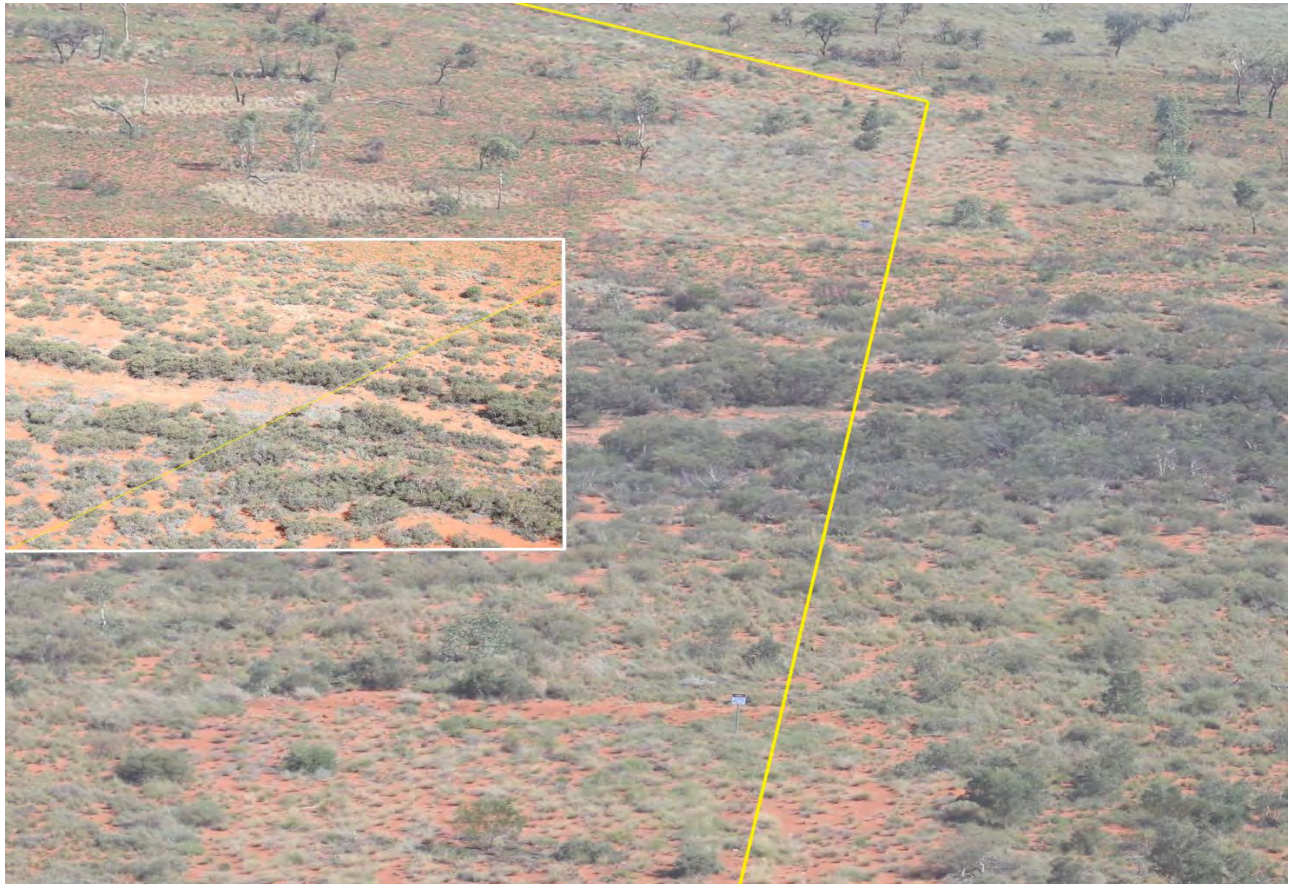
Watercourse
T2 Chilla Well
KP 266.64

- All appeared correct at the watercourse at KP 266.640.

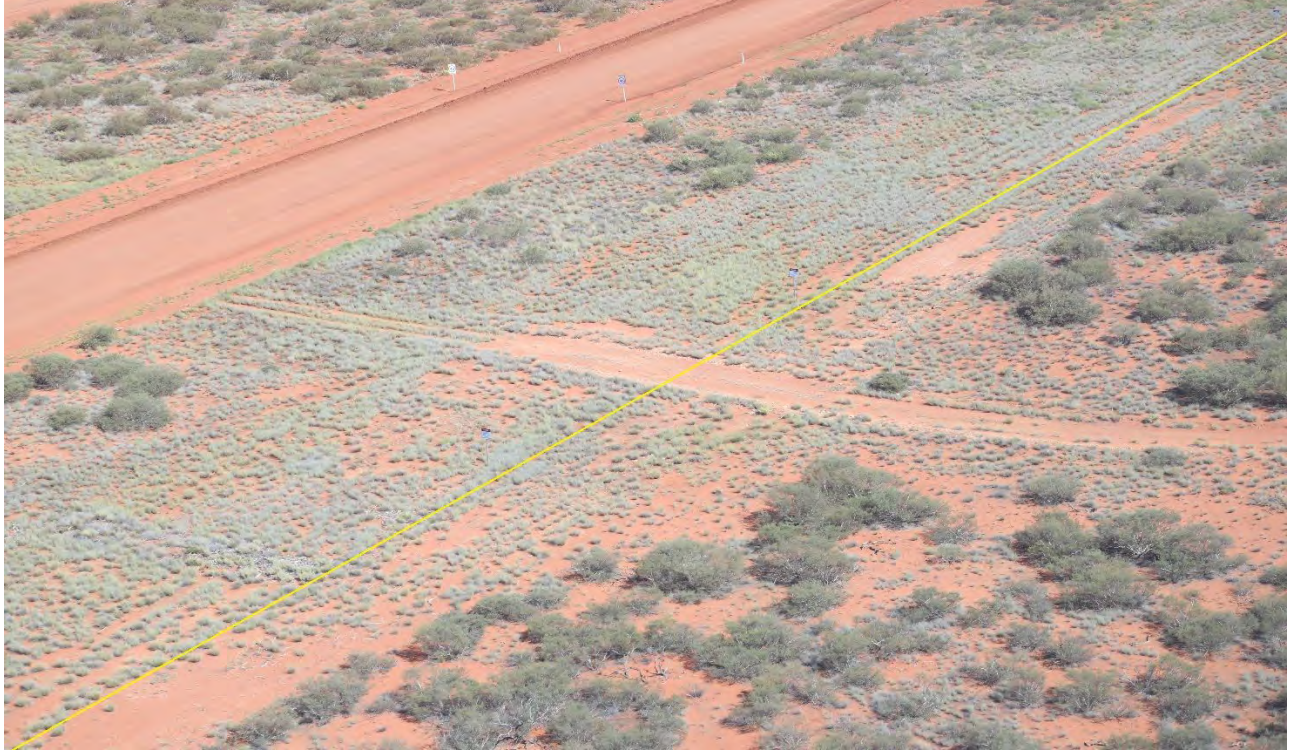
KP 268.41

- All appears correct at the track crossing.

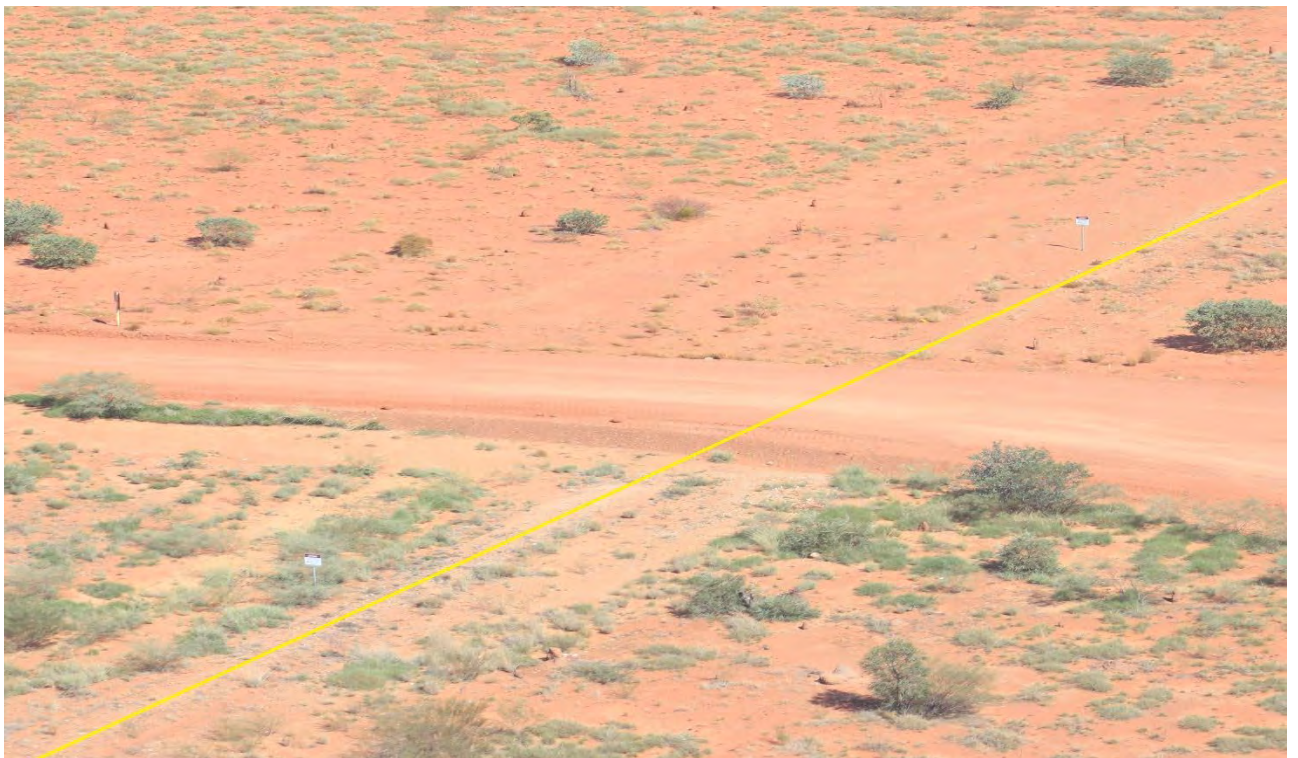
KP 272.35

- Road to the pre-existing borrow pit has been built up and is being utilised as access.
- This activity has been approved by LM and all appears correct.

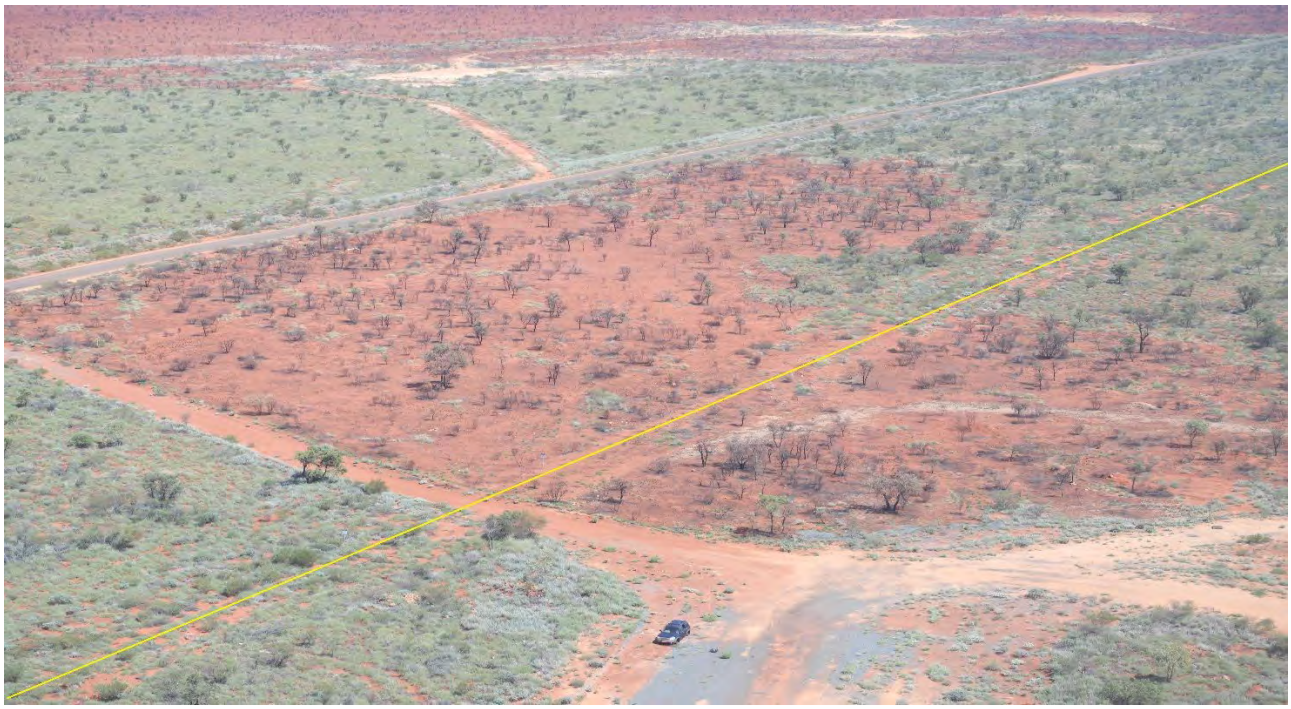
<p>KP 323.83</p>	<ul style="list-style-type: none"> • Access track and truck turn around site in proximity to the easement appears in good condition. • A recent small scrub fire has passed over the easement on the downstream side of the track, Danger signage remains readable.

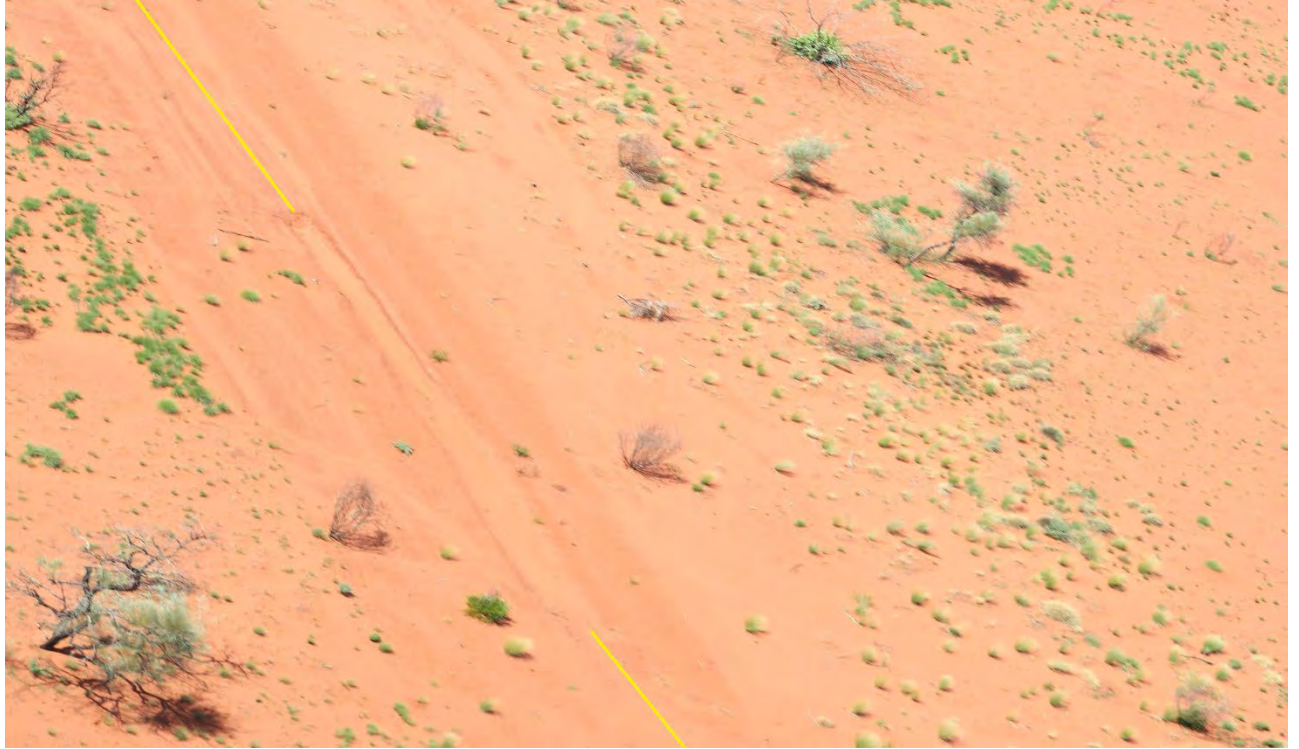
KP 366.95

- Below image details subsidence has occurred over the Tanami Pipeline. The NGL has dropped by approximately 100mm leaving an electronic DOC of 1600mm remaining.
- ASO's to continue monitoring.

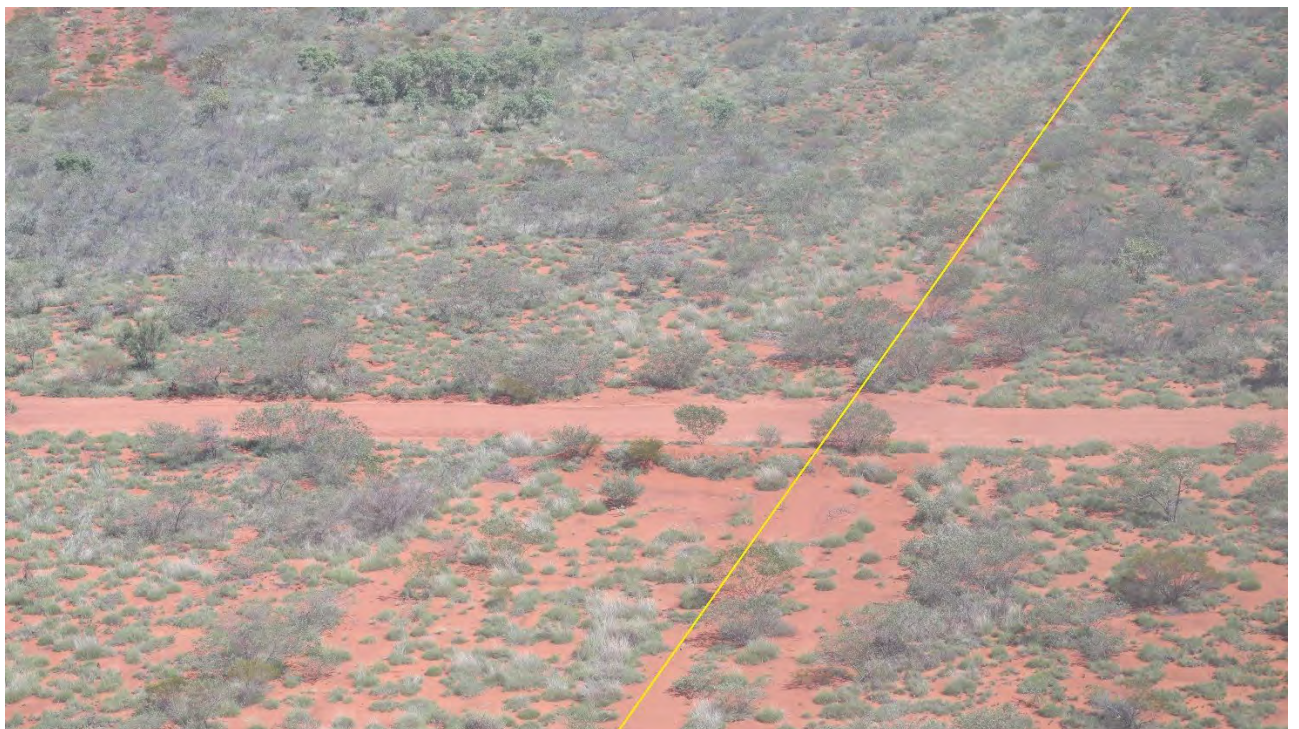
KP 385.45

- All correct at the road crossing; vegetation on the downstream side is now impacting line of sight.

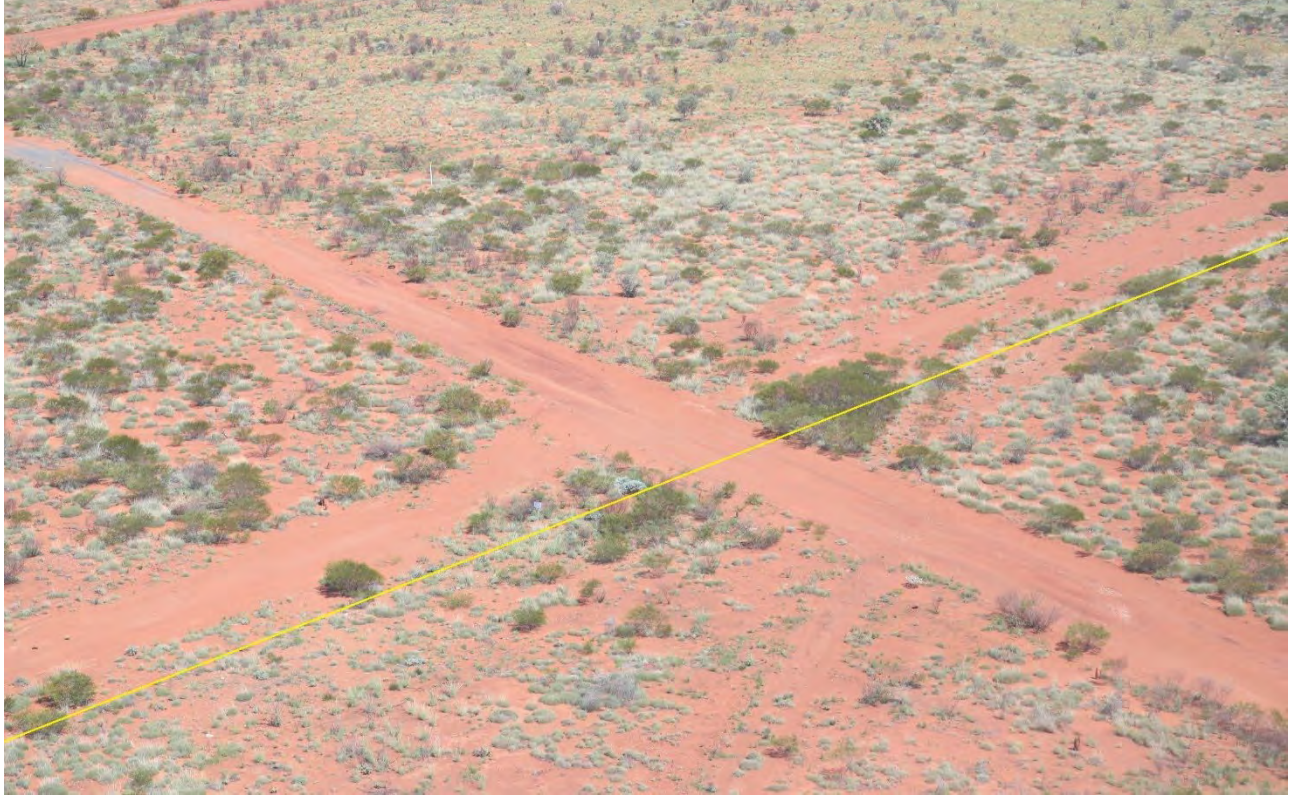
Mount Davidson / Billabong Borefield Rd
KP 390.58

- All correct at the road crossing; vegetation on the downstream side is now impacting line of sight.

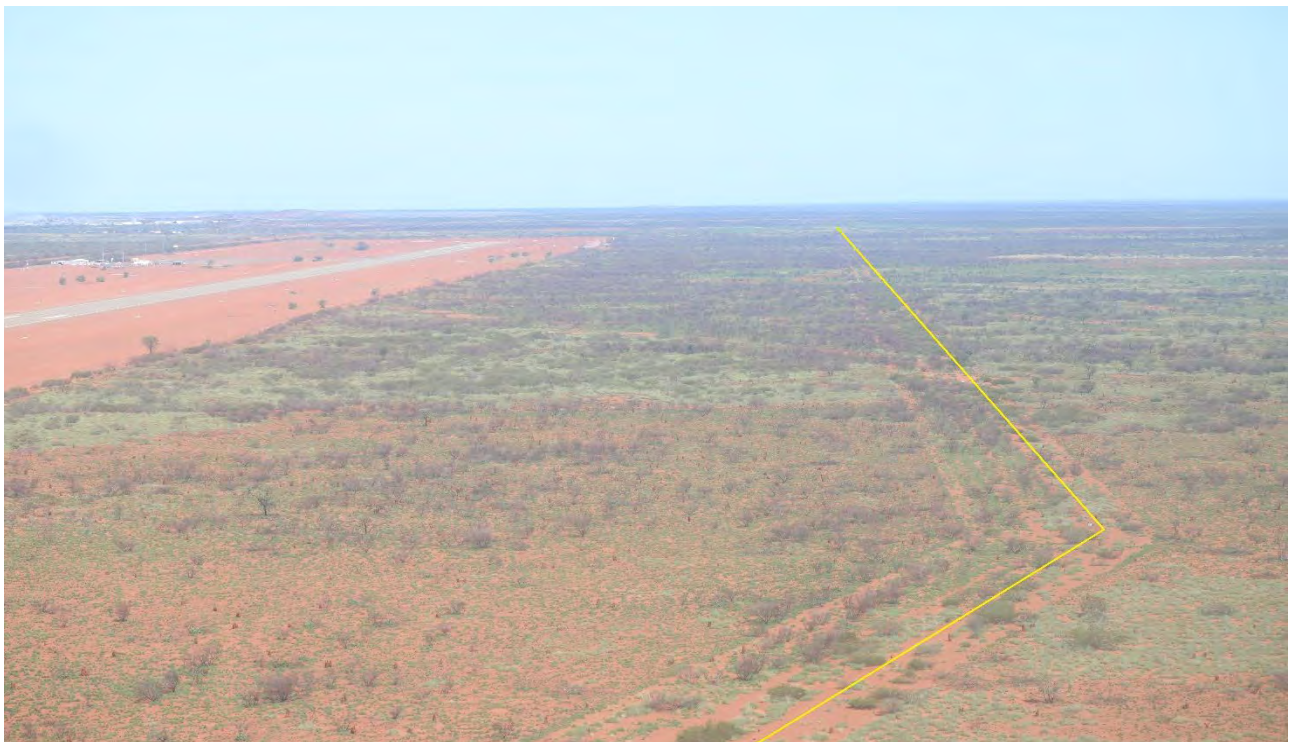
KP 395.10
Granites Airstrip

- Recent rain has increased vegetation in the area, line of sight issues developing.

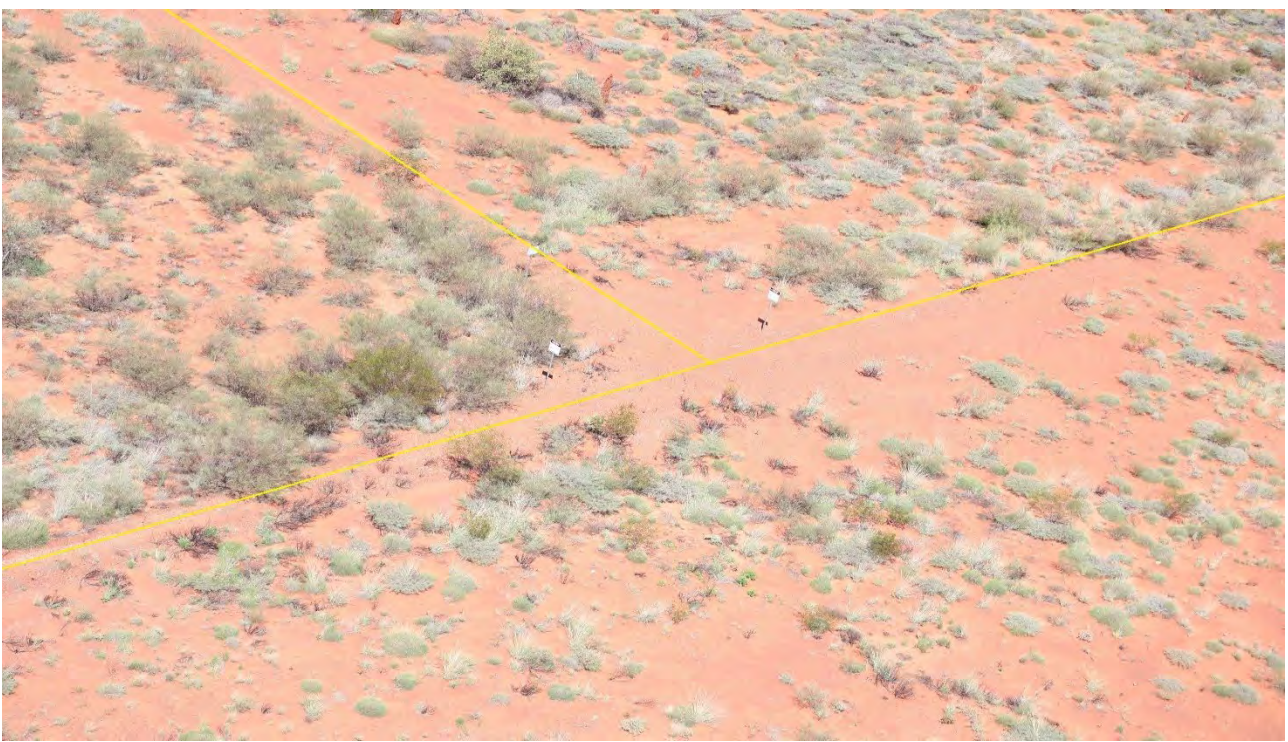
<p>Off take / Valve for Granites Lateral KP 397.84</p>	<ul style="list-style-type: none"> • All appeared correct; no changes to the previously reported drill pads cleared in proximity to the lateral.

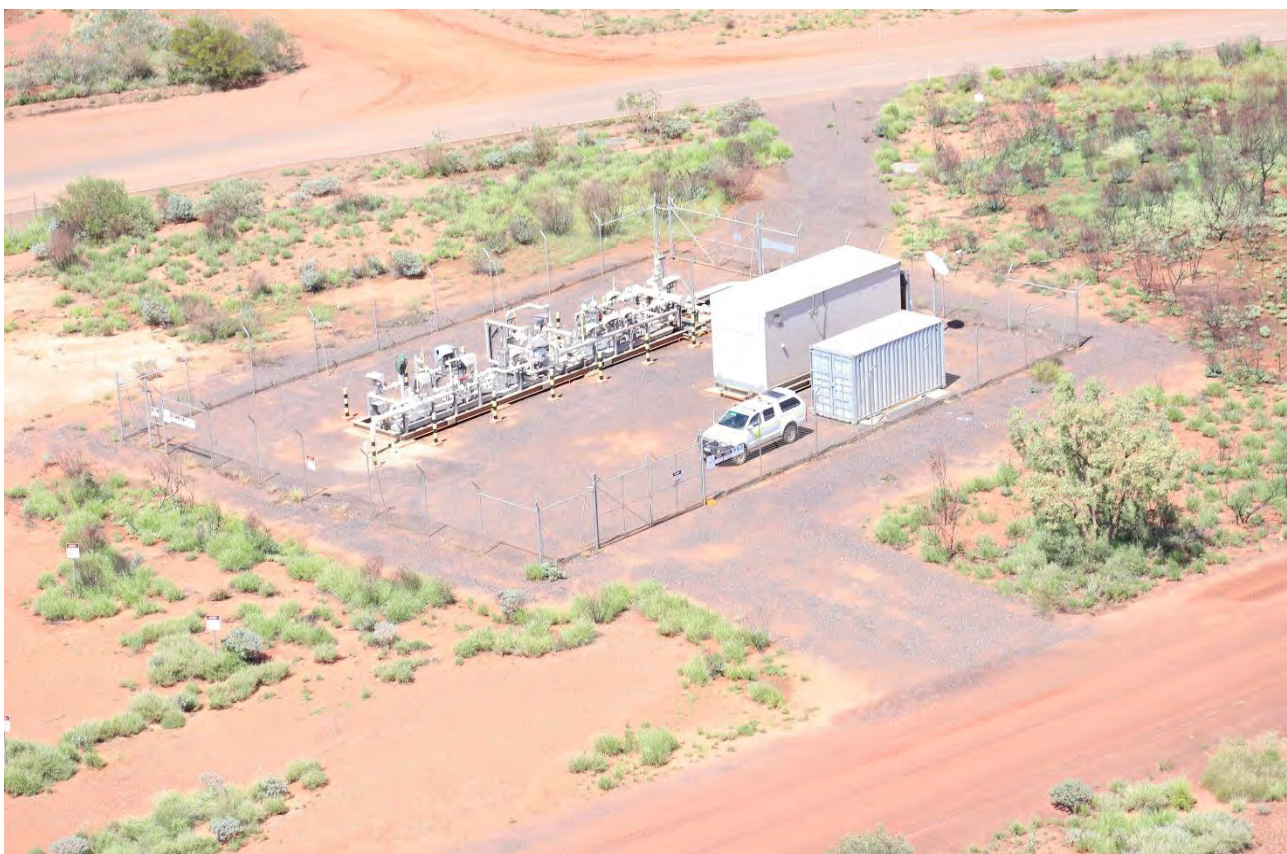
<p>Granites Meter Station KP 0.69</p>	<ul style="list-style-type: none"> All appeared correct and secure; vehicle DBP238 observed inside compound.

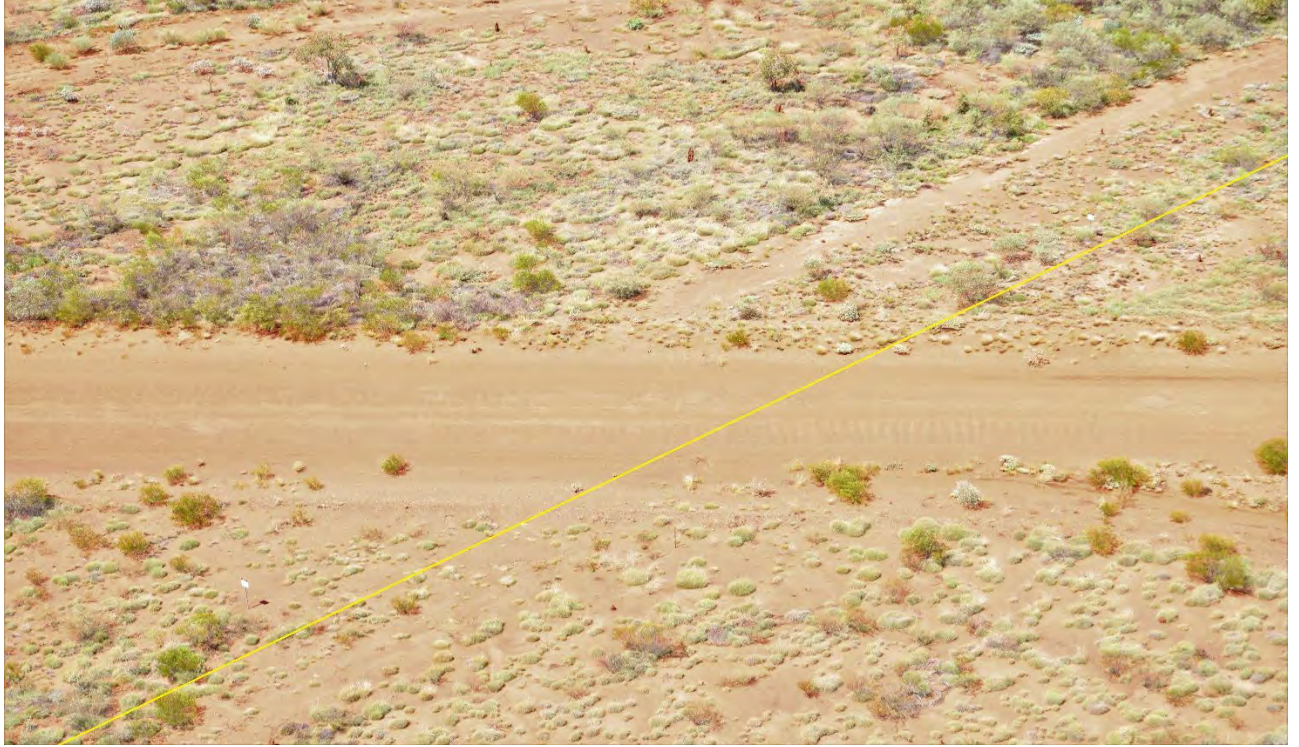
Setlist Hills
Borefield Rd

- Below image shows the current condition of the road crossing. No issue observed.

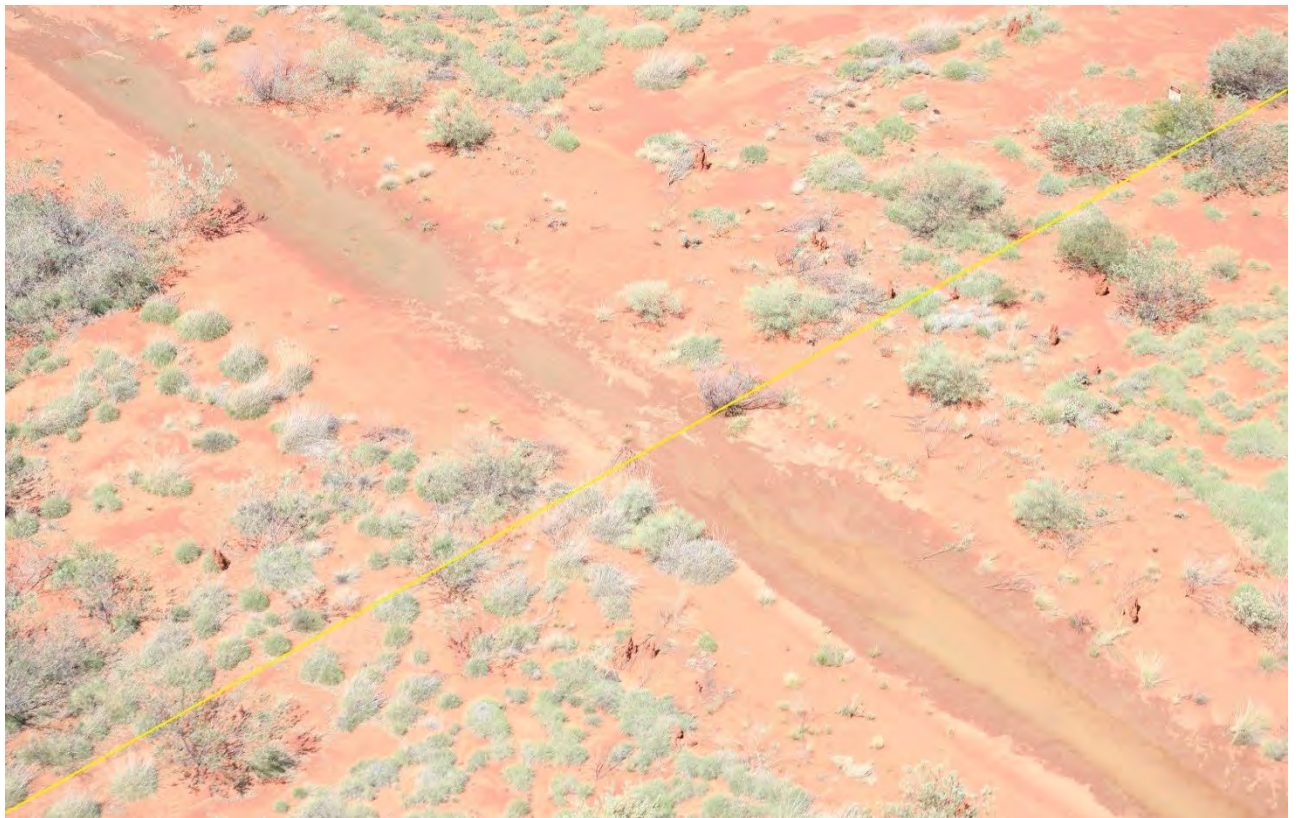
KP 436.07

- Recent heavy rains in the area remain in the Swale Drain.
- All appeared correct at time of flight.

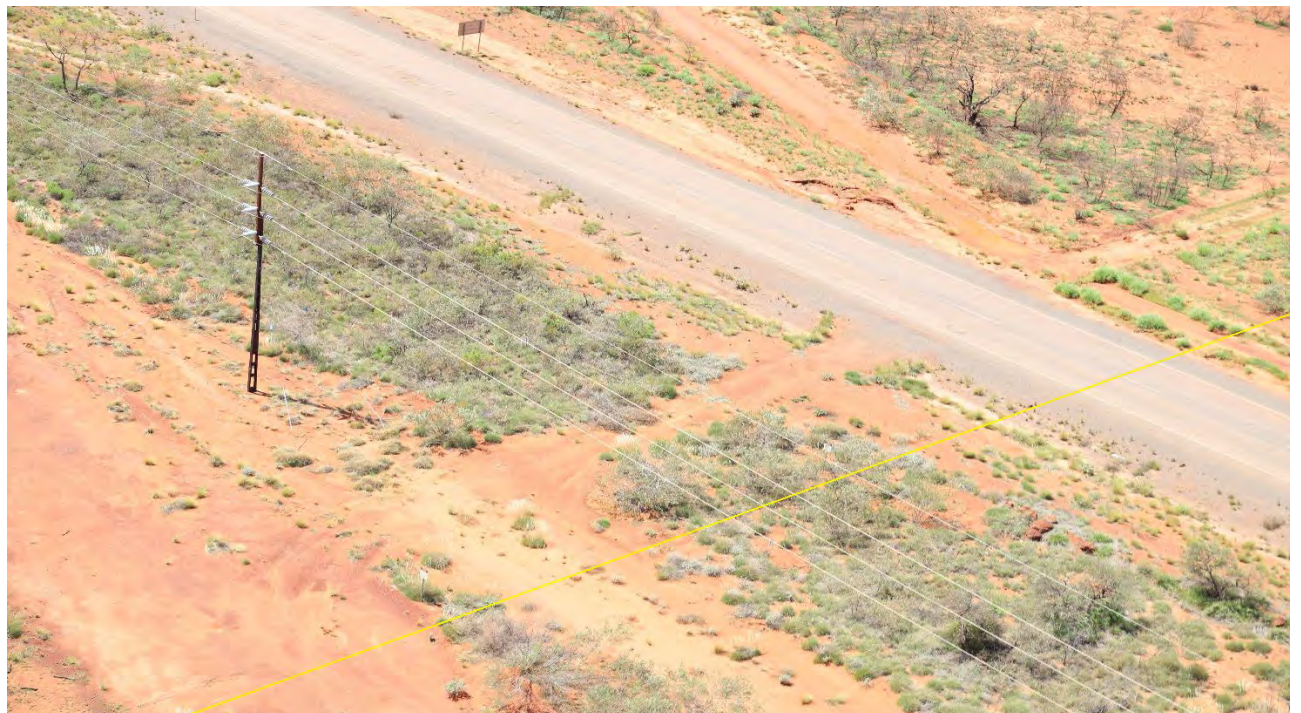
DBS Haul
Road
KP 436.99

- Below image shows the current condition of the haul road crossing point.

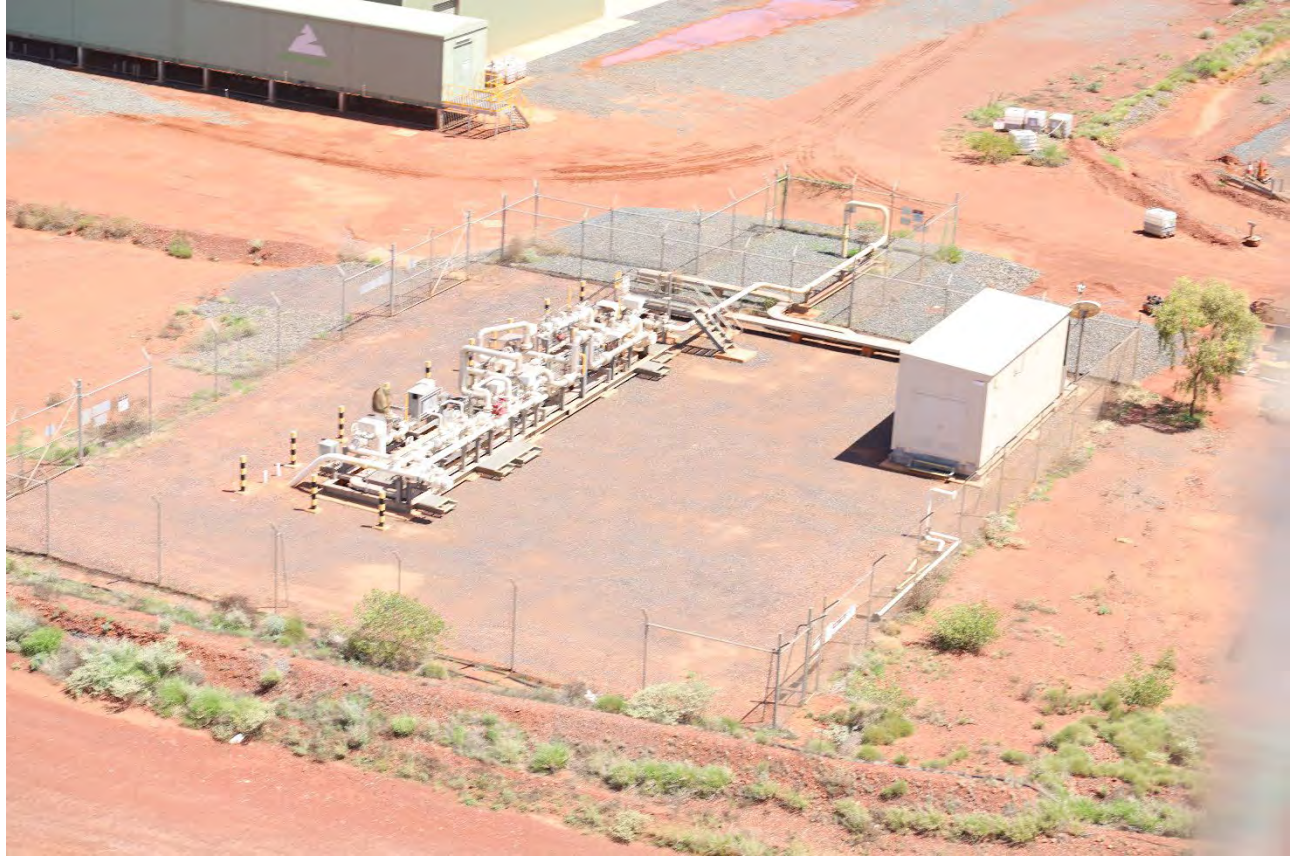
DBS Meter
Station & Haul
Road
KP 440.00

- All appeared correct and secure.
