TANAMI GAS PIPELINE
ANNUAL COMPLIANCE ASSESSMENT REPORT
EPBC 2017 / 7997

E-REP-069

Rev 1

AERIAL SURVEILLANCE REPORT

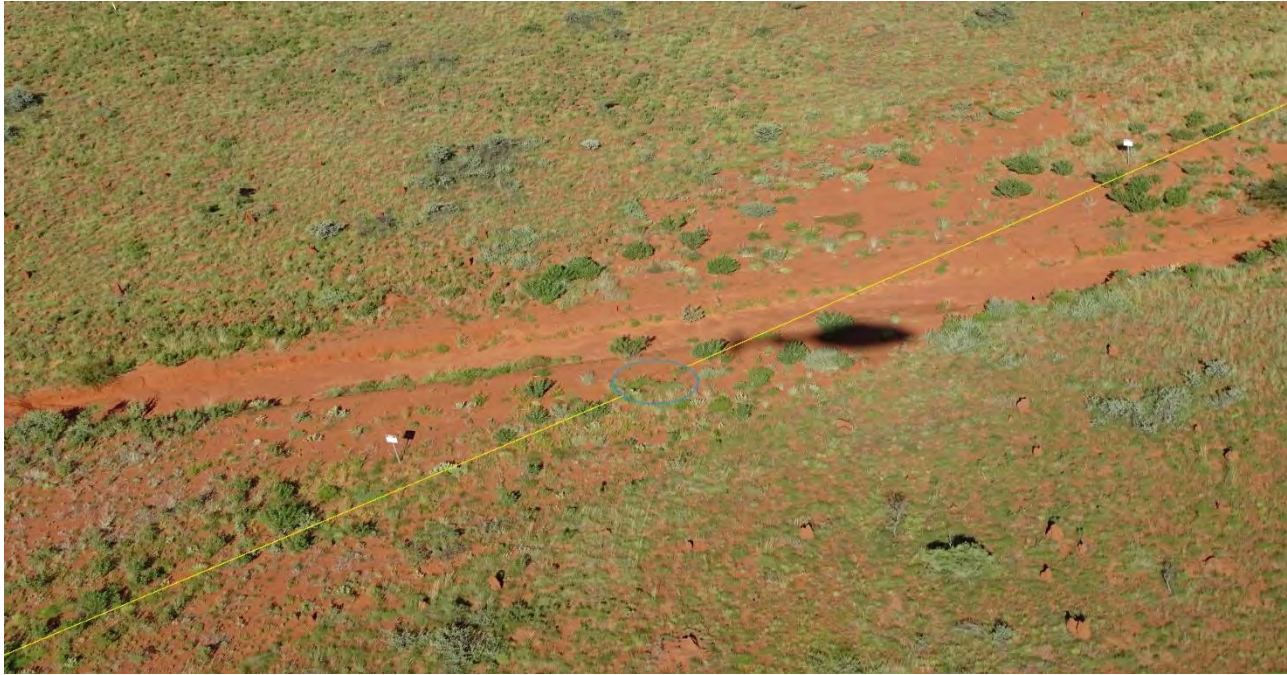
Location	Comment
<p>KP 241.139</p>	<ul style="list-style-type: none"> No changes to known significant erosion on the upstream bank of the swale drain crossing at KP 241.139

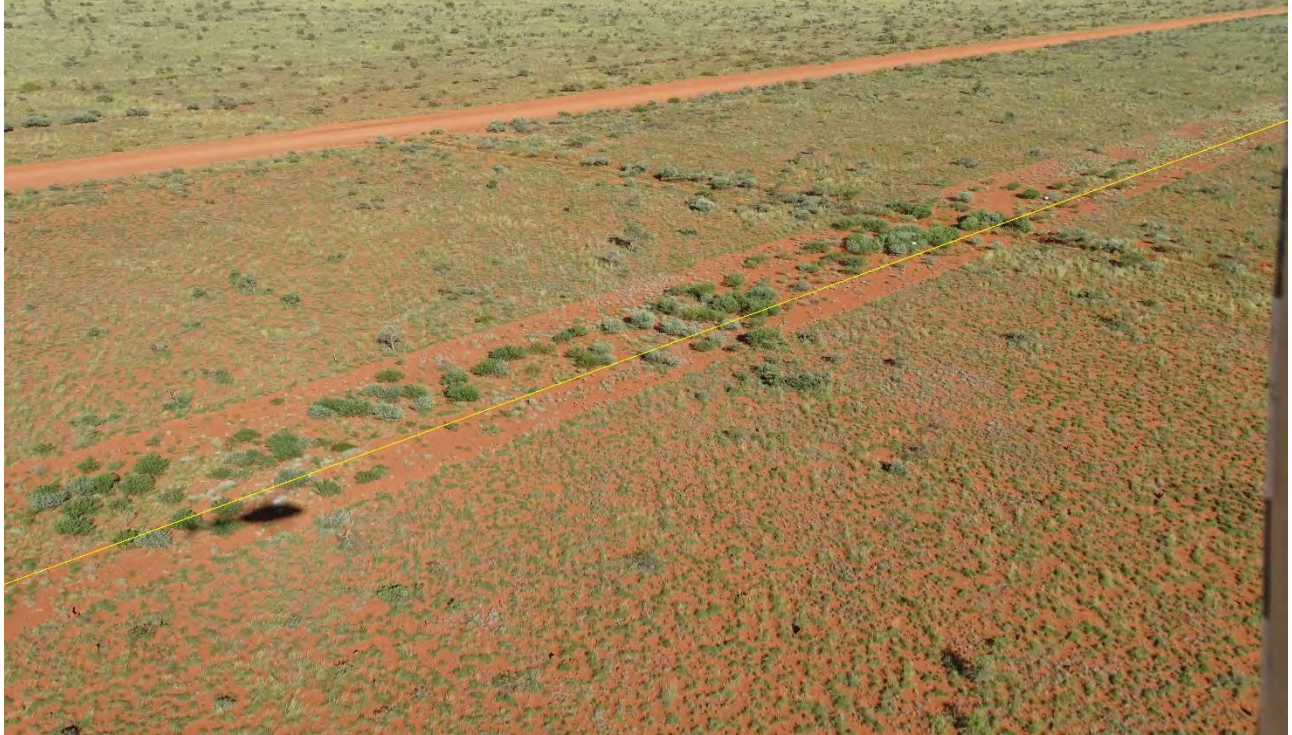
Location	Comment
<p>KP 258.300</p>	<ul style="list-style-type: none"> Below image shows vegetation overgrowth in this section is starting to block line of sight.

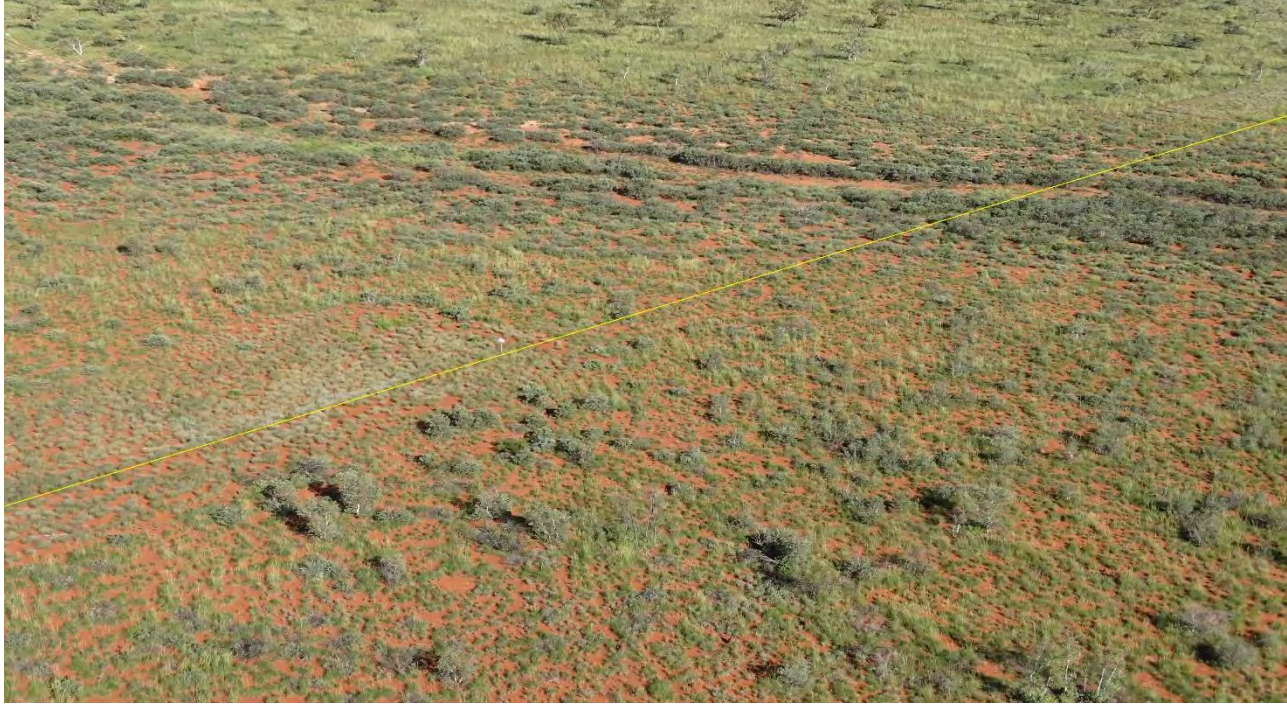
Location	Comment
<p>Watercourse T2 Chilla Well KP 266.640</p>	<ul style="list-style-type: none"> All appeared correct at the watercourse at KP 266.640.

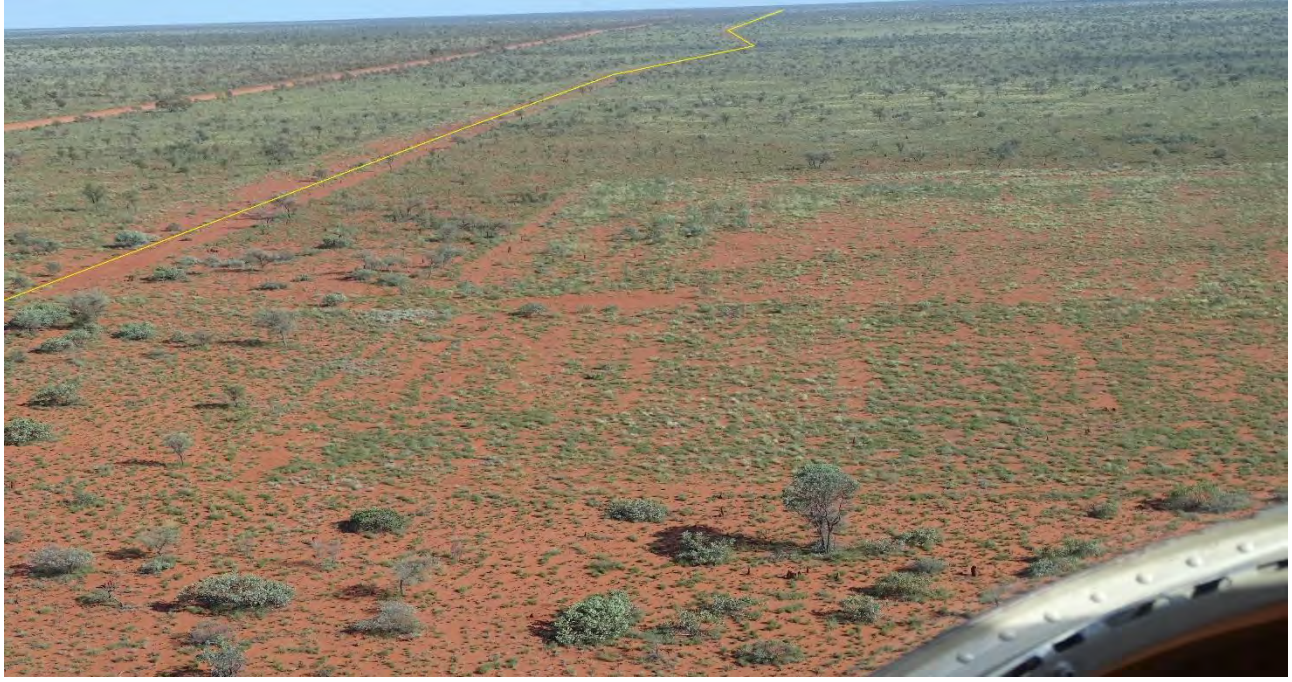
Location	Comment
<p>Camp 3/Laydown KP 286.291</p>	<ul style="list-style-type: none"> All correct at previous camp/laydown yard.

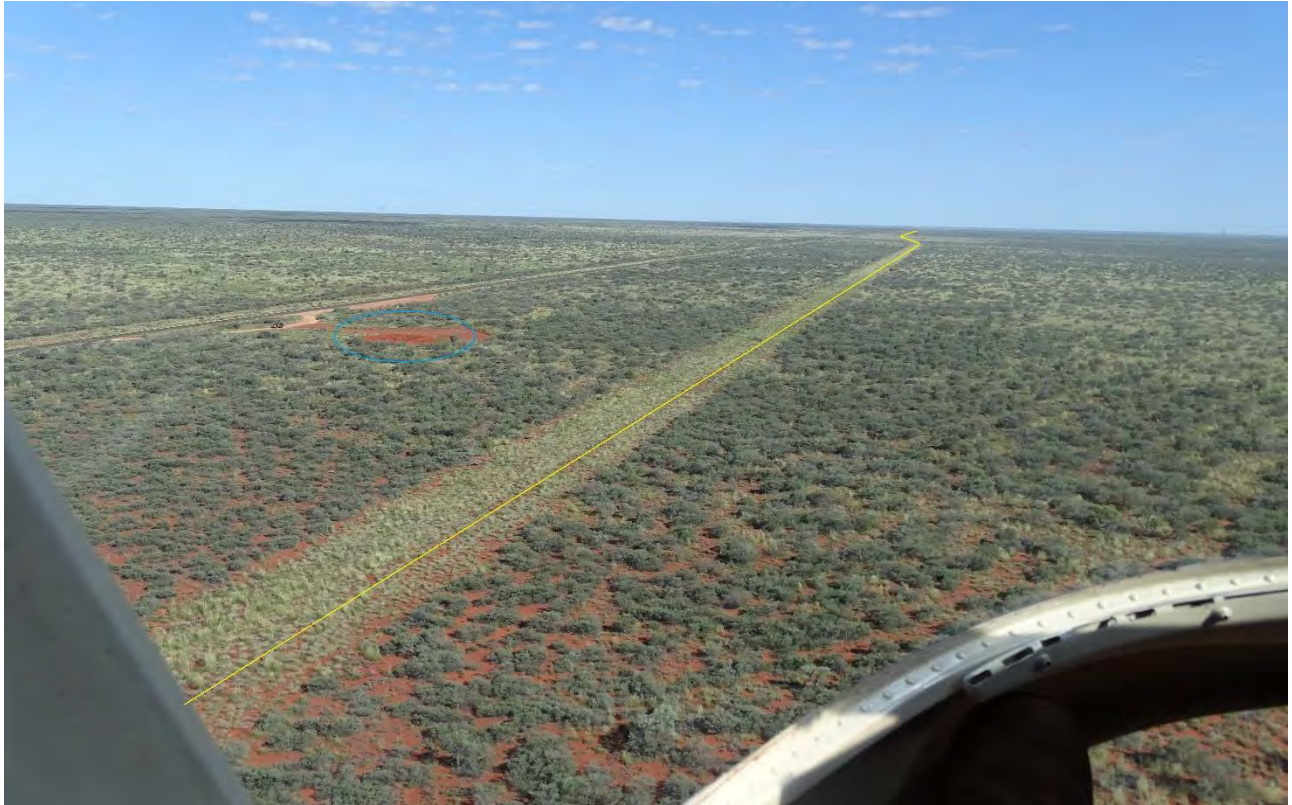
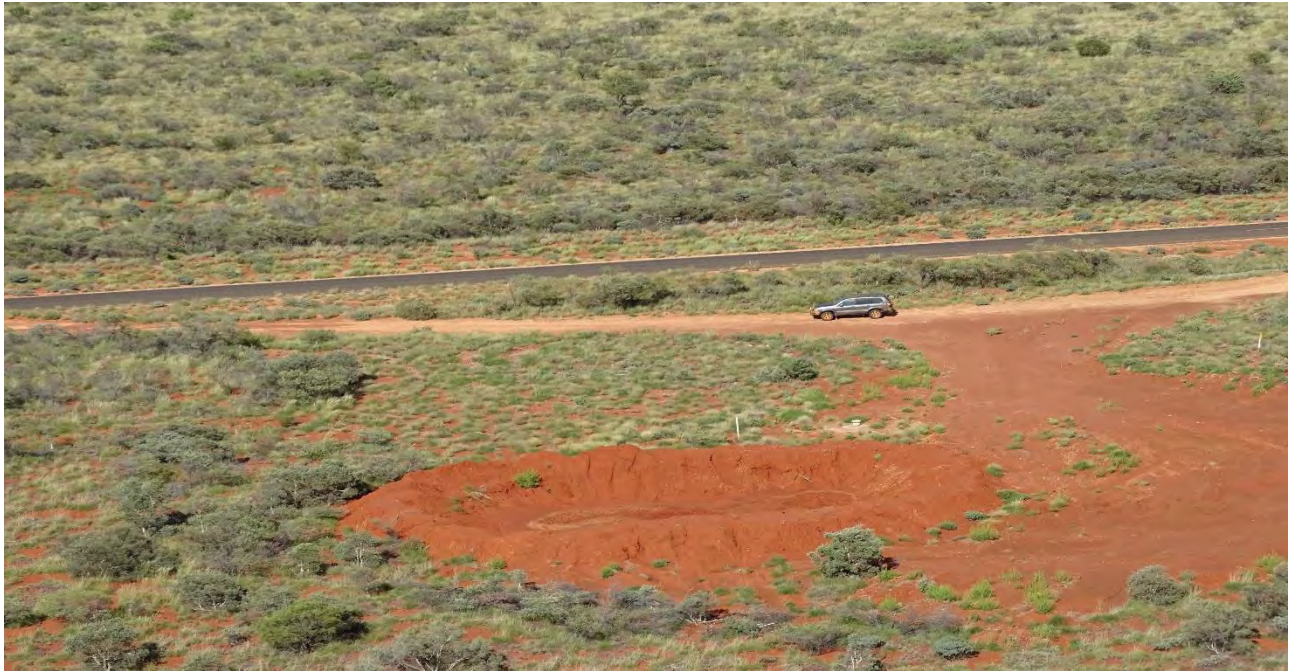
Location	Comment
<p>KP 328.830</p>	<ul style="list-style-type: none"> Below image shows excavation have occurred in proximity to the easement since the previous flight; all remained clear of the easement.

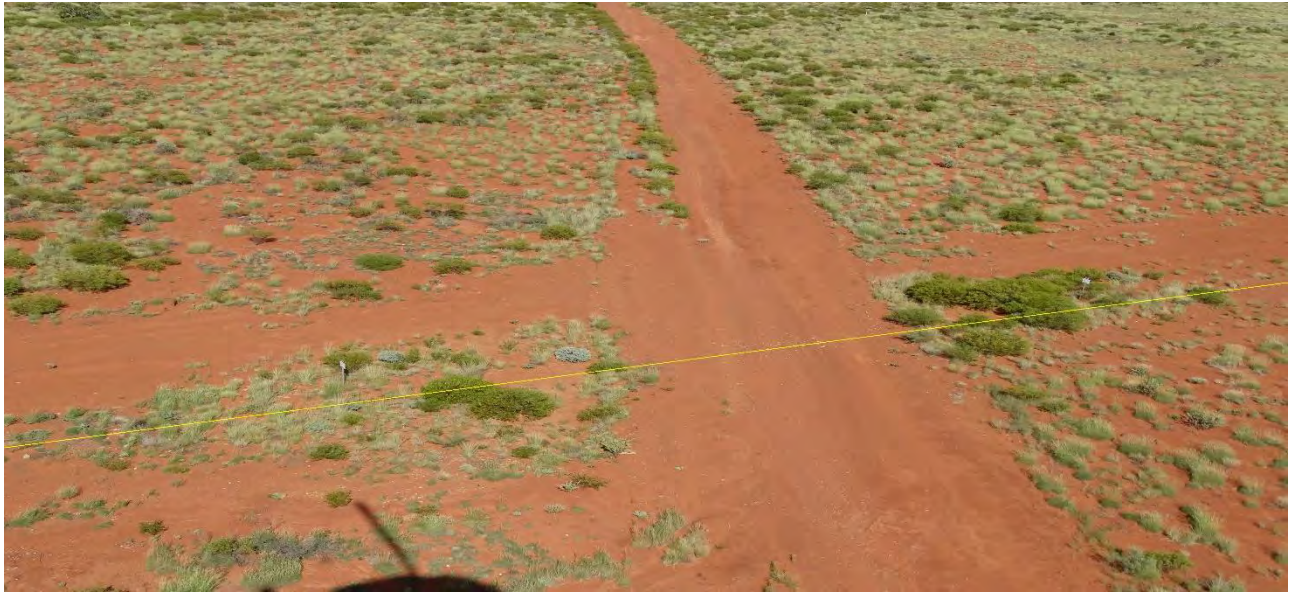
Location	Comment
Camp 4/Laydown No.1 KP 385.321	<ul style="list-style-type: none"> All correct at previous camp/laydown yard.
Mount Davidson/ Billabong Borefield Rd KP 390.576	<ul style="list-style-type: none"> All correct at the road crossing. Vegetation on the downstream side starting to impact line of sight.

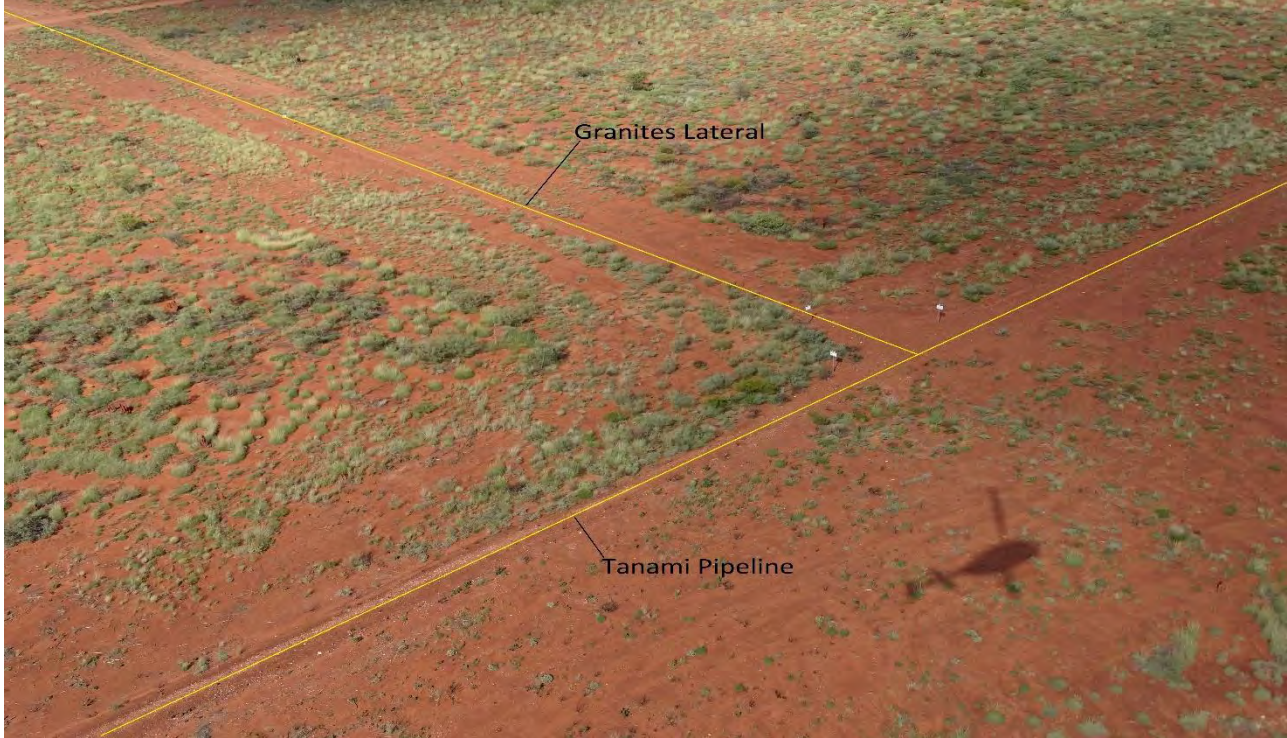
Location	Comment
<p>Off take/Valve for Granites lateral KP 397.837</p>	<ul style="list-style-type: none"> All appeared correct.

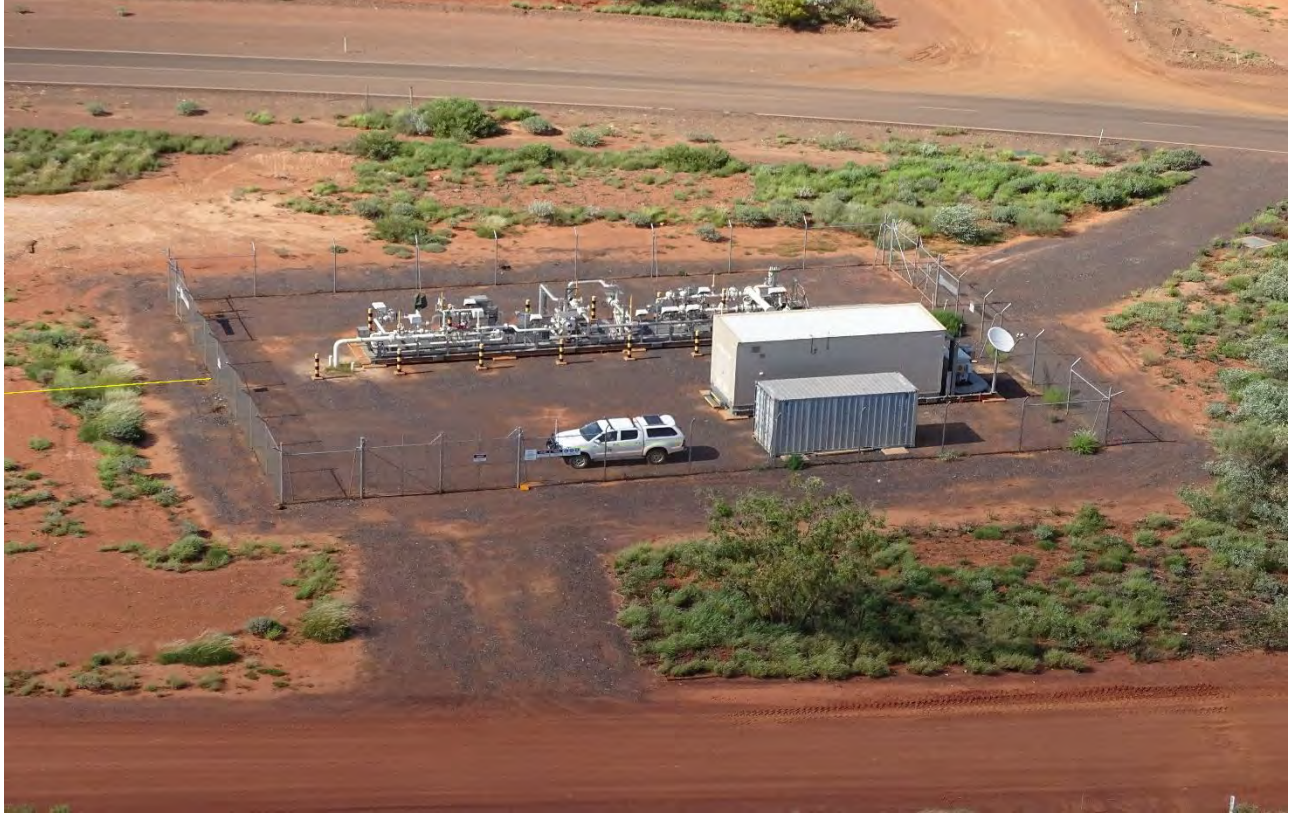
Location	Comment
<p>Granites Meter Station KP 0.69</p>	<ul style="list-style-type: none"> All correct and secure at Granites Meter Station.

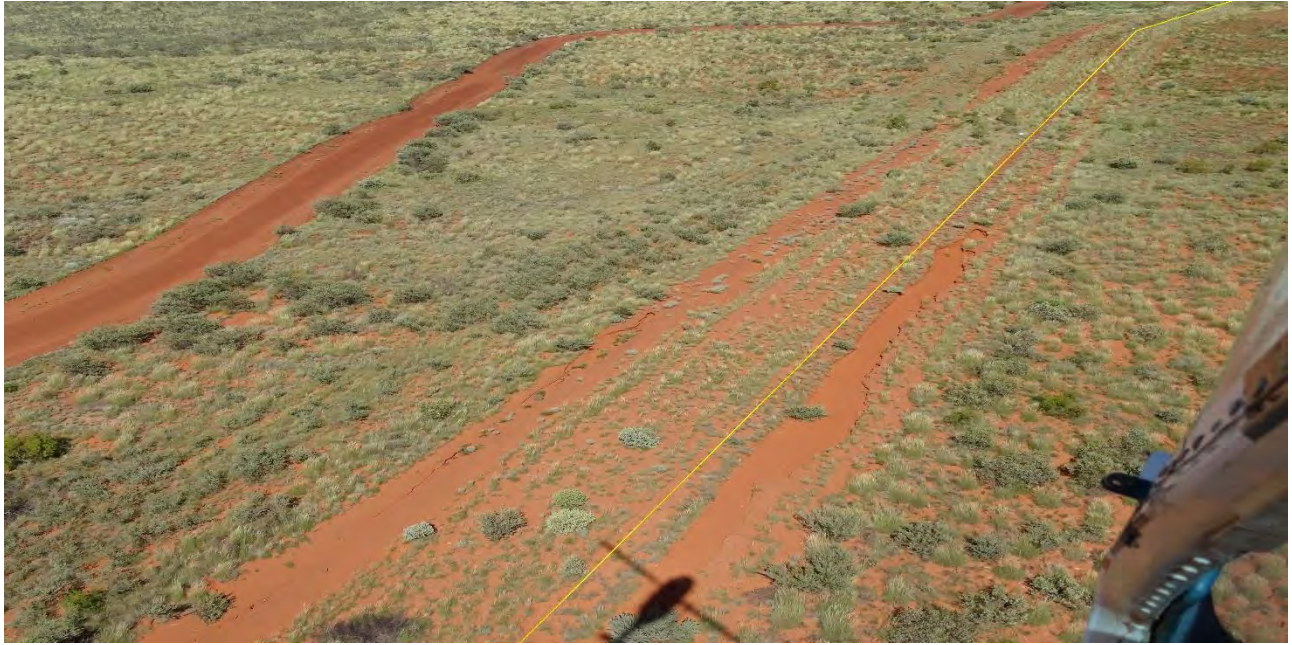
Location	Comment
<p>KP 439.470</p>	<ul style="list-style-type: none"> • No changes to previously reported significant erosion. • Facilities maintenance team attended site 10/08/2021 and completed site assessment. • Erosion confirmed 500mm in depth.
